East Influent Siphon Project

**San Bernardino Municipal
Water Department**

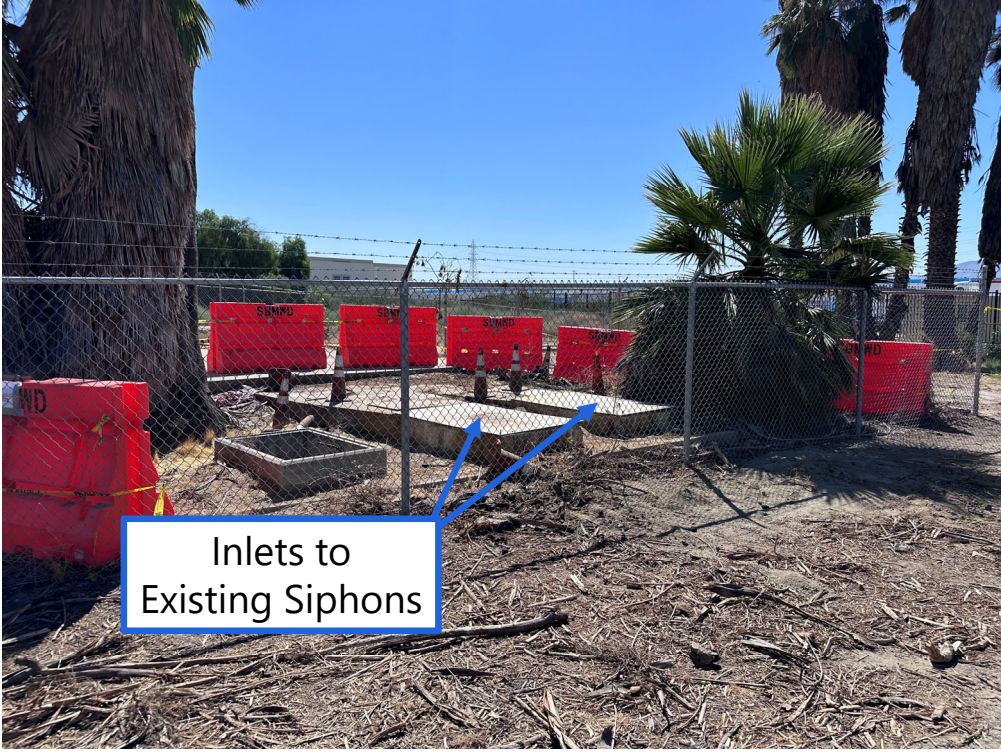
The old siphon structure was on the verge of collapse.

Originally built in June of 1973

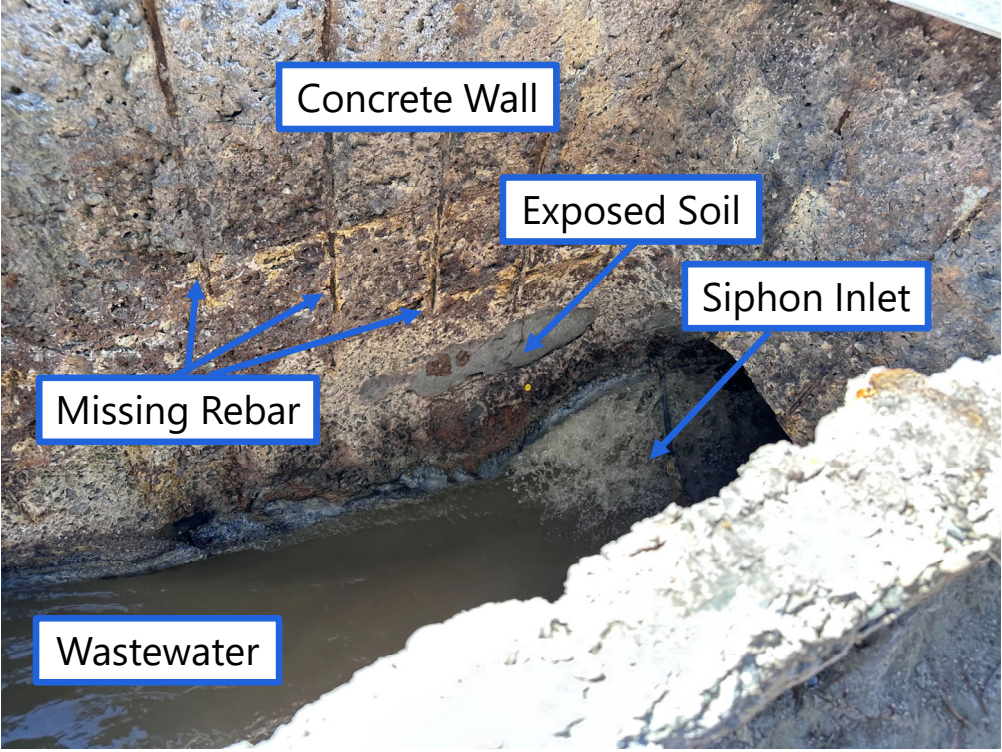
Looking into siphon inlet

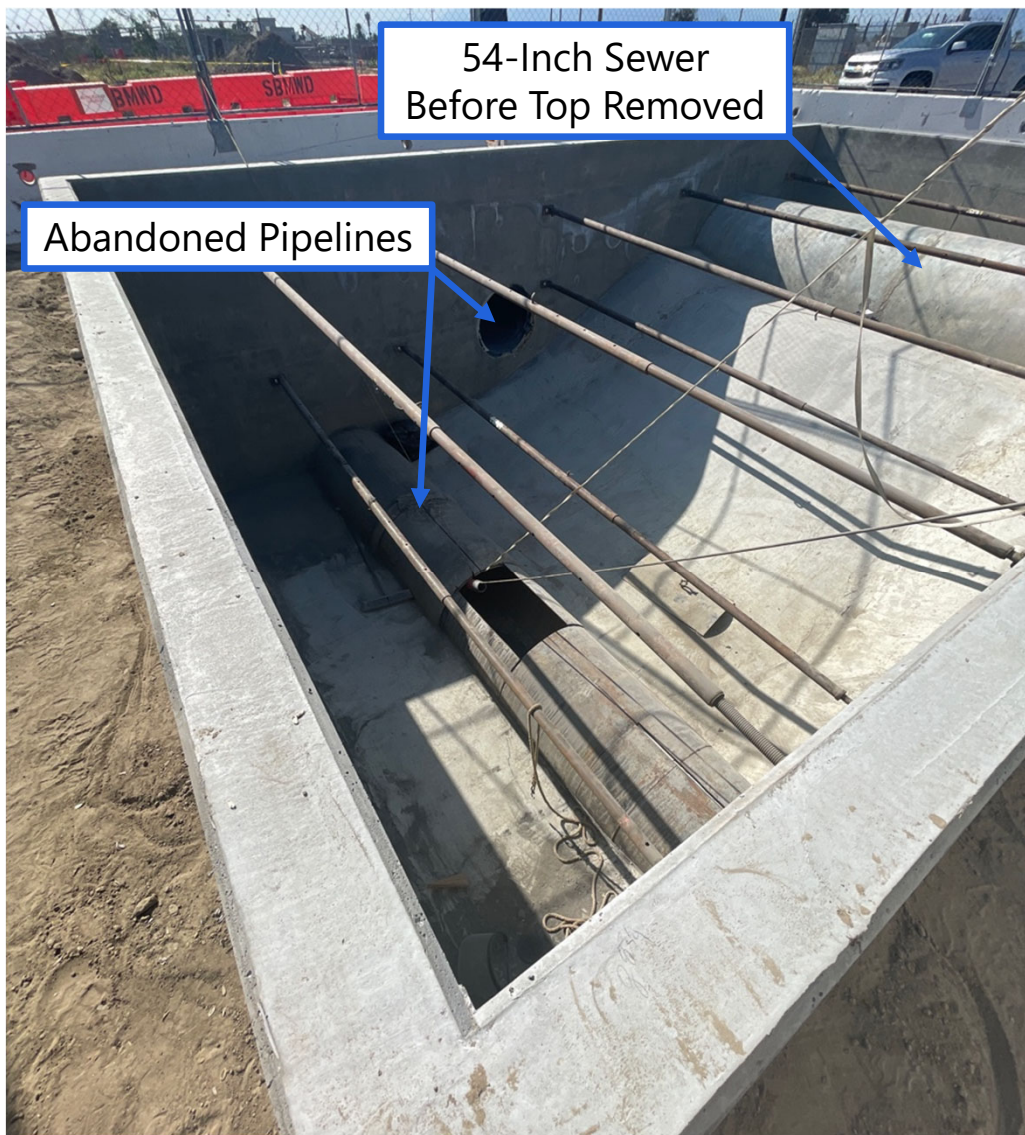
54-Inch Bypass Pit

Flow from the 54-inch sewer had to be redirected to the two abandoned pipelines.

The 54-inch sewer was to be opened and plugged to force water into the concrete box and flow down into the existing abandoned pipes.

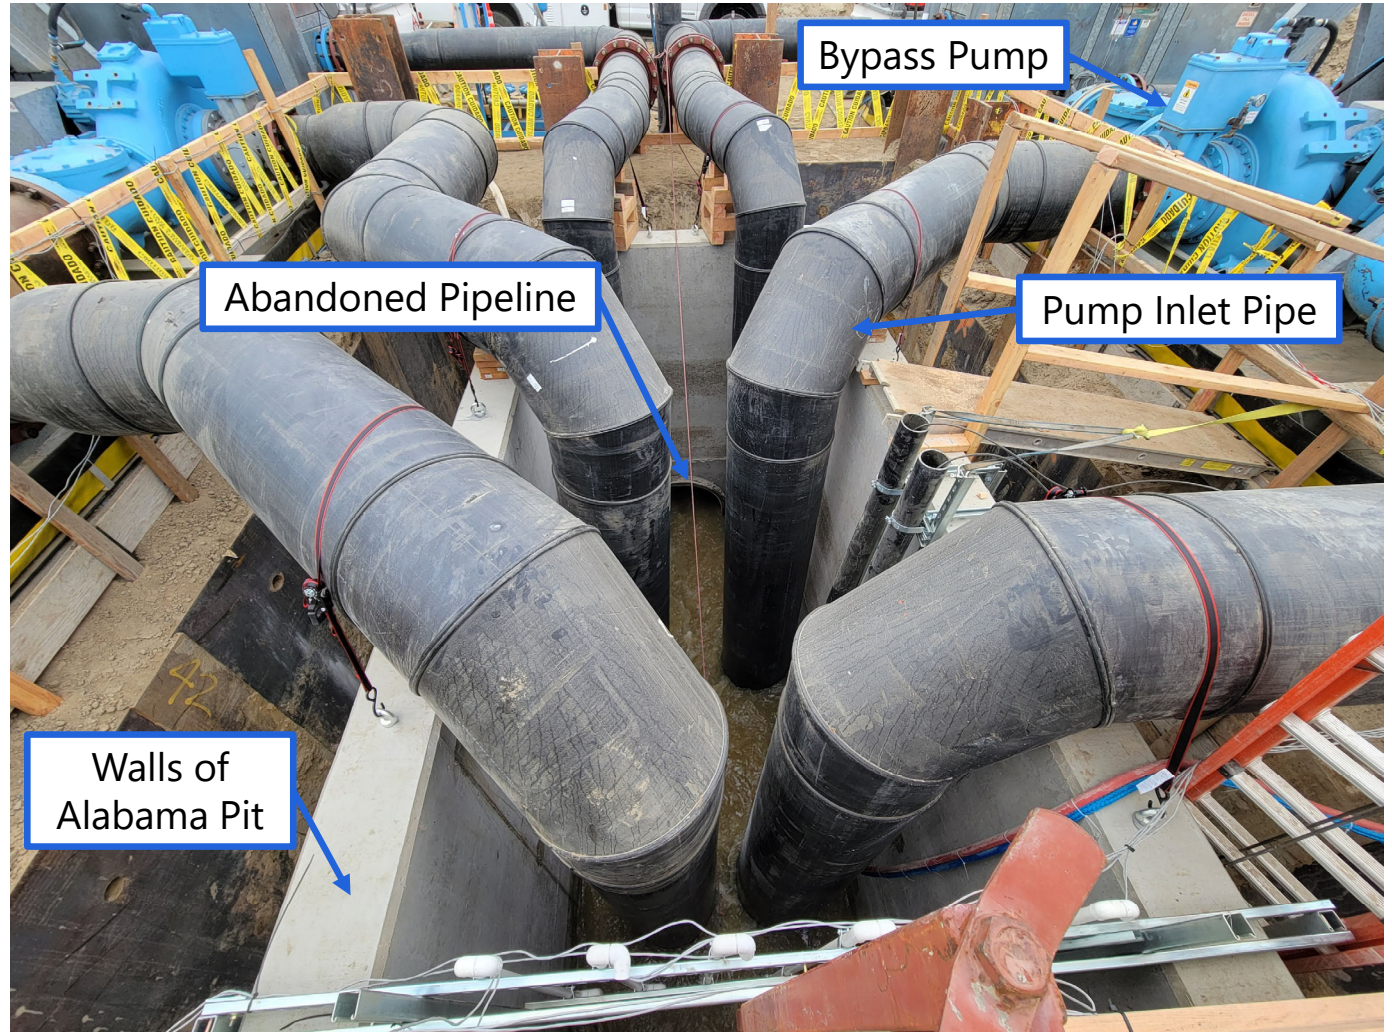
Alabama Pit

Flow from the abandoned pipelines was collected in the Alabama Pit.

Pumps took the water and sent it to the start of the treatment plant.

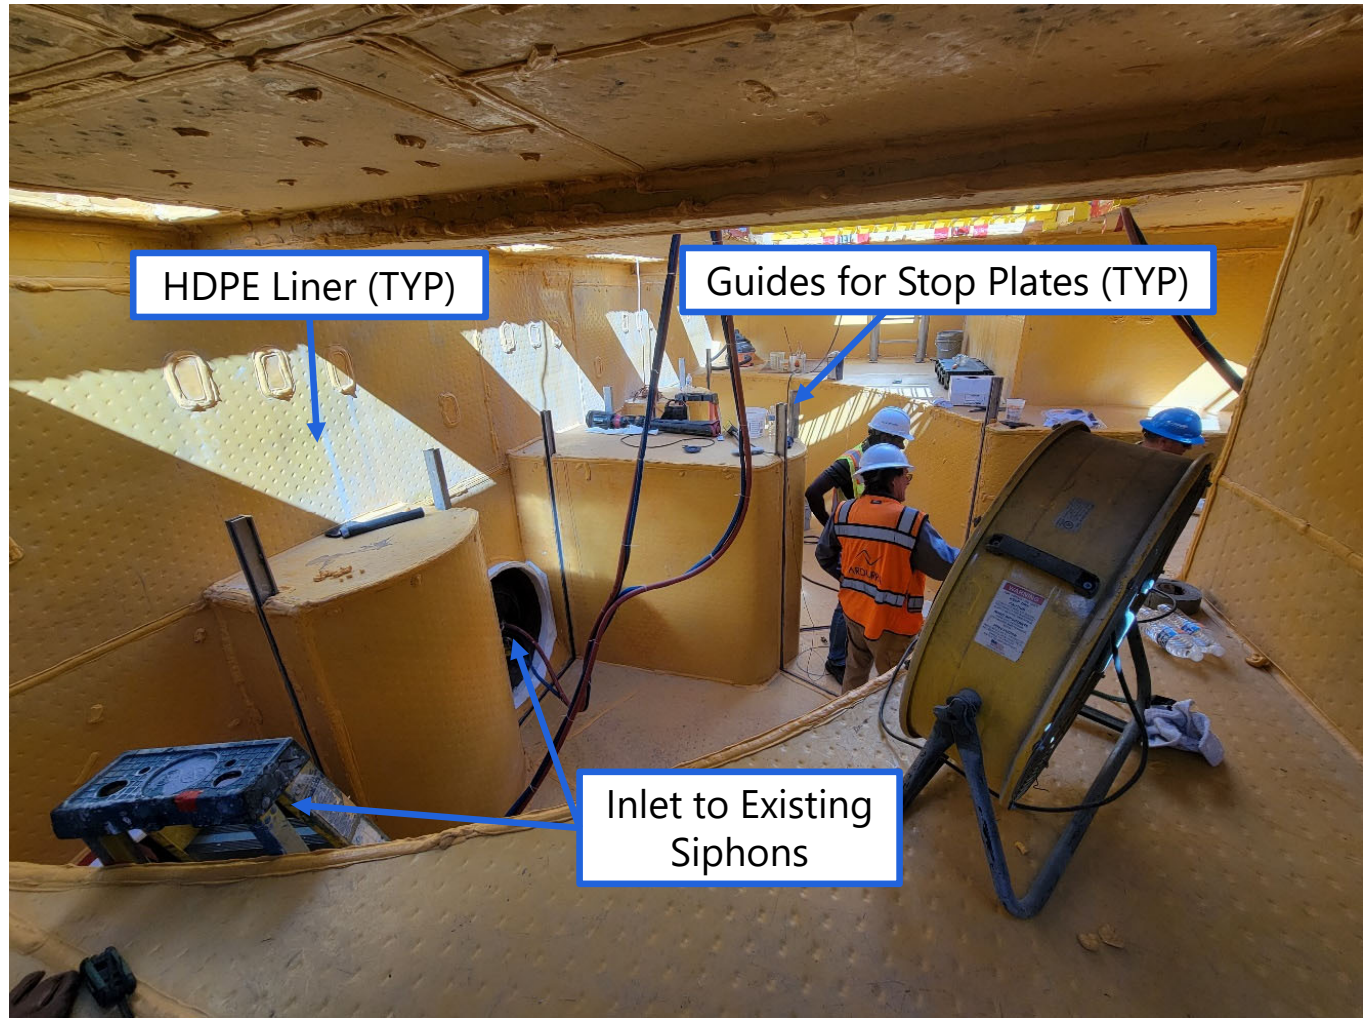
Interior of New Siphon Structure

HDPE liner was used to provide corrosion protection.
