Discovery of unknown “chalk-like” substance found in collection system

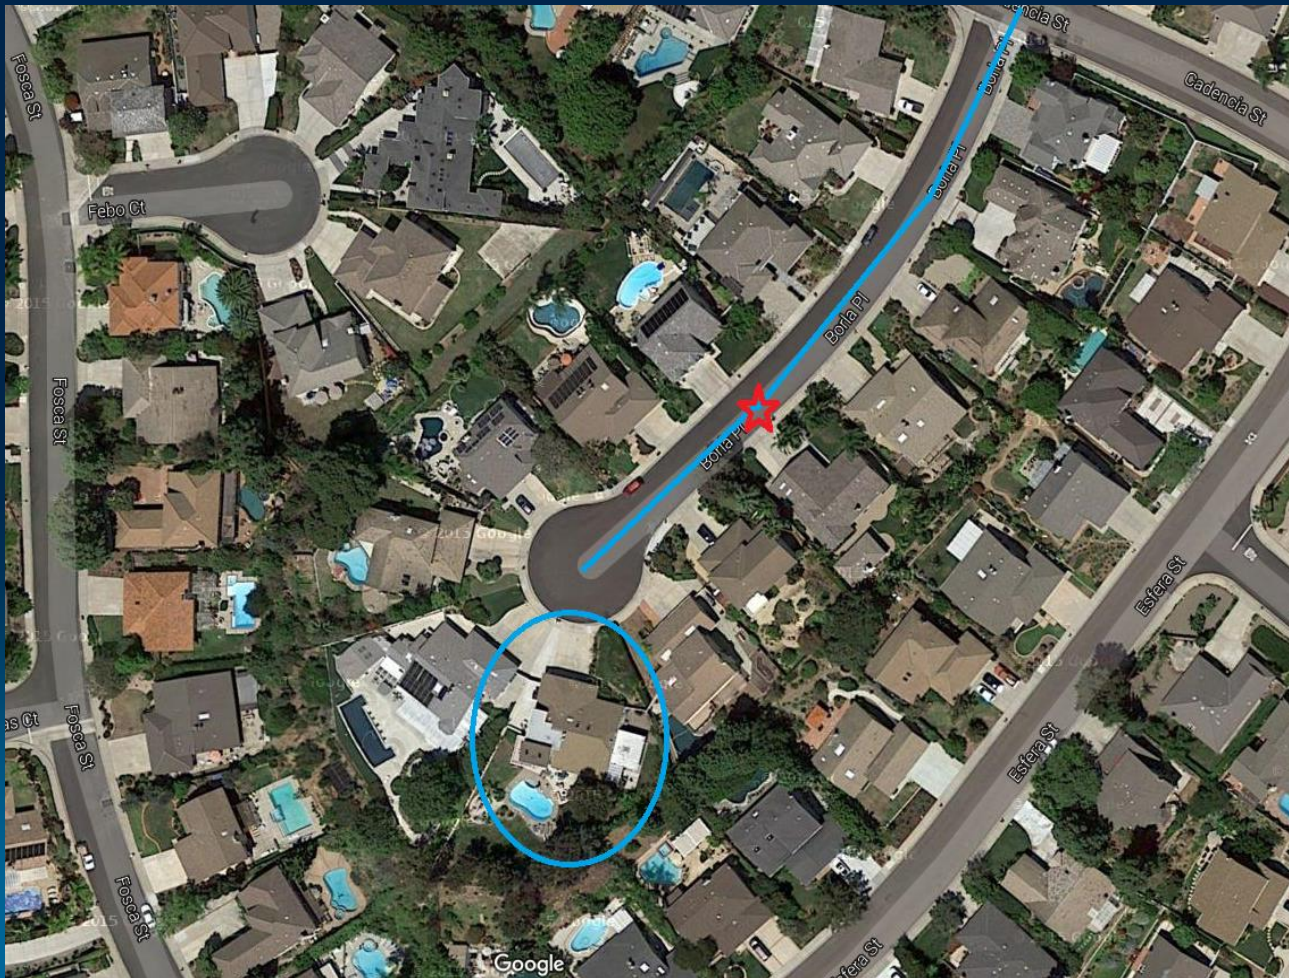
When was it first discovered?

- Date first observed:
 - June 1 2015 on Borla Place off Cadencia Street.

- Hydro-Cleaning PVC section on Borla Place
- Vactor nozzle stuck on its return
- Multiple pieces of “unknown” material protruding into manhole
- Removed and collected “unknown” substance
 - blue in color
 - smelled like cement

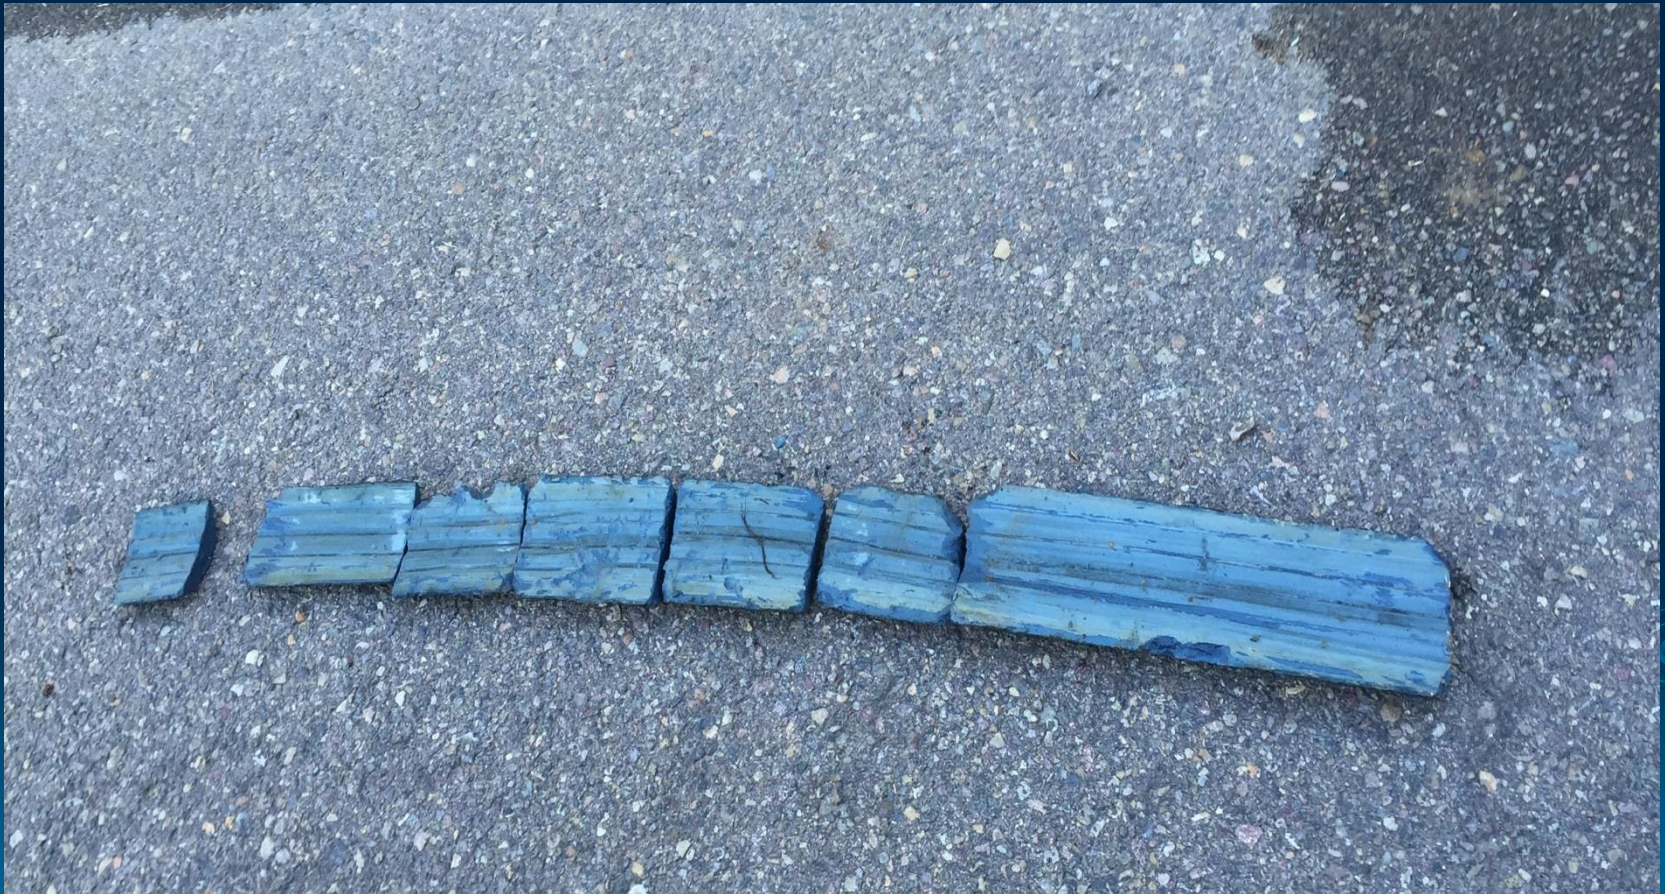
Samples of substance

- Lab results
 - Gives chemical composition of substance, but could not specifically identify product
- Leslie Spa and Plumbing Supply
 - Pool repair kits (possible, but unlikely)
- Mission Pools
 - Newer technology of pool finishing (more likely)
- Pool finishing process
 - Interior wall of pool is smoothed by combining a wax/caulk-like substance with water which is then “vacuumed” up in the finalizing process

- Customer outreach:
 - Downstream newsletter article
 - Website notification
- Digs alerts for pools:
 - Contact customer/contractor
- Field Service crews encounter blue substance, have CCTV crew investigate ASAP.
