CITY OR AGENCY NAME:
Victor Valley Wastewater Reclamation Authority

FACILITY NAME:
Victor Valley Wastewater Reclamation Authority

NON-DISPERSIBLES INCIDENT REPORT

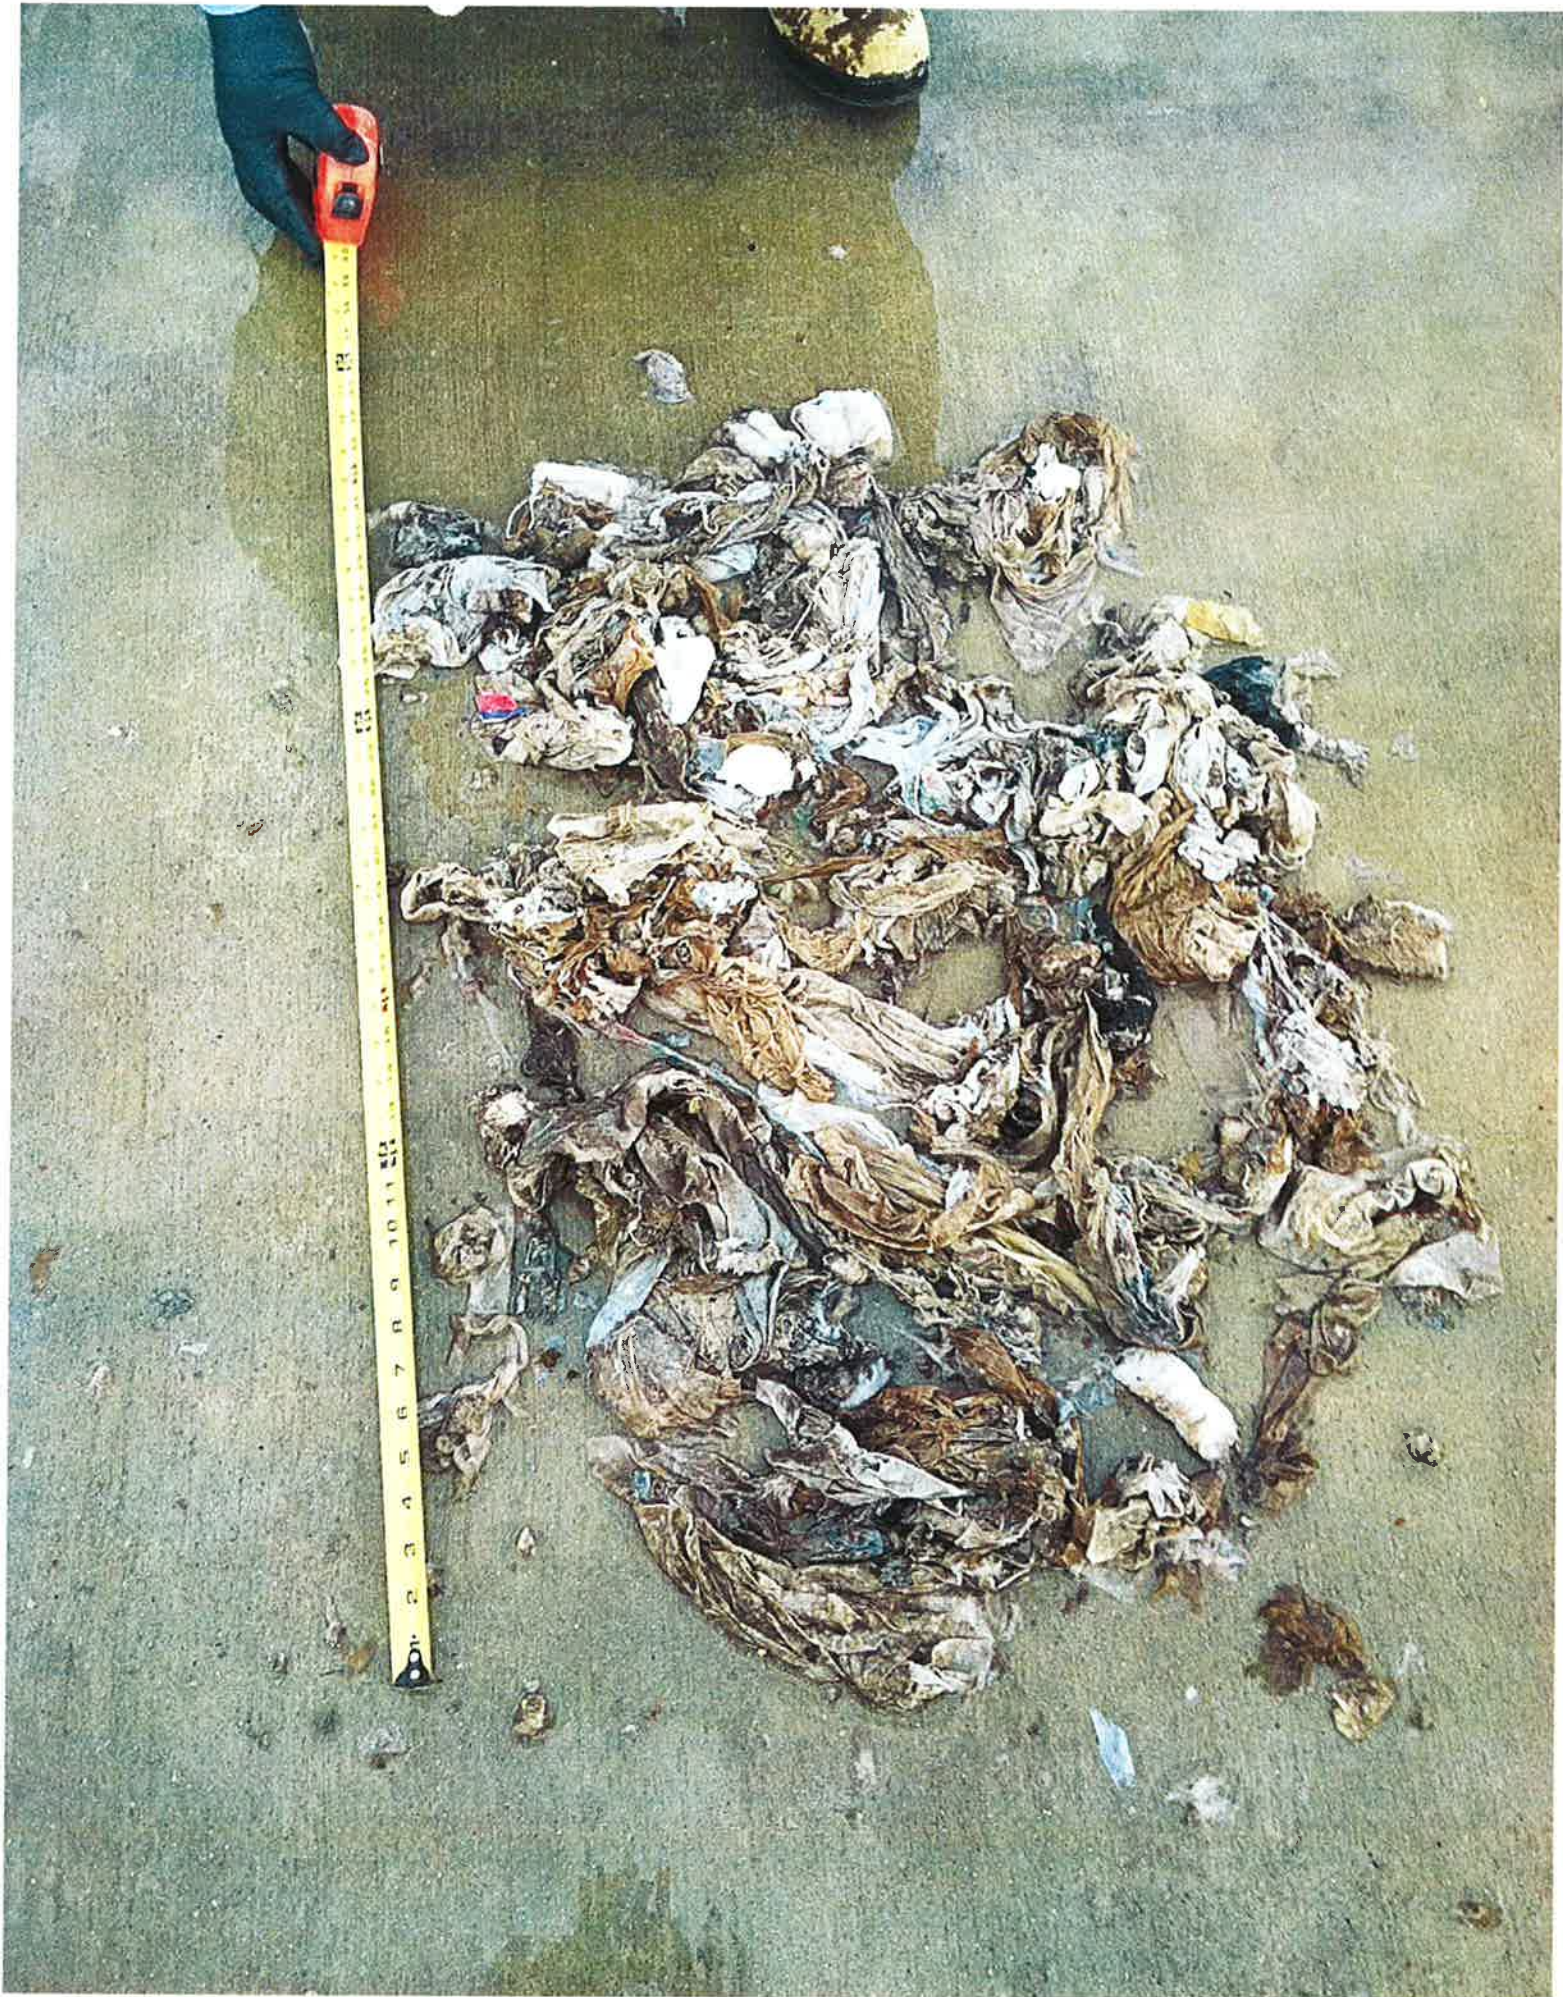
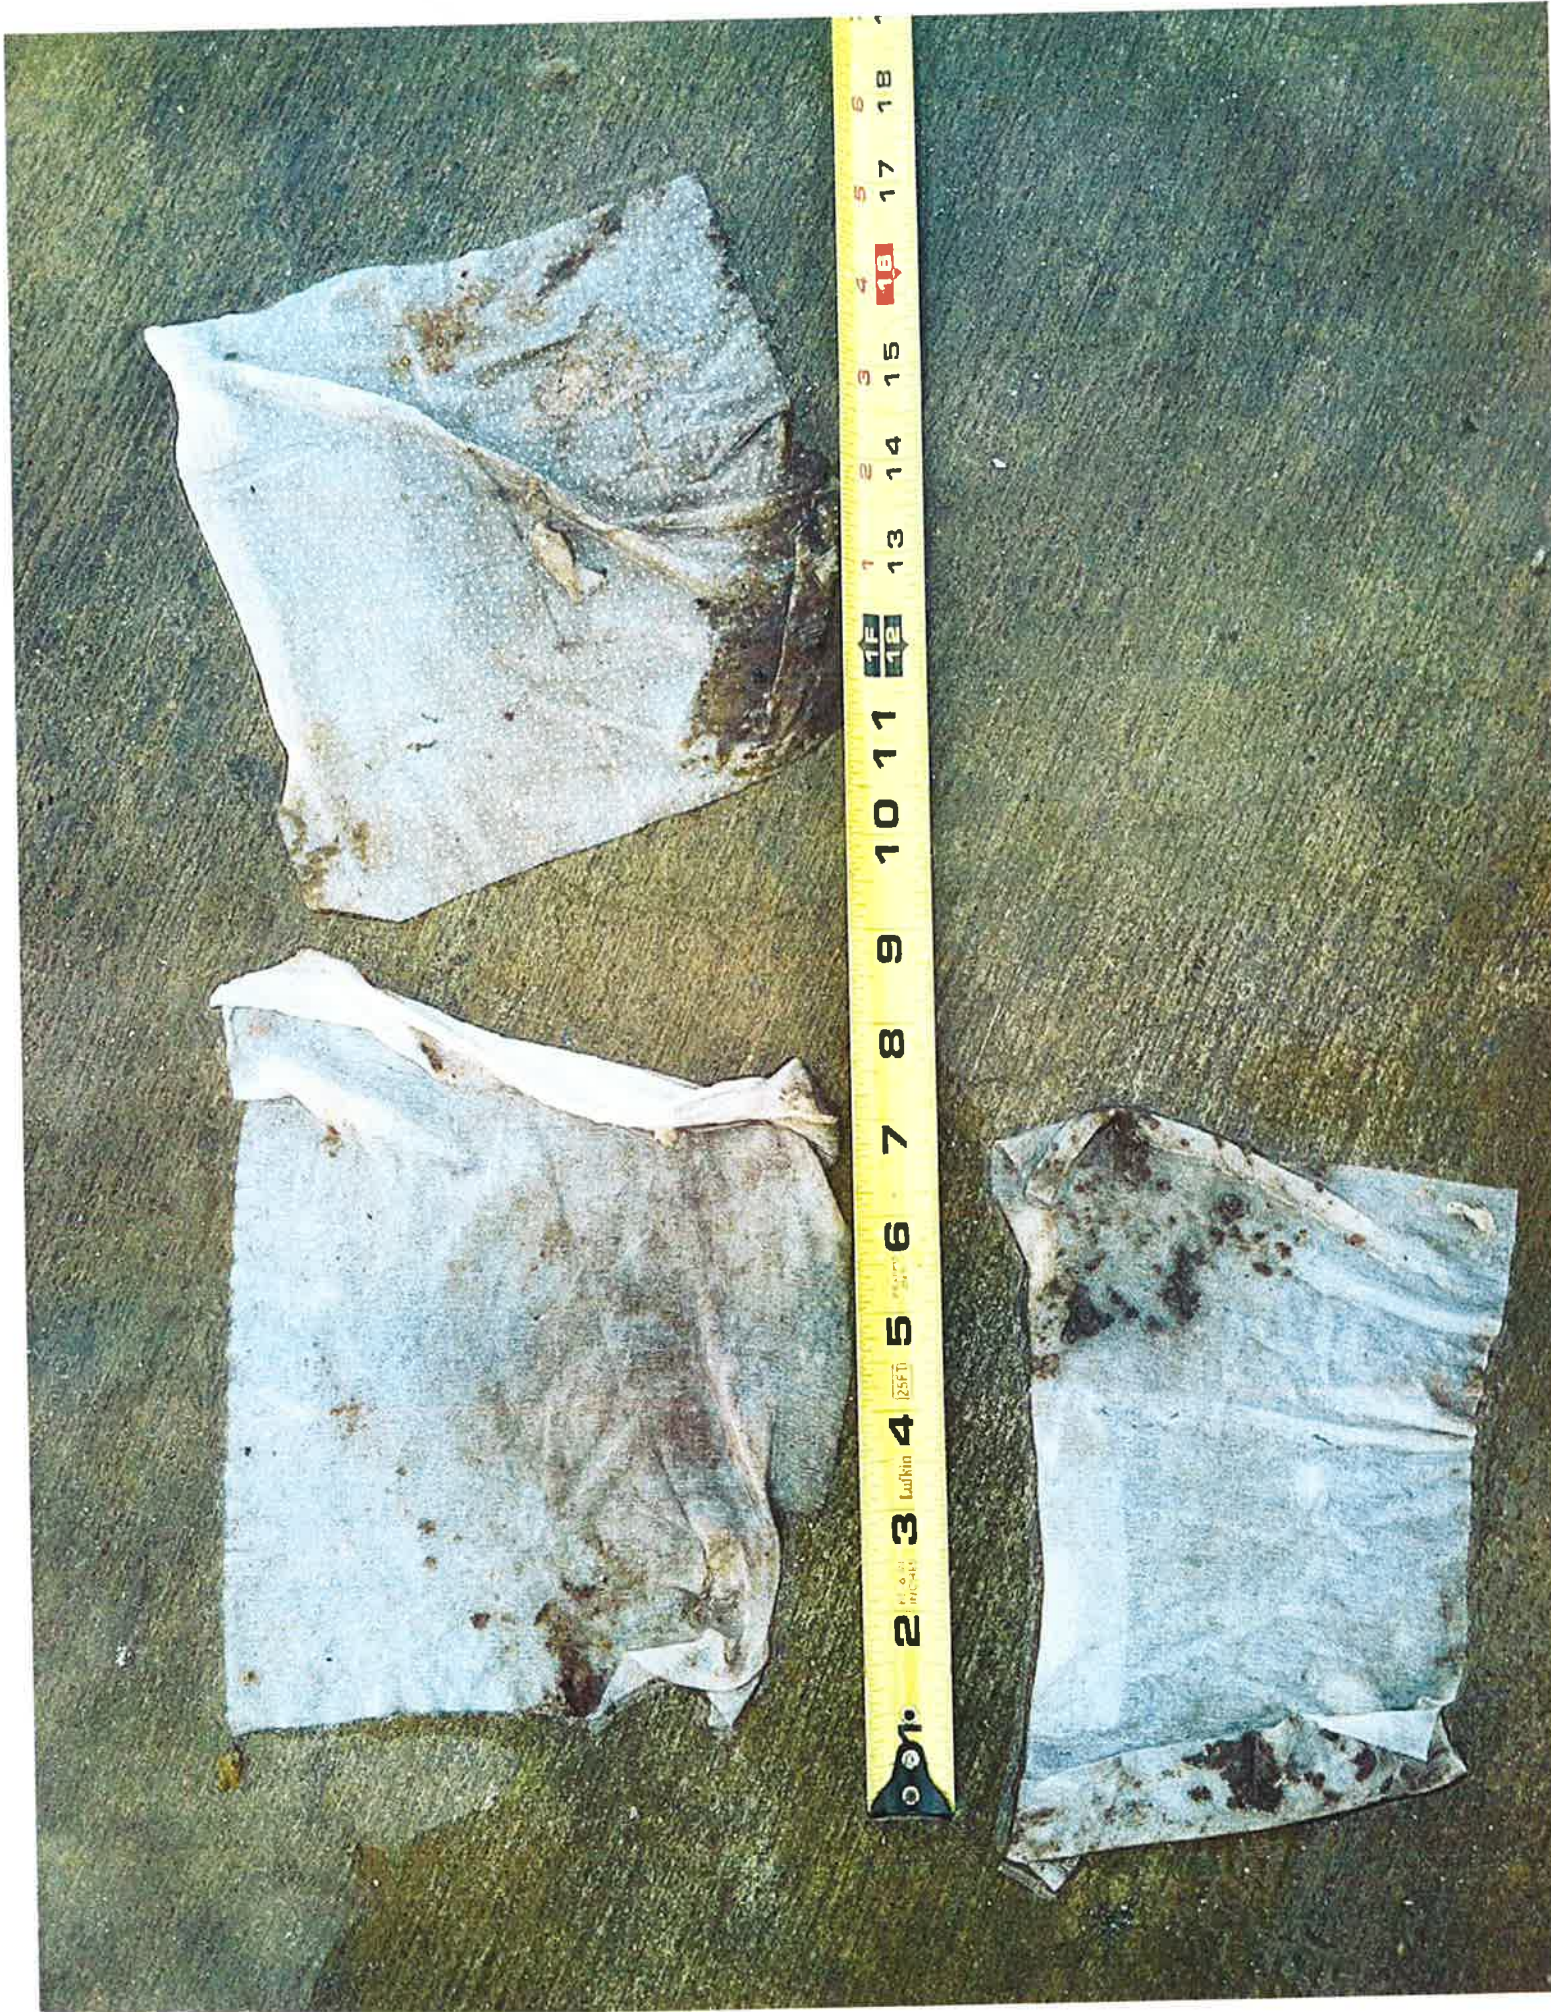
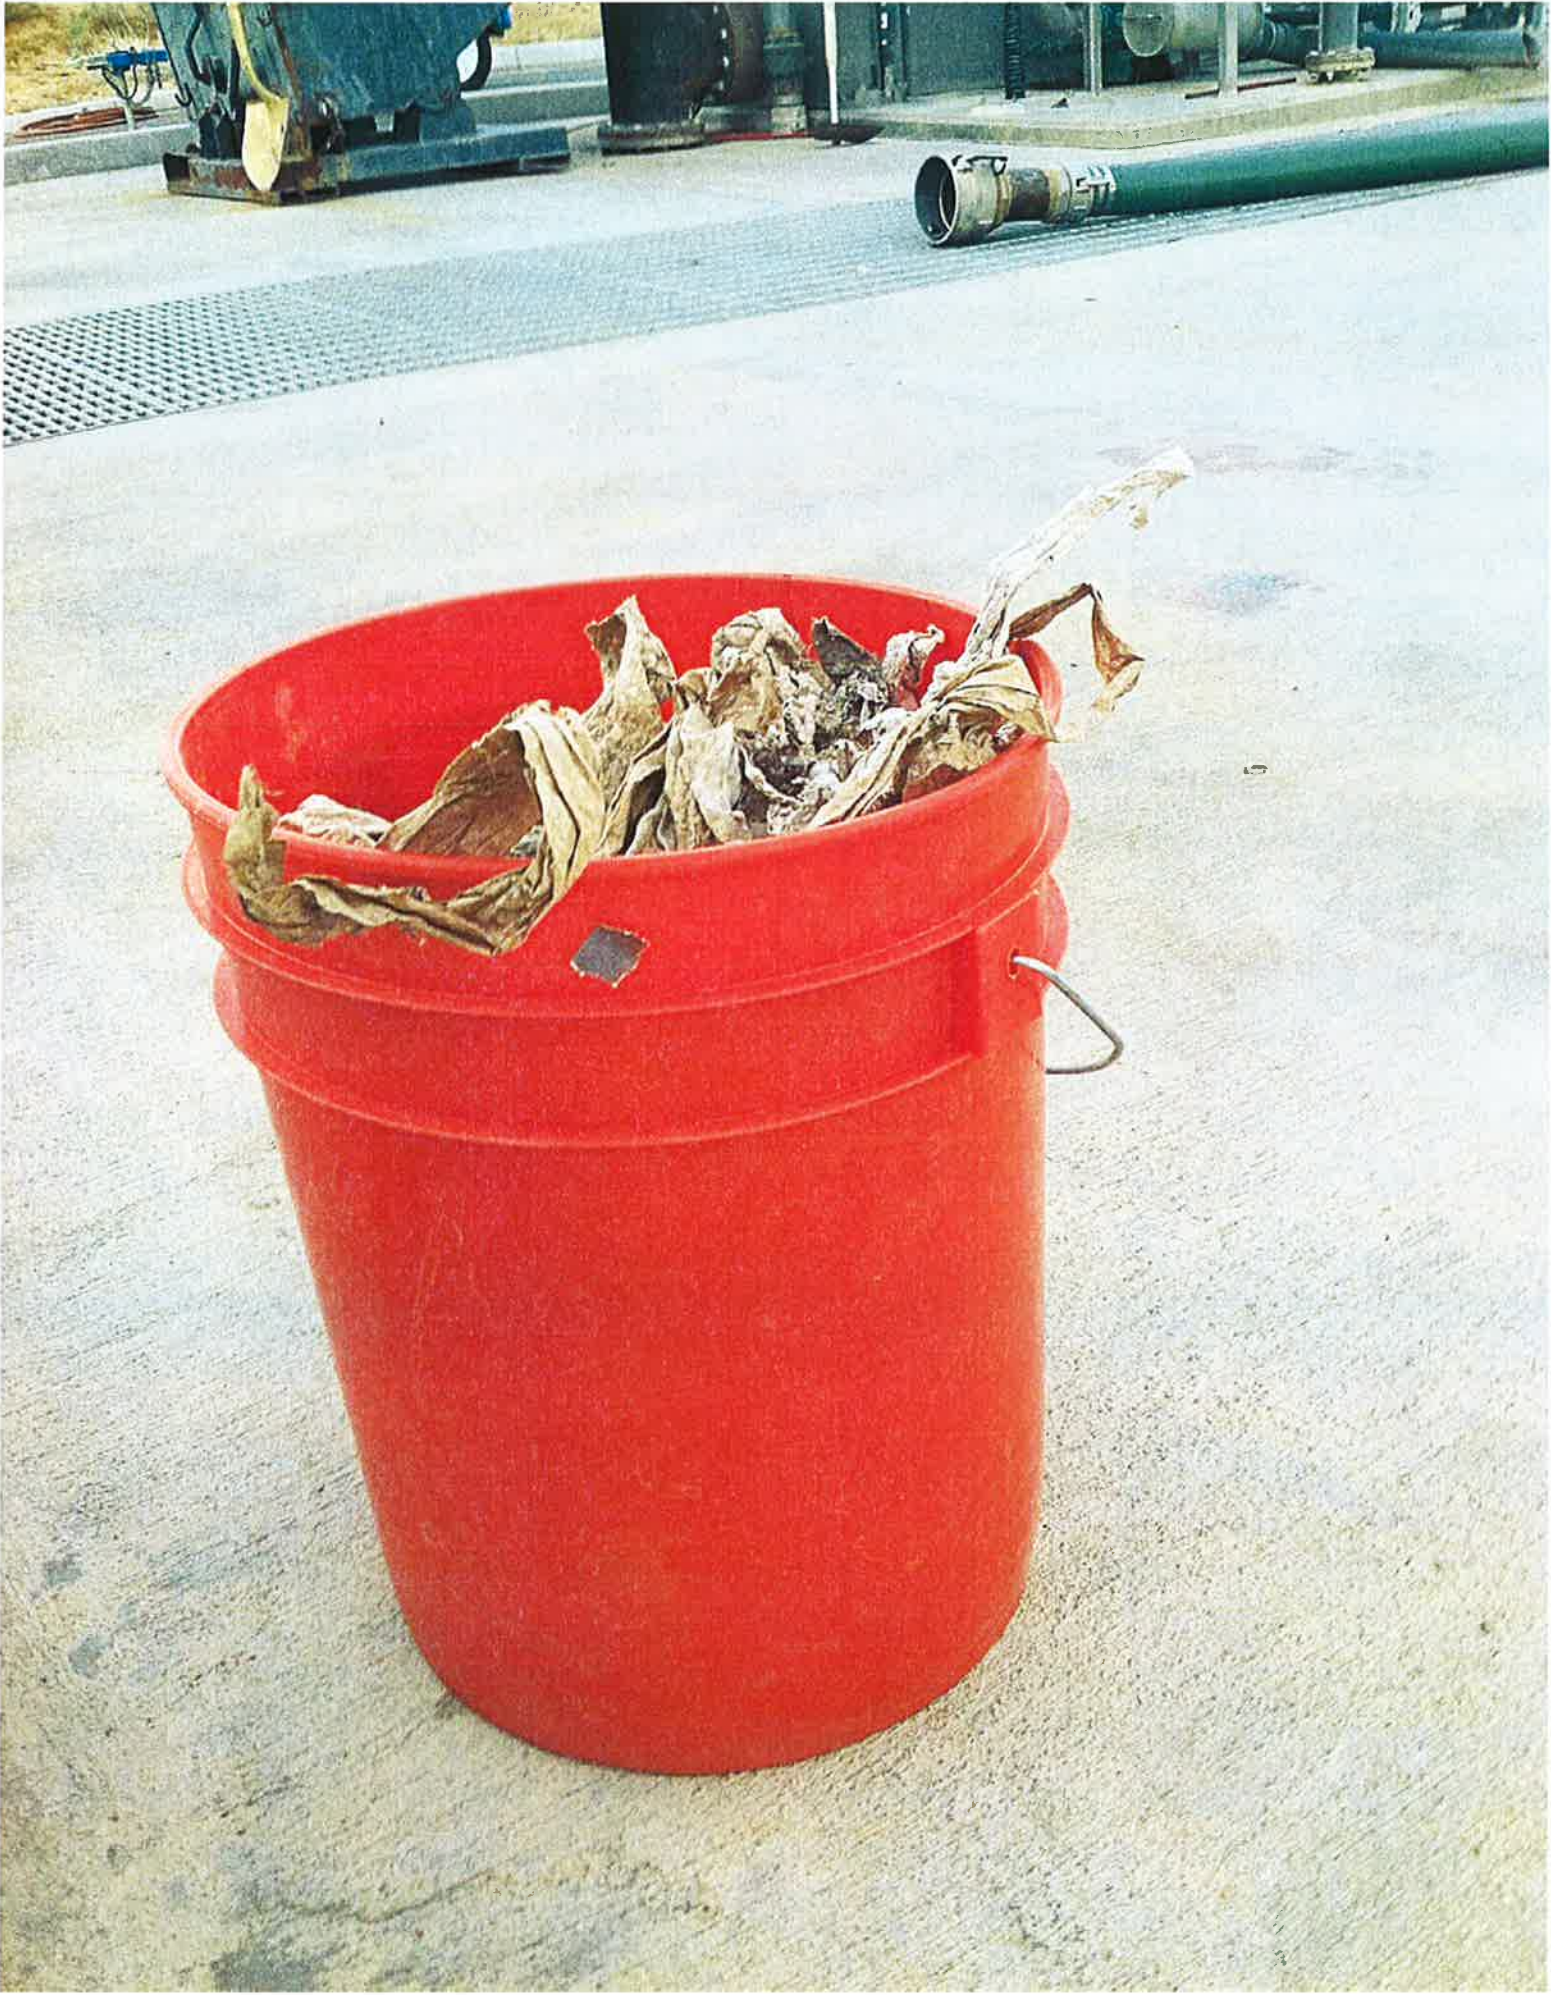
DESCRIPTION OF THIS INCIDENT * :
 In Early 2010 the Submersible pumps at VVWRA Oro Grande Pump Station wet well were being removed and deragged on average once per week. an investigation of the cause of such ragging issues were launched and a final report was issued in February 2013 (attached)

This has been an ongoing issue with the submersible pumps at this particular wet well, no grinder is installed upstream and the amount of non-dispersible material received has been increasing over the years

Non-Dispersible material collected over 12 days study period

- 1. Average flow: 62000 gpd**
- 2. Peak Flow: 280000 gpd**
- 3. Pipe Size: 8"**
- 4. Type of flow: mostly residential
with 1 industry (Cement Plant)**
- 5. Weight: 5.5 pounds dry**
- 6. Volume: 5 gallons wet**

ACTION TAKEN TO REMEDY THIS INCIDENT:
 Exploring options to install grinder upstream of wet well

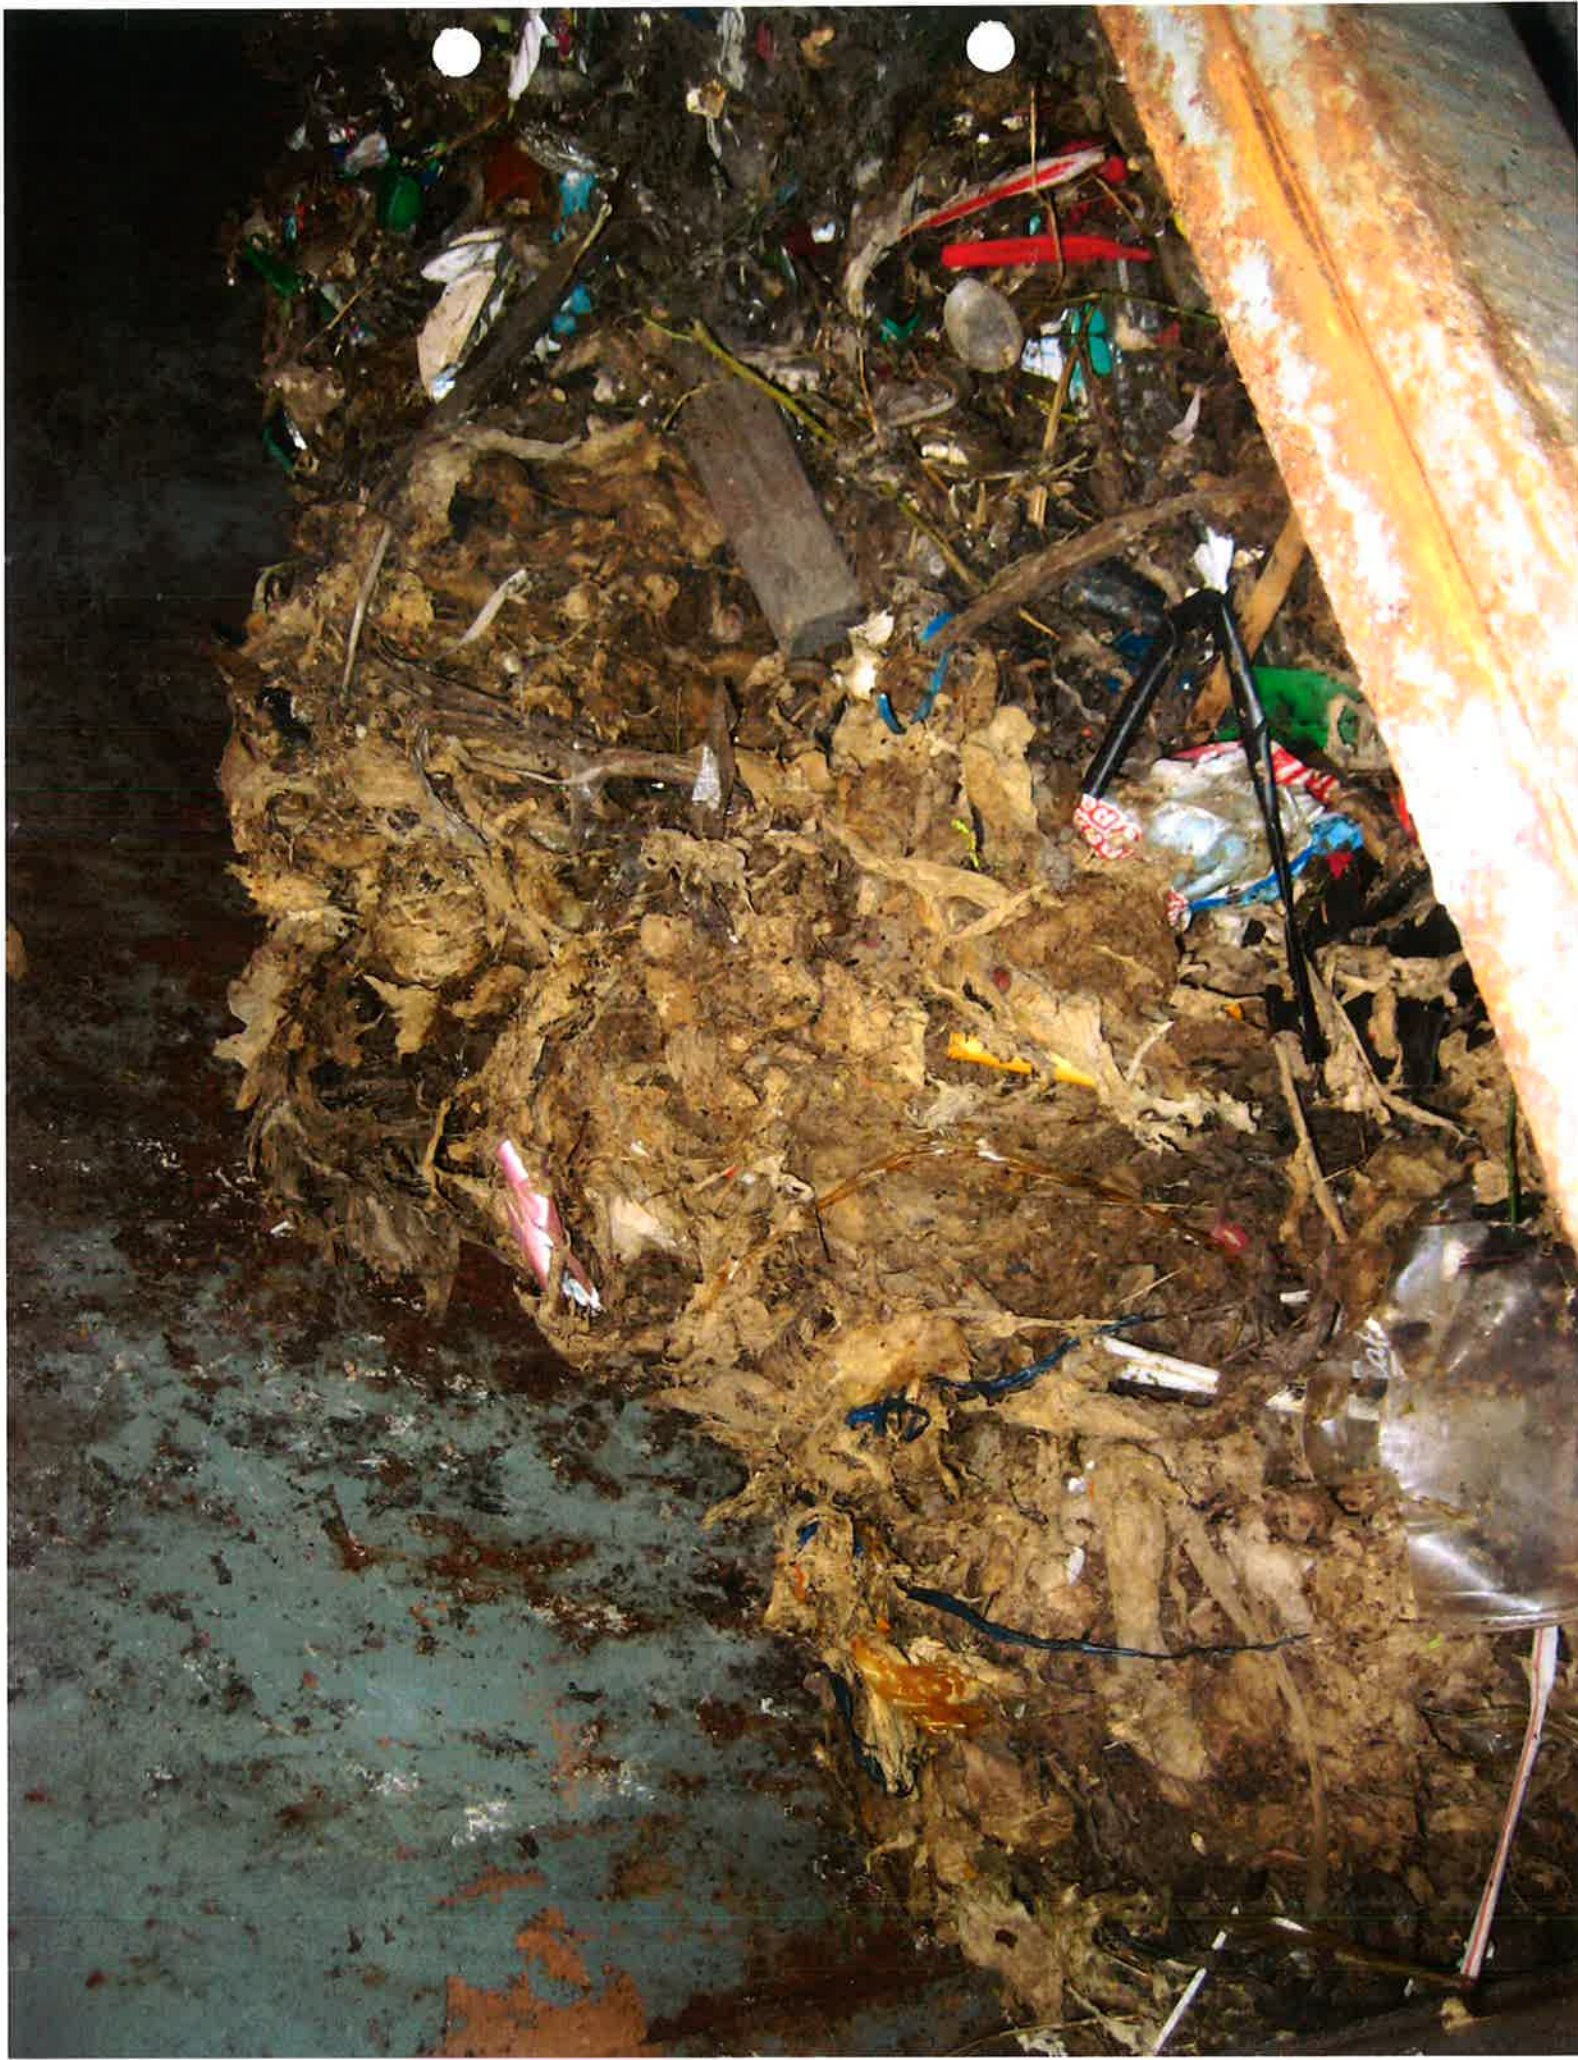
Dumpster full of rags on Sunday 11/27/11, Monday, 11/28/11. Plugged compactor. Rags resembled wipes used at nursing homes.

The pic was from a 2012 rag slugload....I will contact our Collection Crew Supervisor to find out if we've had any sewer back-ups caused by rags.

Checked upstream manholes.

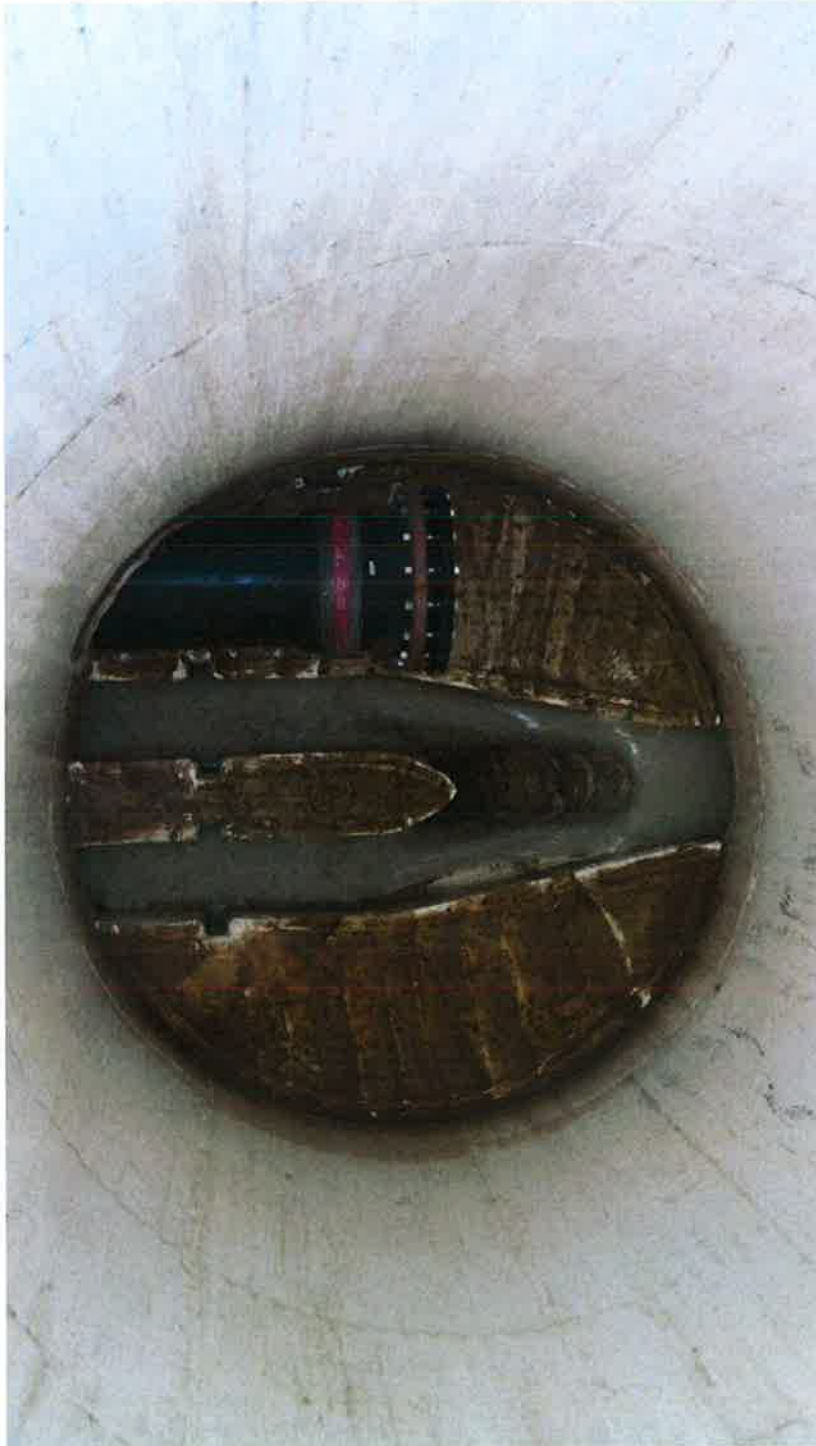
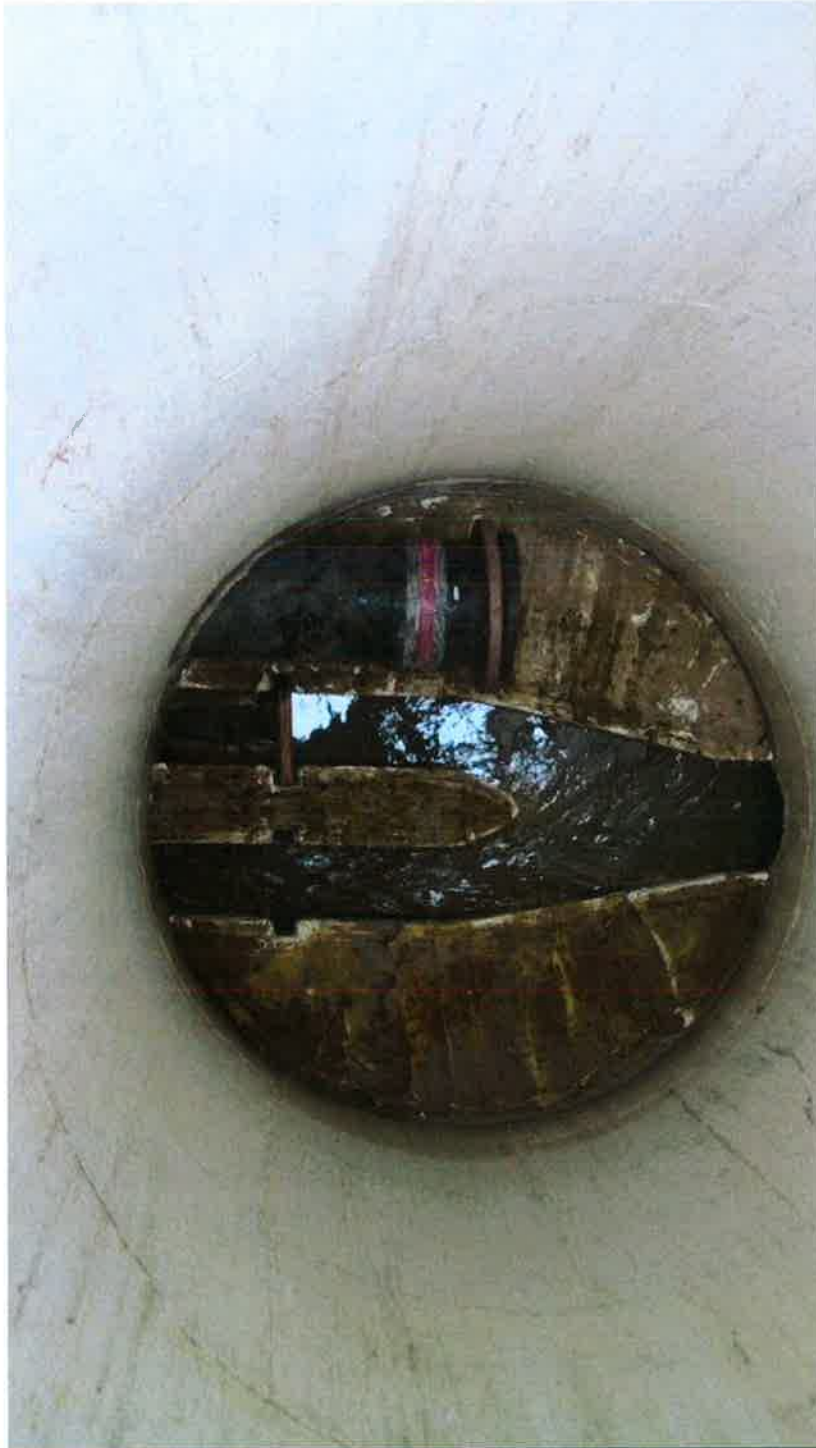
This new facility was recently placed in service in 2013. Non-dispersibles build up on the upstream bullnose in the channel that splits flow to each 12 inch dia. pipe in the two barrel inverted siphon. The siphon is 908 ft. long. The upstream sewer is 18 inches in diameter. The manhole in the attached before and after cleaning photos is 27 ft. deep. A permit required confined space entry is needed to remove the materials to prevent a blockage and a potential spill in the river nearby. This will now be a new trouble spot PM task.

Removed non-dispersibles. Added the location to the trouble spot list.

Possibly keeping the northern siphon pipe blocked off. This may allow the materials to not collect but could create downstream risks. The blocked off pipe could also increase odor and other problems.
