# Condition Assessment of Metallic Force Mains

Gull Lake  
1.94 mile 12" DIP forcemain  
inspection

November 16 – 20, 2014

Richland, MI

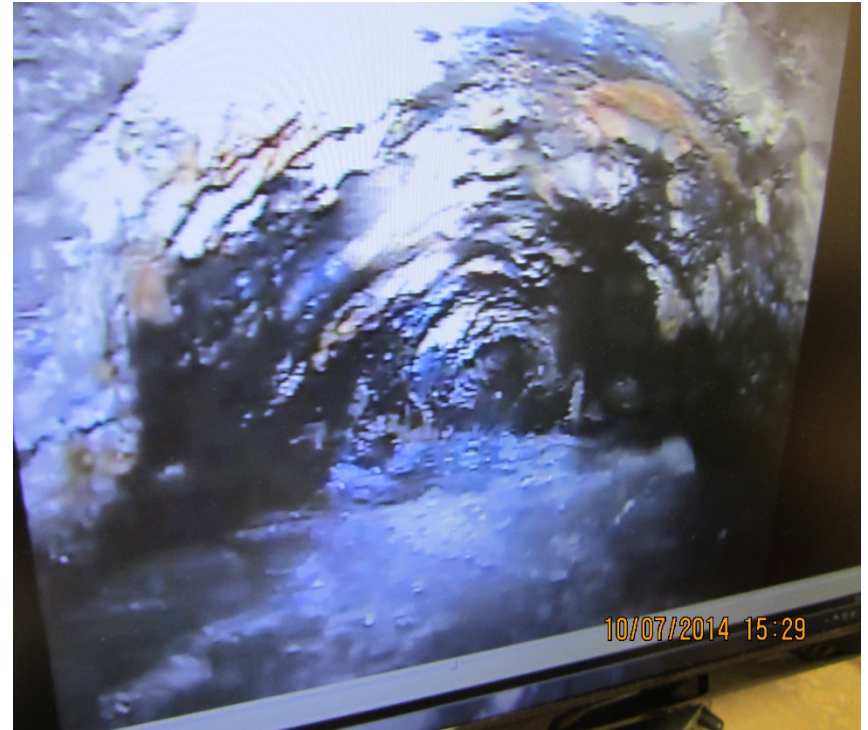
- Calcium build-up identified in last 100' of discharge manhole
- GLSWA attempted to clean pipe – no noticeable improvement
- Replaced final 200' with PVC

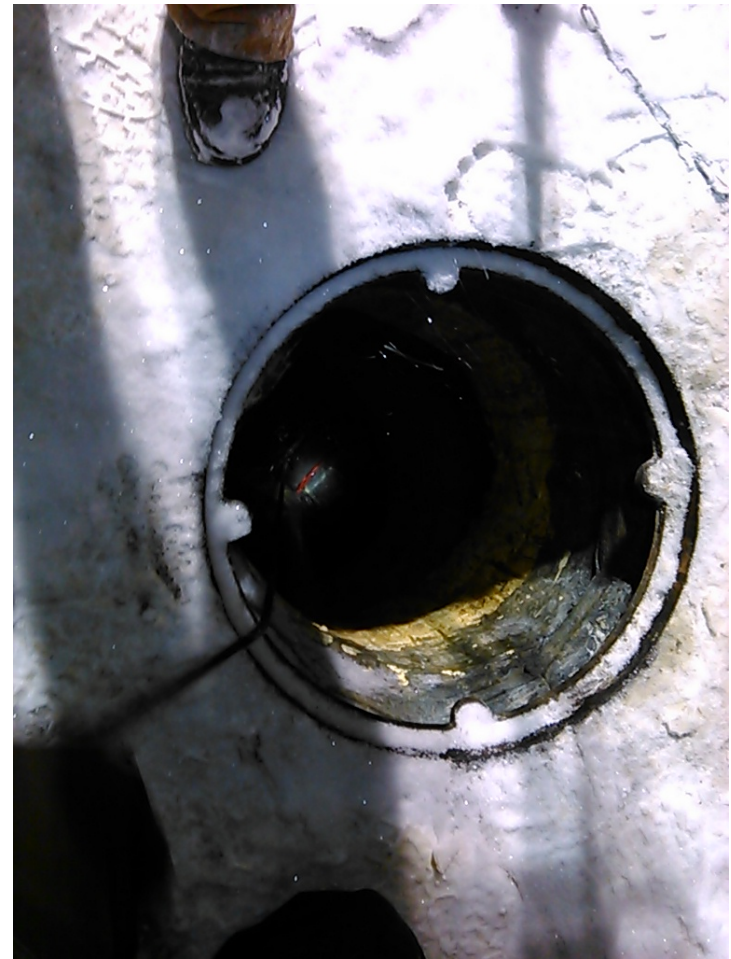
- About 15 minutes before the tool was supposed to arrive the water discharge turned very black
- Manhole started to fill up with a tar-like substance
- Couldn't see tool

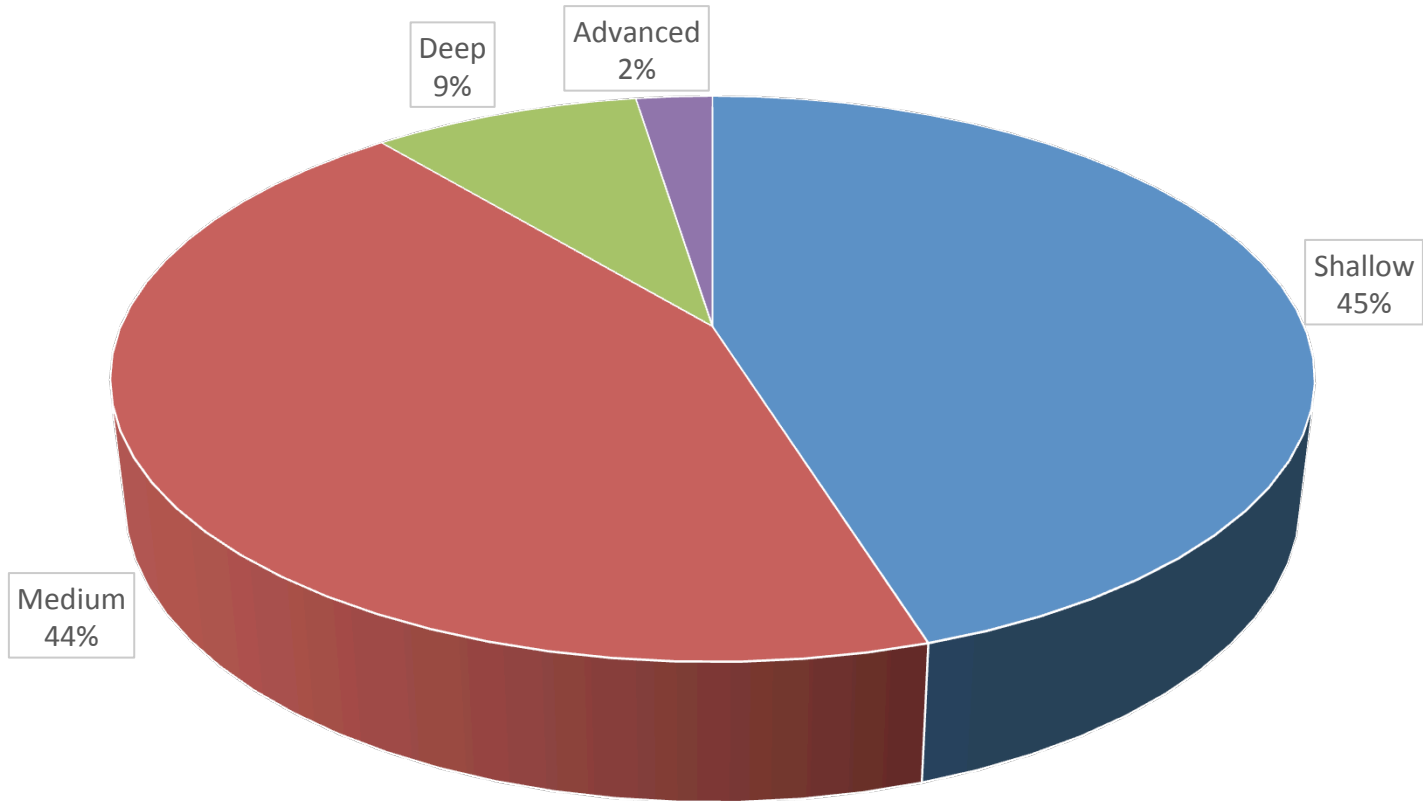
# Pit Break Down

Classification	# of pits in each category	% of total pipeline
Shallow ( $\geq 65\%$ RW)	405	45%
Medium (40 – 64% RW)	393	44%
Deep (20% - 39% RW)	77	9%
Advanced (< 20 RW)	22	2%
Total	897	100%

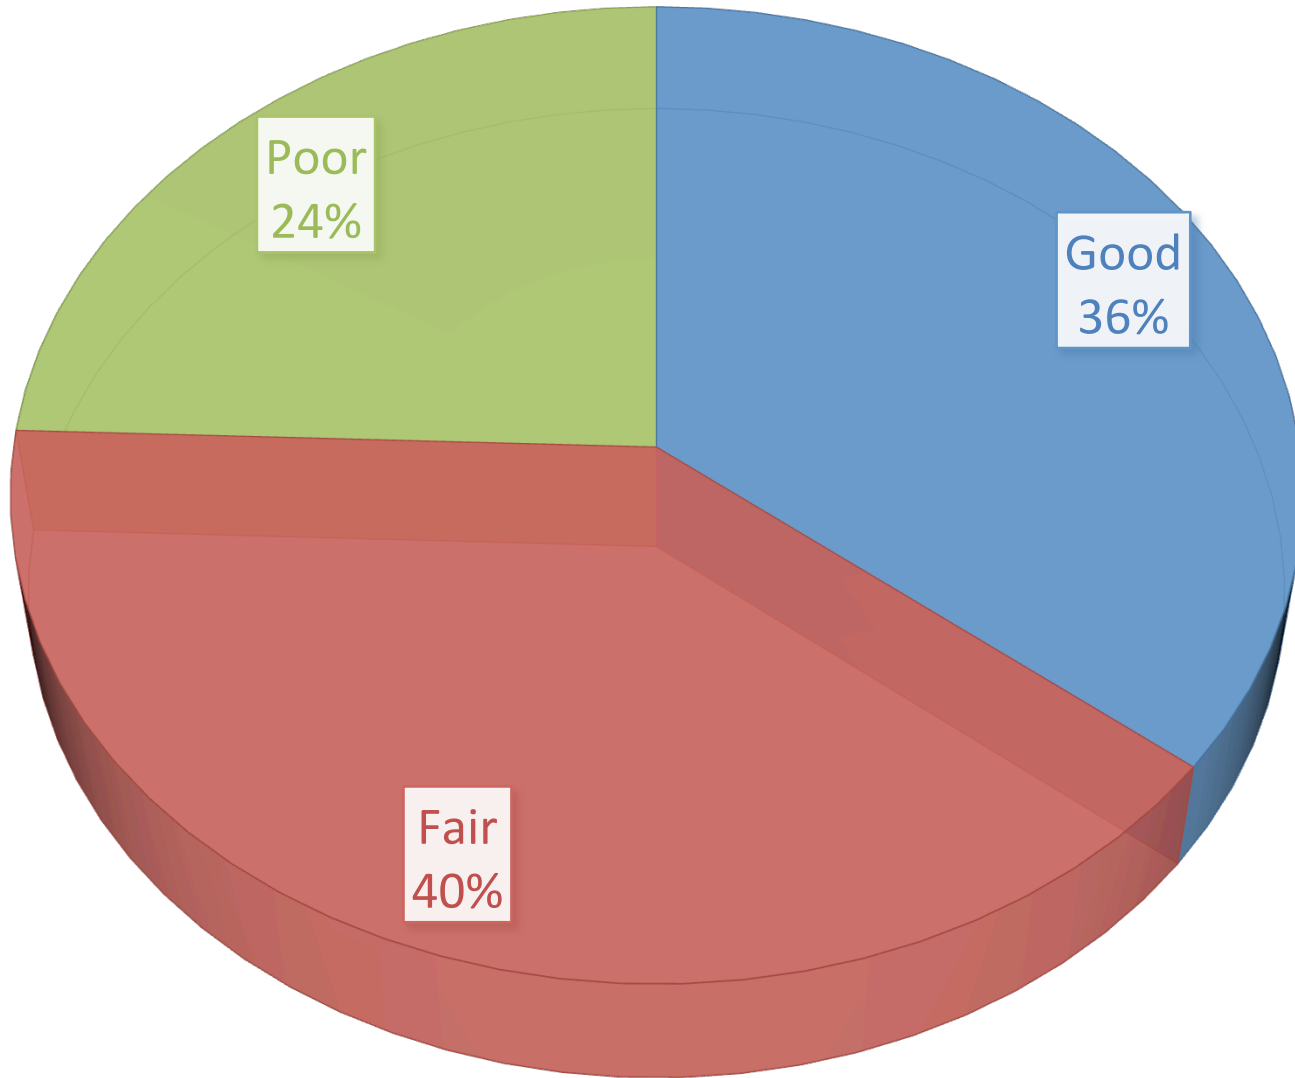
# PICA PIPE CLASSIFICATION

Classification	# of pipes in each category	%
Good (> 74% RW)	194	36
Fair (50 – 74% RW)	217	40
Poor (< 50% RW)	133	24
Total	544	100

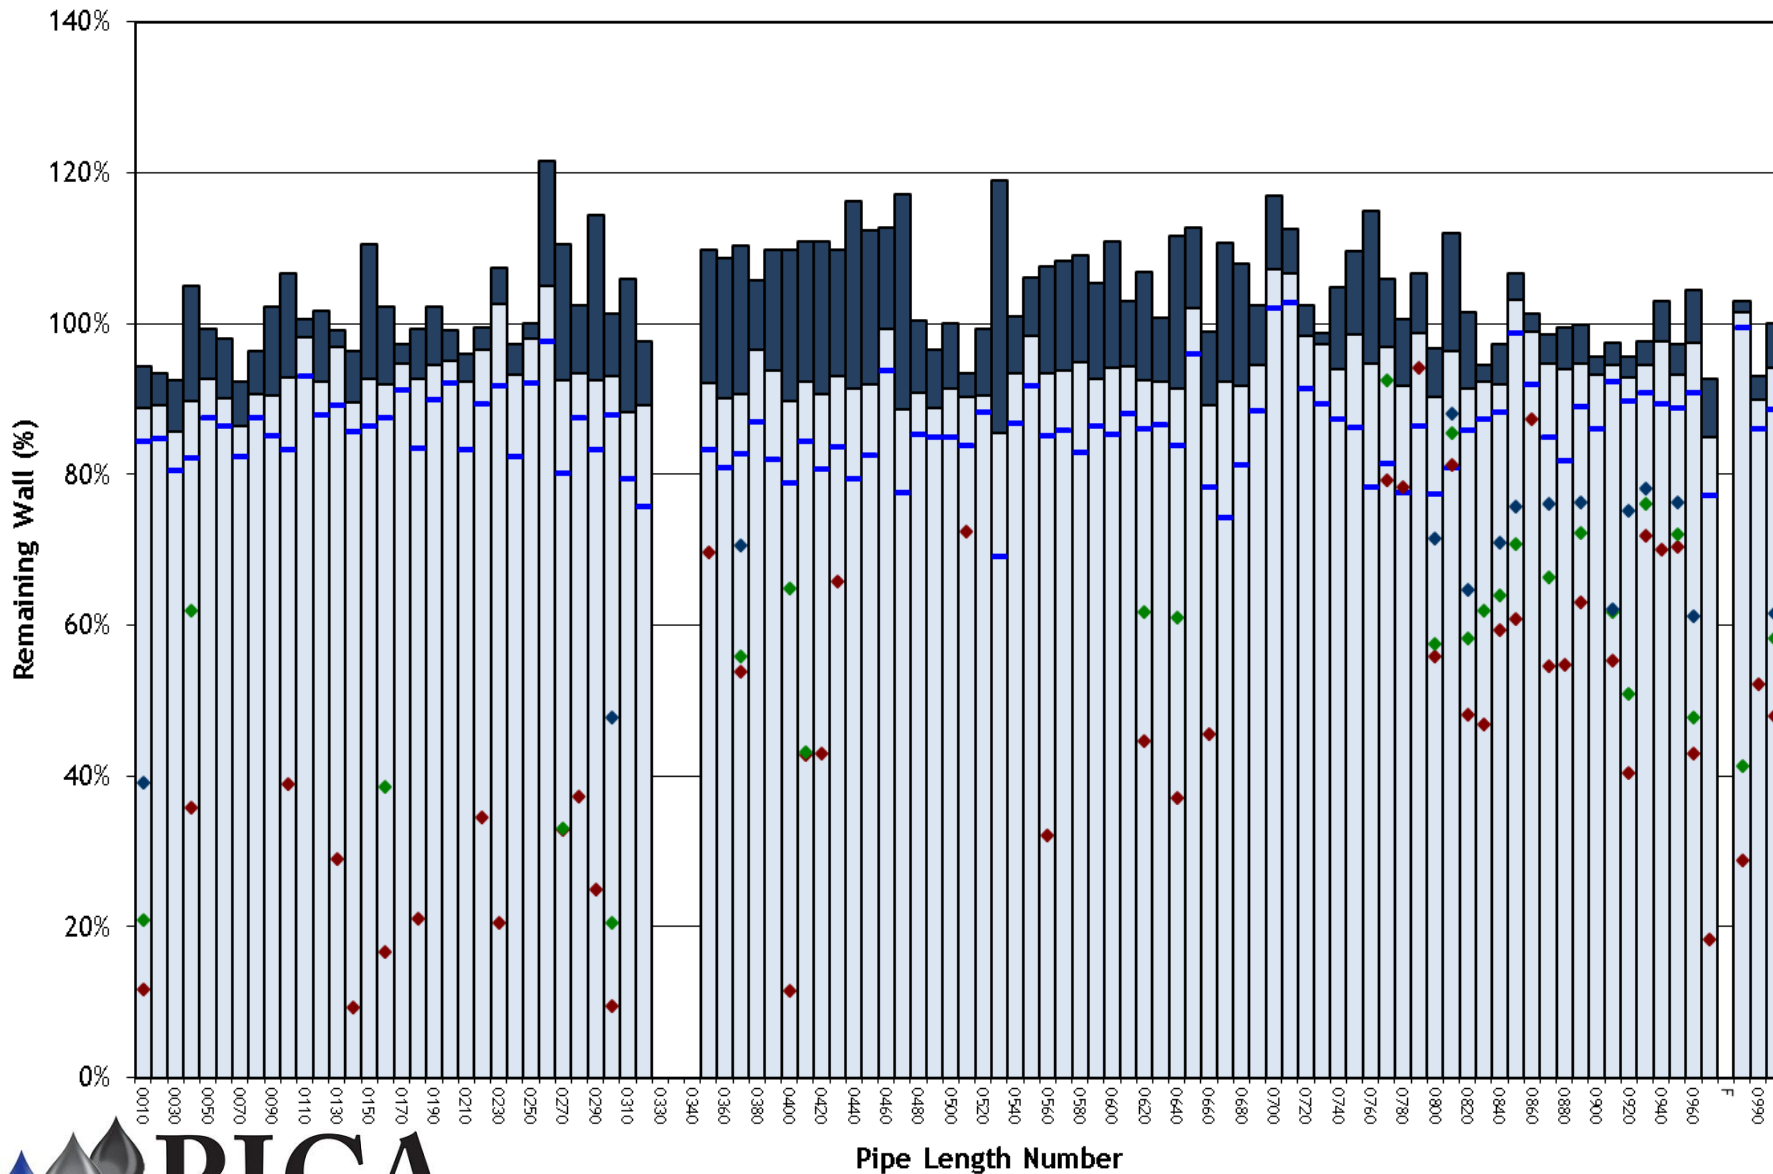
# Gull Lake 37th Street 12in Force Main

Pipe Number	Pipe Location			Tavg RW (%)	Circumferential Wall Thickness		Local Wall Thickness <i>*Clock positions are referenced with a North to South persepective (ie 3:00=West, 9:00=East).</i>								
	Start Location [ft]	End Location [ft]	Length [ft]		Tcircmax RW [%]	Tcircmin RW [%]	Tmin1			Tmin2			Tmin3		
							RW (%)	Location [ft]	Clock Position	RW (%)	Location [ft]	Clock Position	RW (%)	Location [ft]	Clock Position
0010	0.00	15.27	15.27	89%	94%	84%	12%	9.73	7:30	21%	0.74	0:30	39%	1.70	12:00
0020	15.27	33.42	18.15	89%	93%	85%									
0030	33.42	51.60	18.18	86%	92%	81%									
0040	51.60	69.74	18.14	90%	105%	82%	36%	54.78	4:30	62%	57.08	6:00			
0050	69.74	88.00	18.26	93%	99%	87%									
0060	88.00	106.31	18.31	90%	98%	86%									
0070	106.31	124.77	18.46	86%	92%	82%									
0080	124.77	142.98	18.21	91%	96%	88%									
0090	142.98	160.99	18.01	90%	102%	85%									
0100	160.99	179.24	18.25	93%	107%	83%	39%	162.94	12:00

0110	179.24	197.53	18.29	98%	101%	93%									
0120	197.53	214.98	17.45	92%	102%	88%									
0130	214.98	233.78	18.80	97%	99%	89%	29%	223.60	12:00						
0140	233.78	251.79	18.01	90%	96%	86%	9%	248.58	2:00						
0150	251.79	269.89	18.10	93%	111%	86%									
0160	269.89	288.18	18.29	92%	102%	87%	17%	283.64	2:00	38%	273.96	5:00			
0170	288.18	306.38	18.20	95%	97%	91%									
0180	306.38	324.57	18.19	93%	99%	83%	21%	323.64	6:30						
0190	324.57	342.76	18.19	94%	102%	90%									
0200	342.76	360.95	18.19	95%	99%	92%
