# ORANGE COUNTY SANITATION DISTRICT

SUBJECT: Final Phase II FOG Control Study Report

*ORANGE COUNTY*  
**Fats, Oils, and Grease (FOG) Control Study**  
**Phase II – Final Report**

**FOG Control Technology**  
**Field Testing Evaluations**

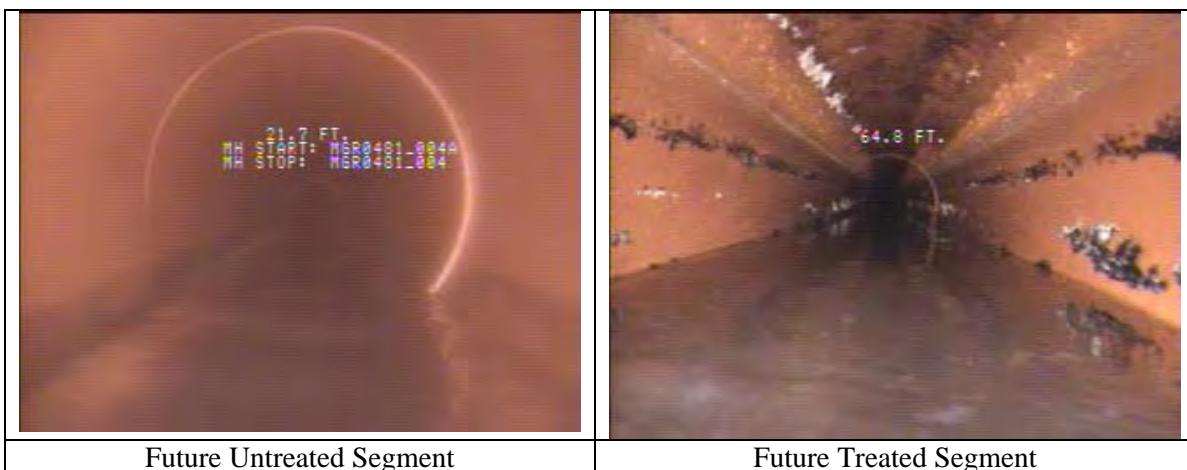
Sewer Pipe Immediately after Line Cleaning

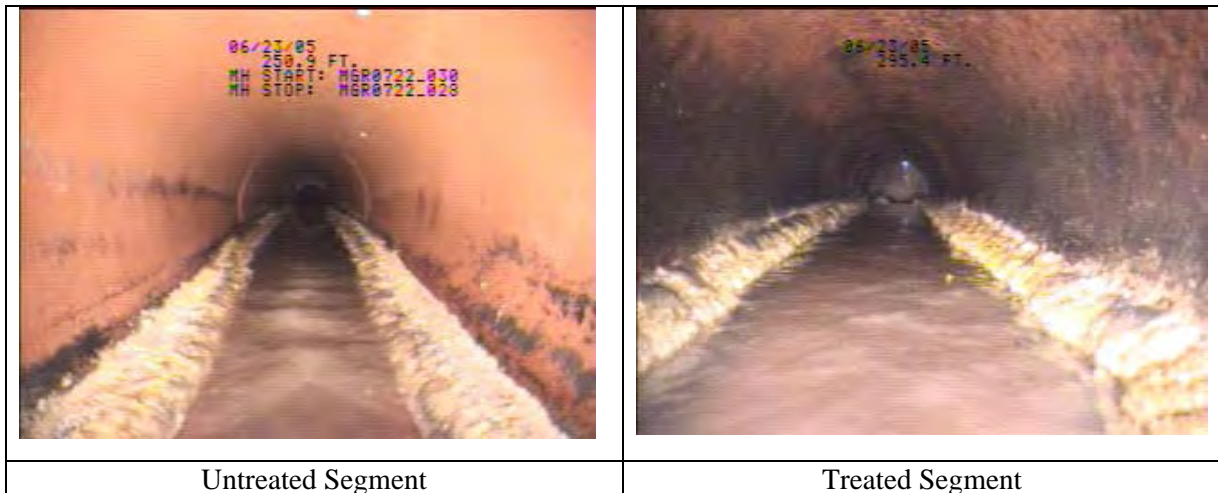
FOG Accumulation 5.5 Months after Cleaning

Immediately after the cleaning and CCTV inspection, the additive was applied in the middle of the hot spot according to the supplier's recommended dosage. This provided the benefit of being able to compare the effect of the additive on a treated section of sewer pipe with an untreated section of sewer pipe in the same hot spot. This comparison was not possible for 1 of the 7 evaluations where the additive was also applied upstream of the hot spot at an FSE (i.e., a Sewer Line-applied/FSE-applied hybrid evaluation). The treated portion of each hot spot was not cleaned for the duration of the test. Every 30 days, at a minimum, the sewer line hot spot was inspected by CCTV. FOG accumulation after 5.5 months is shown in the untreated and treated pipe segments in one evaluation below:

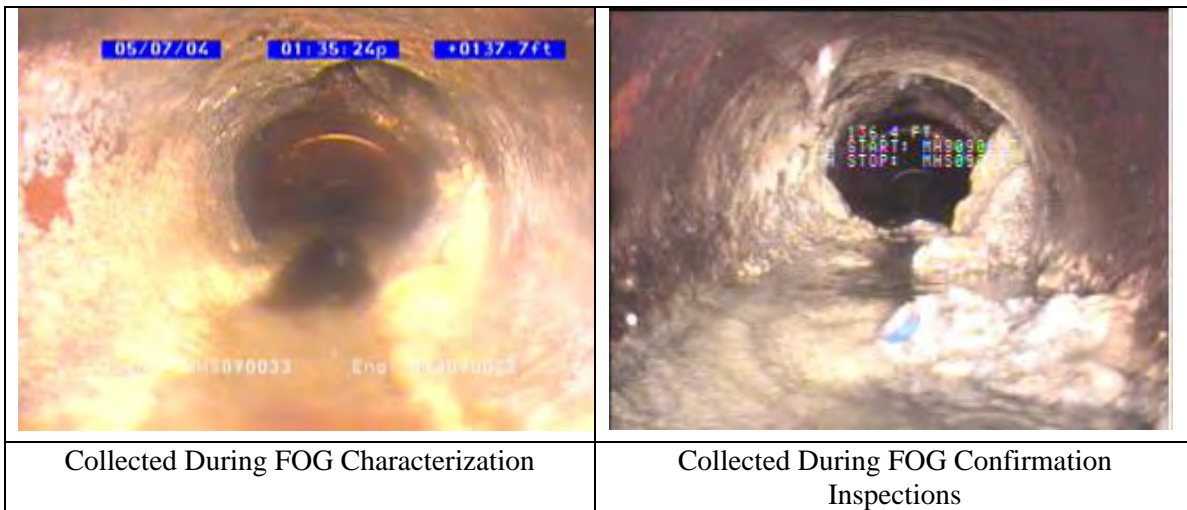
FOG Accumulation before Cleaning and Field Evaluations

The testing protocol for a typical FSE-applied additive started with inspecting the sewer line hot spot and the FSE lateral connection with CCTV immediately before and after cleaning. This indicated the grease build-up prior to initiation of the test, and also verified that the line does not have any major obstructions or defects that may compromise the test. Photos from the CCTV inspections before and after cleaning at one hot spot are provided below:

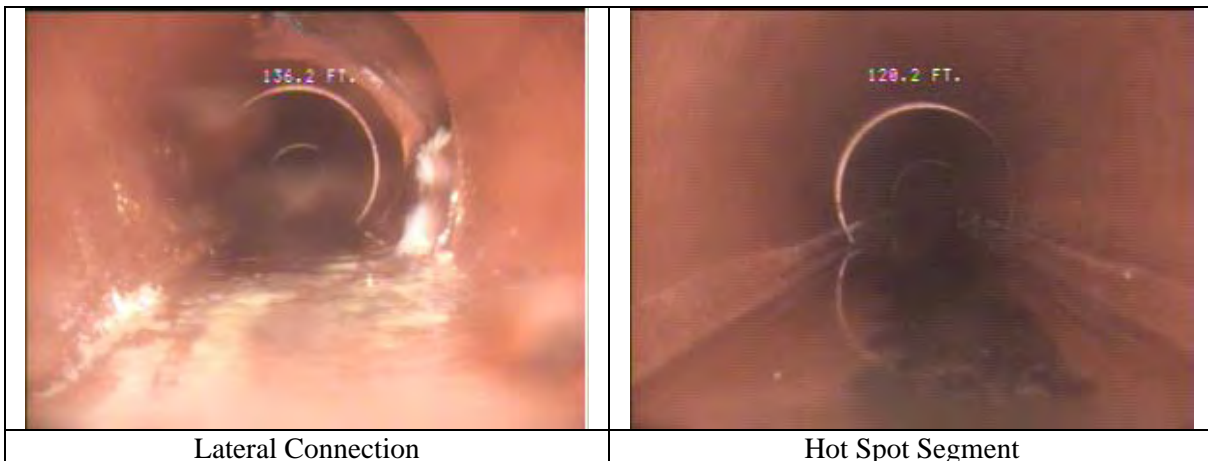
Sewer Pipe Immediately after Line Cleaning

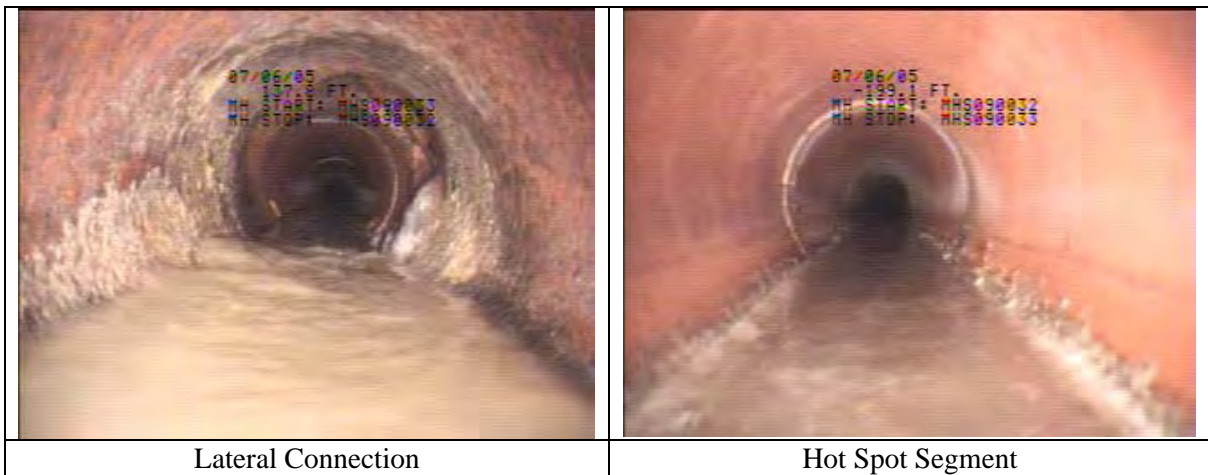
FOG Accumulation 6 Months after Cleaning

Immediately after the cleaning and CCTV inspection, the additive was applied at the FSE according to the supplier's recommended dosage. Since the additive was applied at the source of the FOG (the FSE), there were no untreated pipe segments to compare against treated segments as was conducted in 6 of the 7 Sewer-line applied additive evaluations. The hot spot was not cleaned for the duration of the test. Every 30 days, at a minimum, the hot spot was inspected by CCTV. FOG accumulation after 6 months is shown in the hot spot pipe segment in one evaluation below:

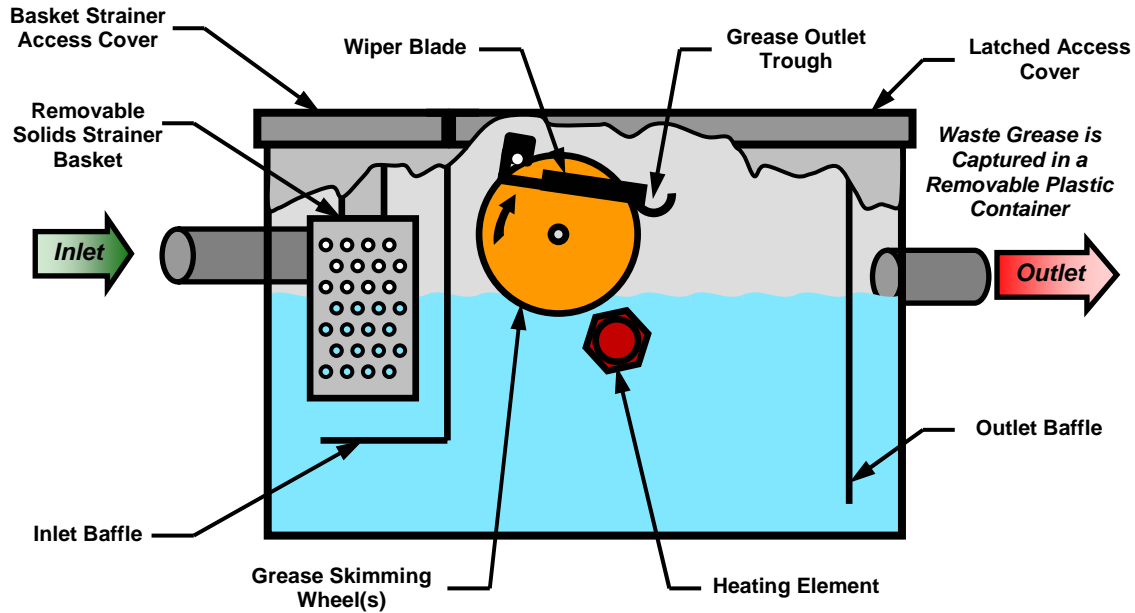
GRD with Grease Skimming Wheel(s) (Sketch Based on *ASPE Data Book*, Volume 4, Chapter 8, and Information Provided By Suppliers)

The only products that were offered by suppliers for evaluation in this portion of the Study were GRDs. The 3 suppliers that committed to the Study provided 2 types of GRDs for evaluation. A conceptual diagram of a GRD with a grease skimming wheel to remove the grease from the main chamber is depicted below:

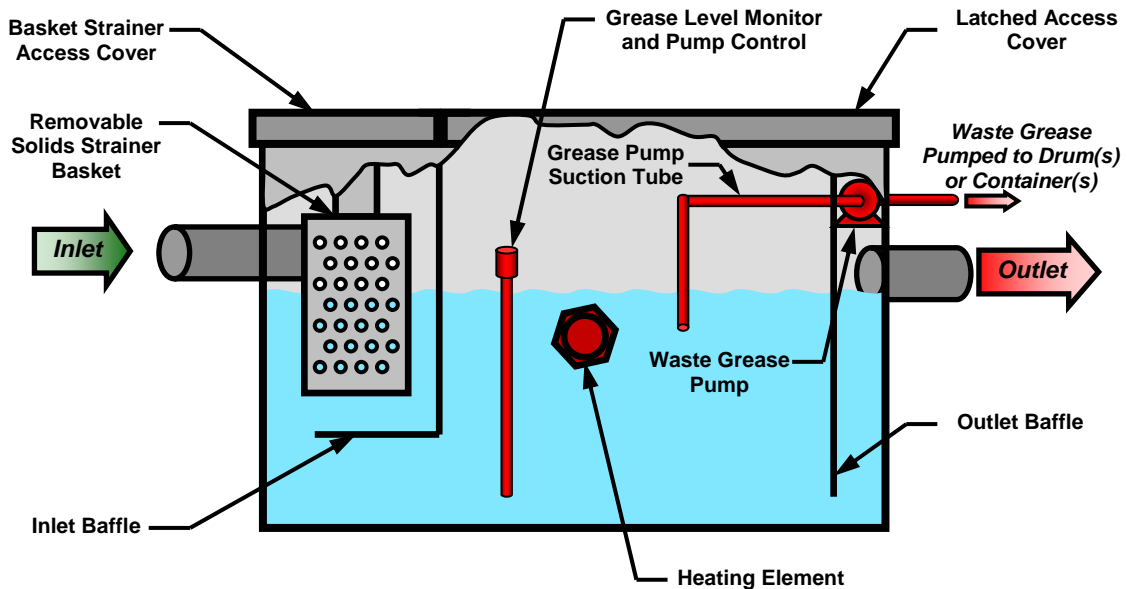
GRD with Grease Level Monitor and Pump (Sketch Based on *ASPE Data Book*, Volume 4, Chapter 8, and Information Provided by Supplier)

A conceptual diagram of a GRD that utilizes a grease level monitor and pump rather than a skimming wheel to remove the grease is depicted below:

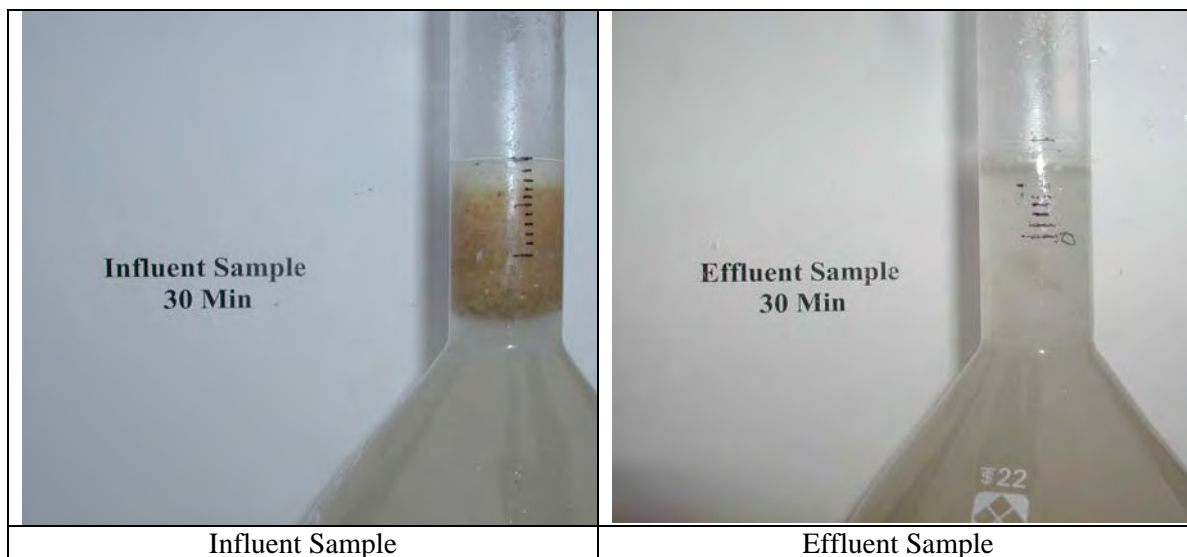
Example of Floating FOG Samples after 30 Minutes of Separation Time in the Flask

providing a simple and logical field method of determining the GRD's effectiveness in removing floating FOG from the wastewater. Utilizing this test, measurements of the influent and effluent floating FOG were collected on multiple occasions over a period of 4-6 months under a variety of conditions. Examples of the floating FOG samples are shown below:

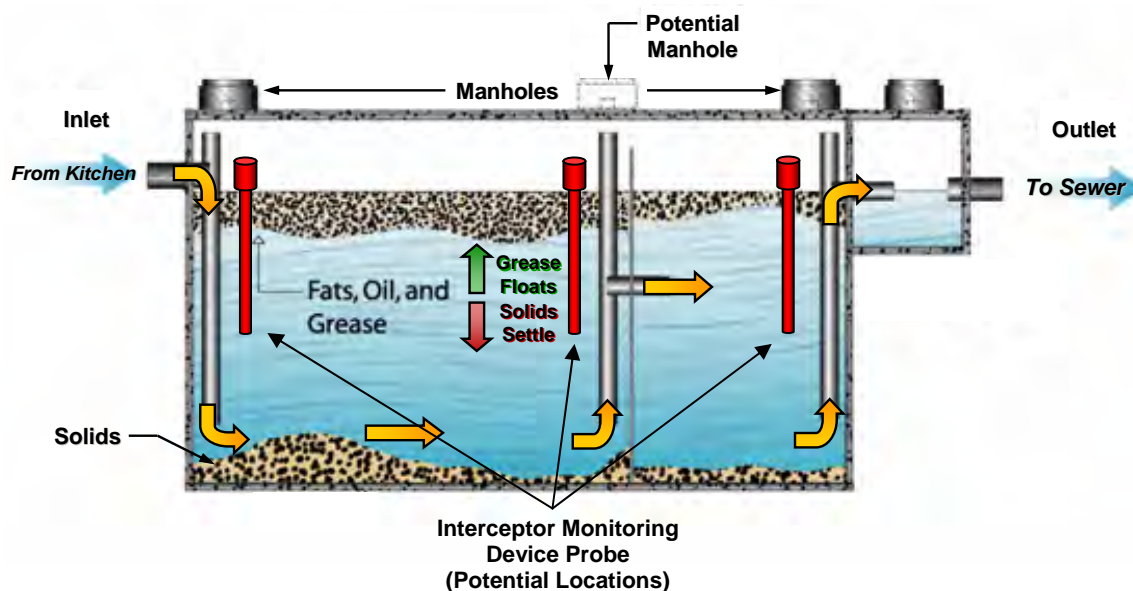
Interceptor Monitoring Device (IMD) Installation (Probe Installation Location May Vary)

The Phase I Study recommended extensive agency monitoring of grease interceptors due to the importance of proper maintenance of interceptors. IMDs were identified in the Phase I Study as the most promising technology to provide automated monitoring with minimal agency involvement. The IMDs evaluated in the Study utilize different grease and/or solids level monitoring technologies (ultrasonic vs. capacitance), but in both cases, the IMD probe is installed in one of the grease interceptor manholes and is wired to a datalogger (or controller) that displays and records the probe measurements. A diagram of a typical IMD probe installation location in an interceptor is provided below:

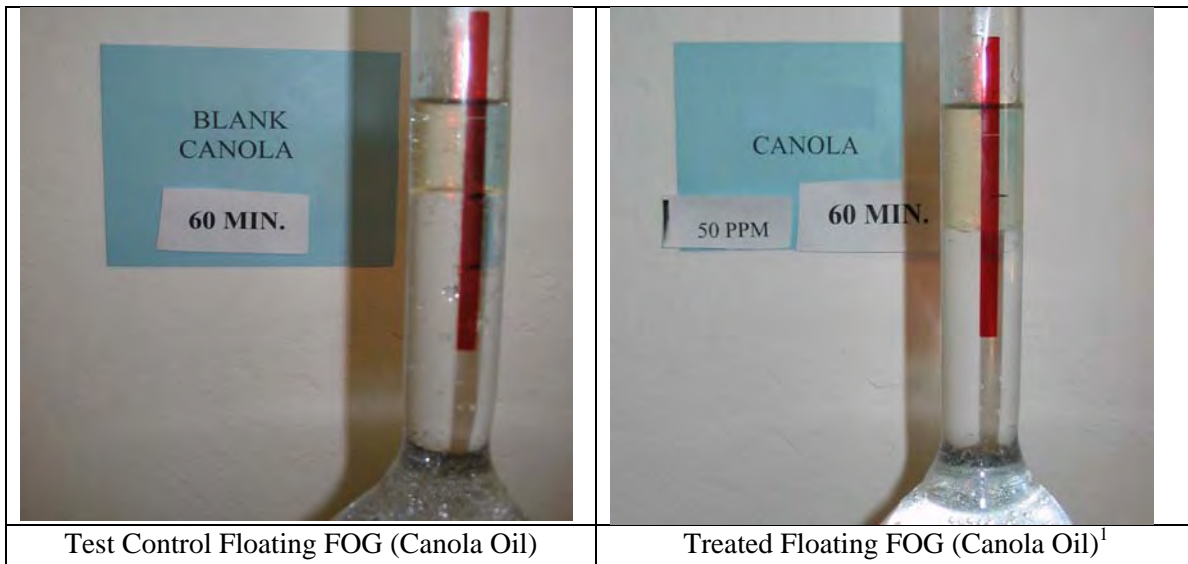
**Figure 2.1** Bench Scale Test with Canola Oil after 60 Minutes

<sup>1</sup>Note: The apparent increased volume of oil is due to the addition of a high dosage of the additive.

No measurable emulsification properties (i.e., no disturbance of the oil-water interface) were observed in any of the additives tested during the emulsification bench scale tests. Figures 2.1 and 2.2 depict flasks of water mixed with vegetable oil and lard, untreated and treated with the addition of a supplier's additive. A summary of the results is provided in Table 2.2 and the details for all of the products tested are included in Appendix D.

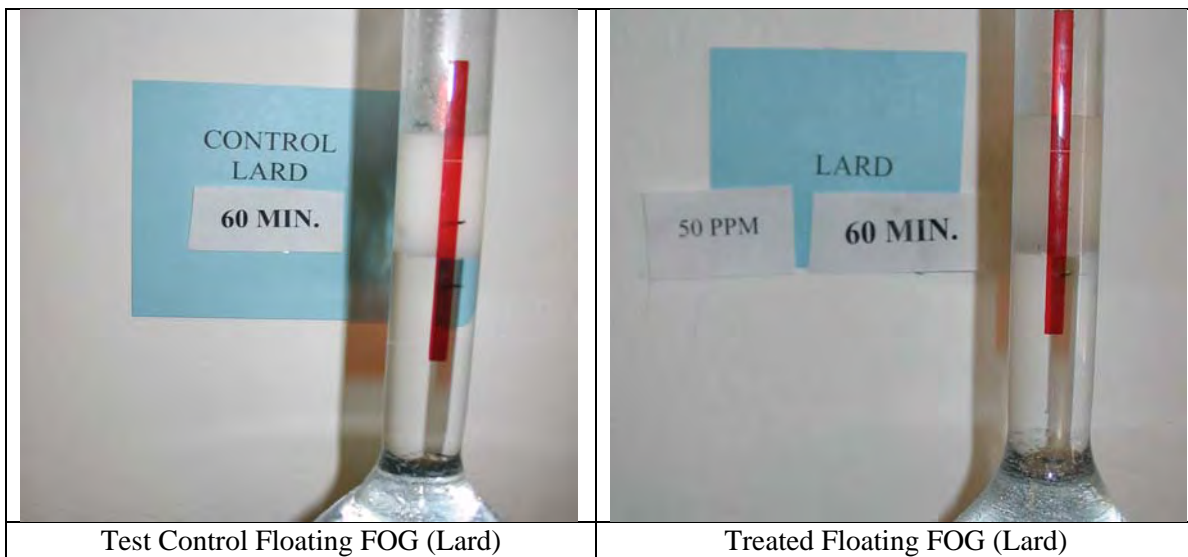
**Figure 2.2** Bench Scale Test with Lard after 60 Minutes

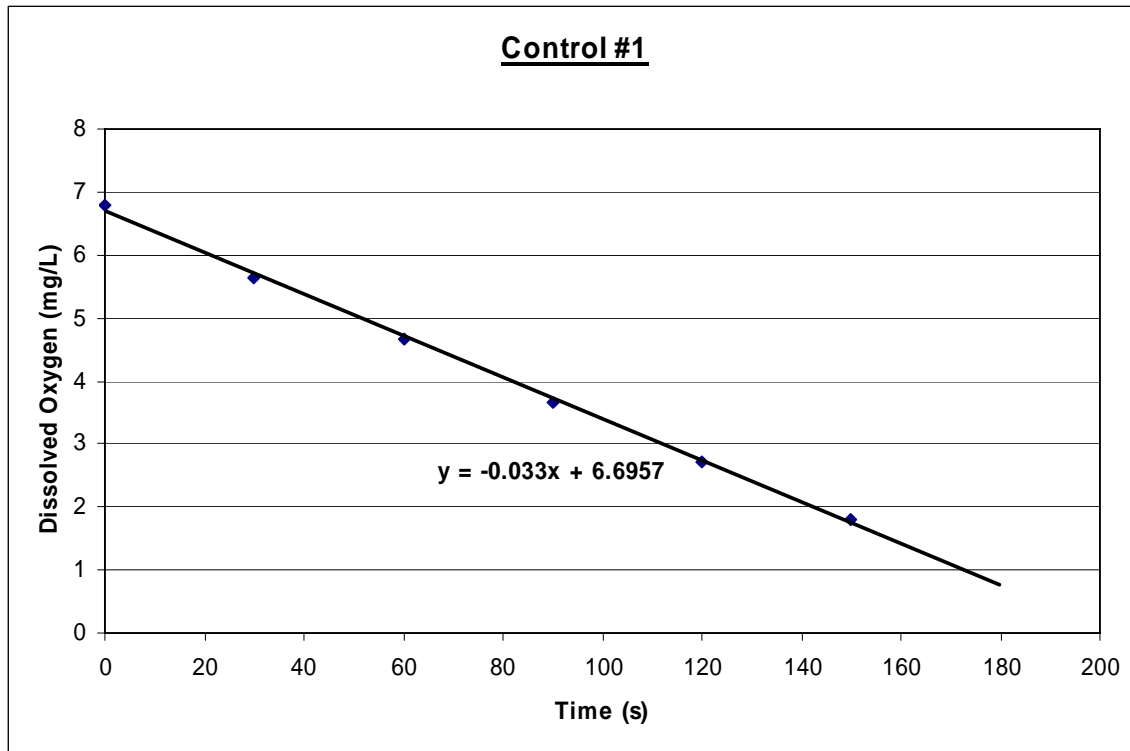
**Figure 2.4** Oxygen Uptake Rate (OUR) Test for Control #1 = 120.0 mg/L/hr

<sup>3</sup> Based on the OUR variability in the control samples, if the additive OUR result was <20 mg/L/hr lower or higher than the control test, the difference is considered to be insignificant due to the inherent variability of the test.

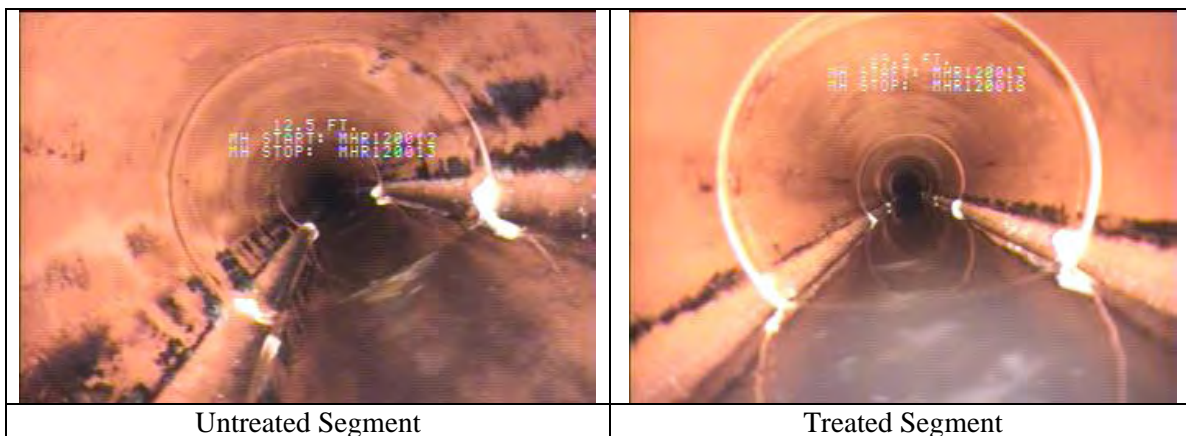
**Figure 2.11** GGSD HS4 Immediately after Line Cleaning

Line cleaning of this location was conducted with a standard jetting nozzle on 1/13/05, followed by CCTV inspection where the following baseline (clean pipe) images were collected:

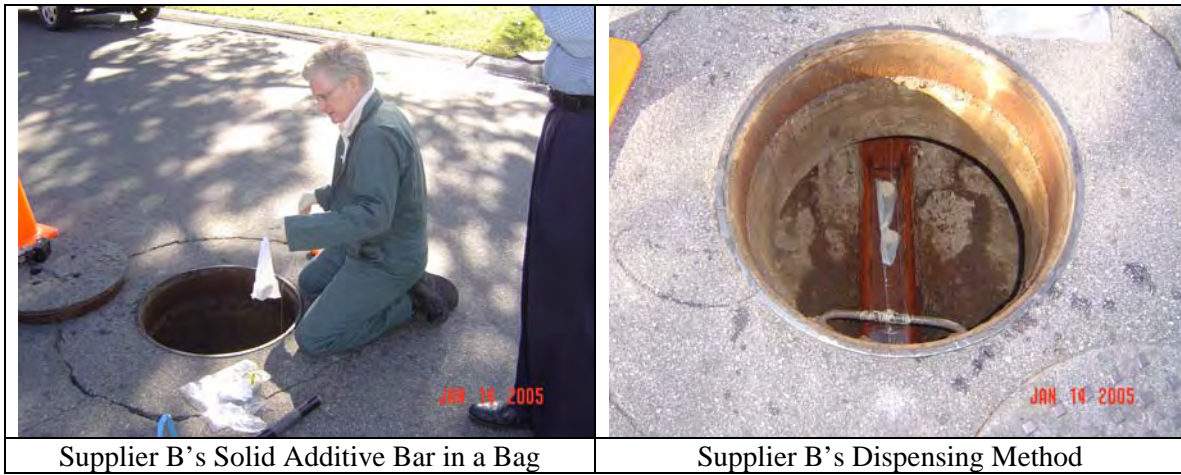
**Figure 2.12** Additive Dispenser Setup at GGSD HS4

The additive setup for this location was conducted on 1/14/05 by a Supplier B representative. The Supplier B product is a solid bar contained in a porous bag (photo below). The bag was suspended in the manhole channel and dispensed as the flowing wastewater dissolved the bar (photo below). Replacement of the bars was conducted on a monthly basis. No problems or complications were encountered during additive set-up and replacements.

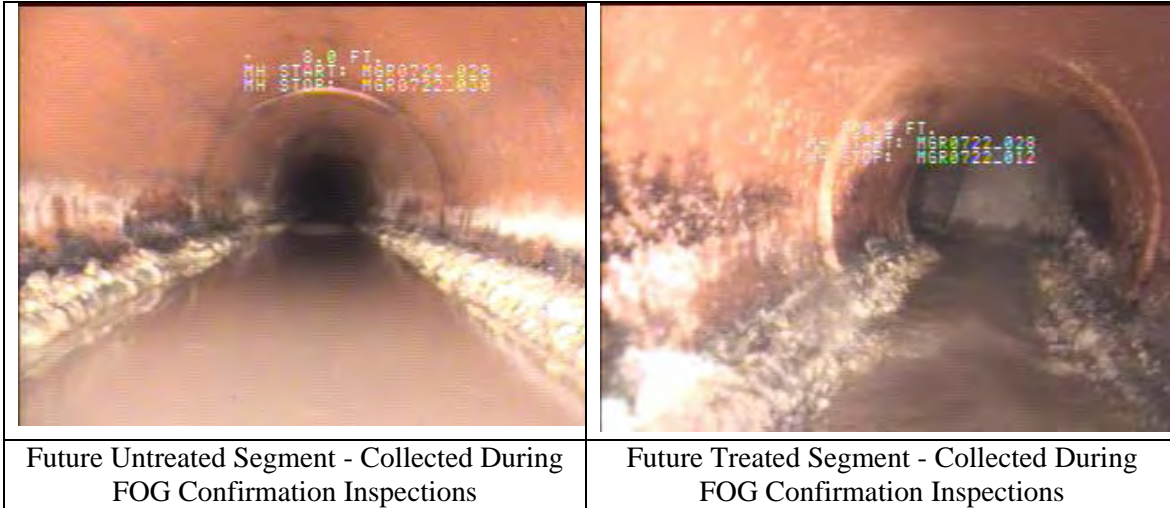
**Figure 2.15** FOG Accumulation at OCSD HS15 Before Field Testing

Prior to suspension of the sewer cleaning for this evaluation, cleaning in this location was conducted on an 8-week basis due to grease accumulation from FSEs discharging directly to this hot spot pipe segment. A low flow condition due to the proximity of this pipe segment to the starter may contribute to grease accumulation. Selection of this location as a candidate for the study was based on CCTV inspections conducted during FOG characterization and confirmed with CCTV inspections prior to the start of this study (see photos below).

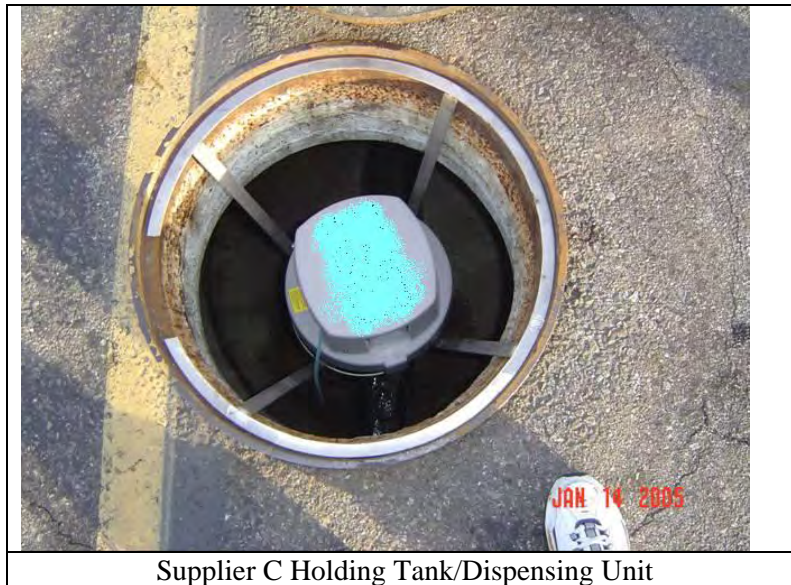
**Figure 2.17** Additive Dispenser Setup at OCSD HS27

The additive set-up for this location was conducted on 1/14/05 by a Supplier C representative. The Supplier C product was dispensed in a liquid form from a holding tank located inside the manhole at MGR0722\_028 (photo below). The holding tank was replenished on a weekly basis. No problems with the dispensing unit were encountered during the evaluation.

Supplier C Holding Tank/Dispensing Unit

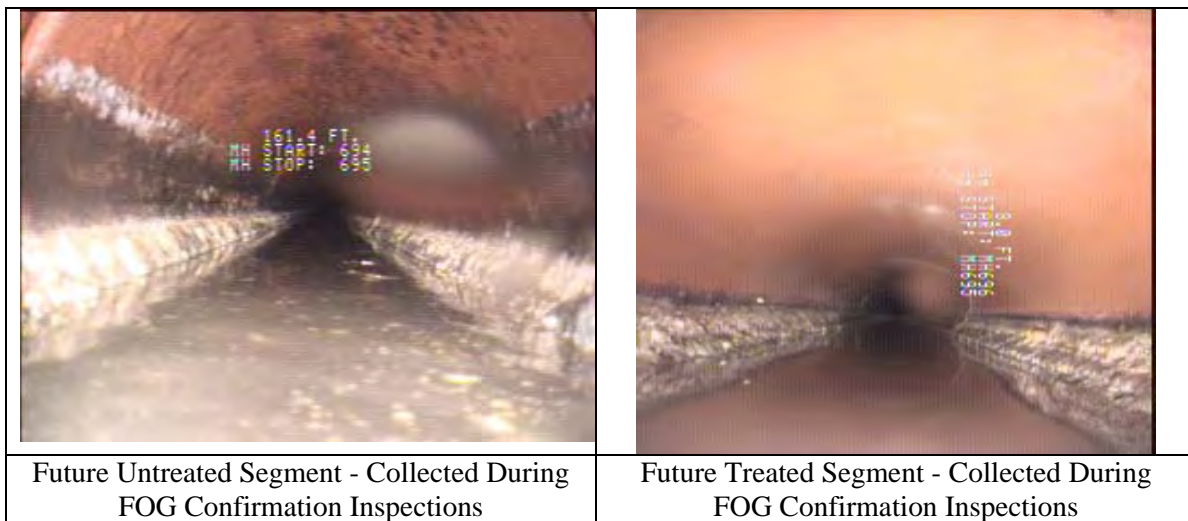
**Figure 2.21** FOG Accumulation at CMSD GS26 before Field Testing

Prior to suspension of the sewer cleaning for this evaluation, cleaning in this location was conducted on a weekly basis due to a FOG-like accumulation. FSEs, a laundromat and high density residences discharge directly to the hot spot pipe segments. A low flow condition (due to the proximity to a starter) and slight sags may contribute to grease accumulation in this location. Selection of this location as a candidate for this study was based on CCTV inspections conducted during FOG characterization and confirmed with CCTV inspections prior to the start of this evaluation (see photos below).

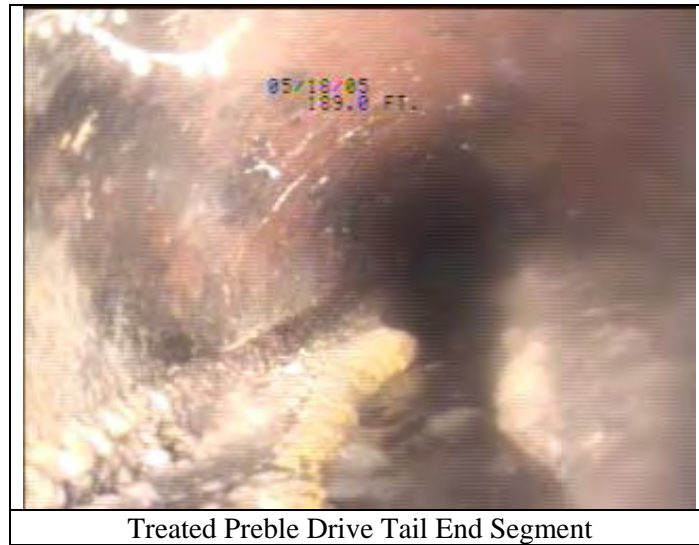
**Figure 2.32** FOG Accumulation 3.5 Months after Cleaning

CCTV inspection of the Preble Drive tail end pipe segments was conducted on 5/18/05 and the video was reviewed with OCSD Sewer Maintenance Staff. Based on the observed grease accumulation (photo below), OCSD staff determined that line cleaning was required for the tail end of the treated pipe segments (i.e., the Preble Drive segment) and the evaluation was terminated in this location.

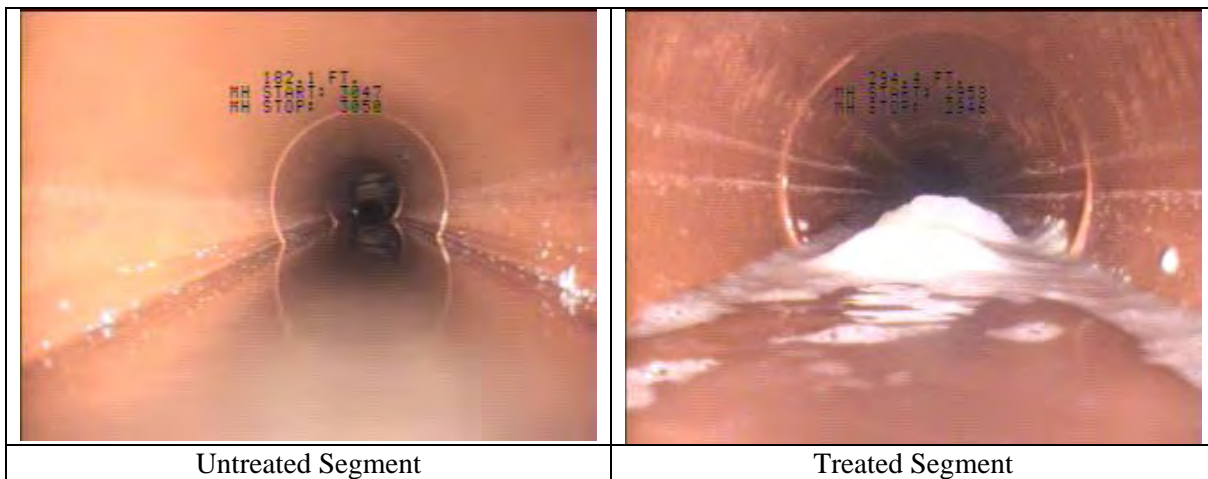
**Figure 2.34** COO HS28 Immediately after Line Cleaning

Line cleaning of this location was conducted with a standard jetting nozzle on 1/24/05, followed by CCTV inspection where the following baseline (clean pipe) images were collected:

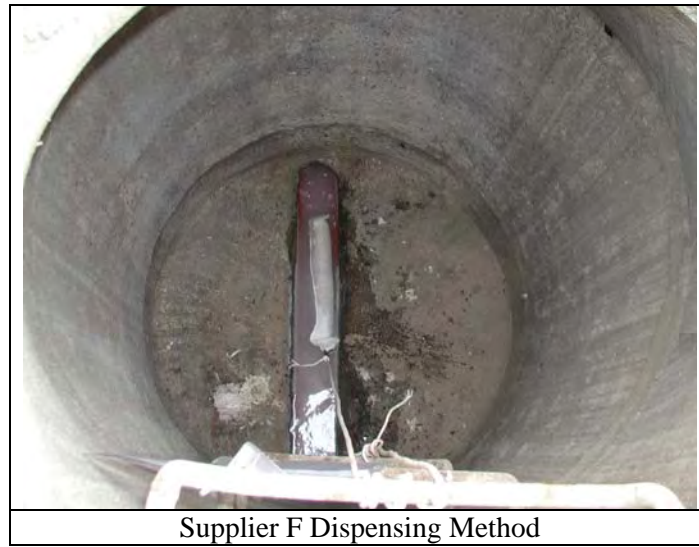
Supplier F Dispensing Method

The additive setup for this location was conducted on 1/26/05 by a Supplier F representative. The Supplier F product is a dry product contained in a porous bag. The bag is suspended in the manhole channel and dispensed as the flowing wastewater dissolves the product (photo below). Replacement of the product is conducted on a 2-week basis. No problems or complications were encountered during additive setup and replacements.

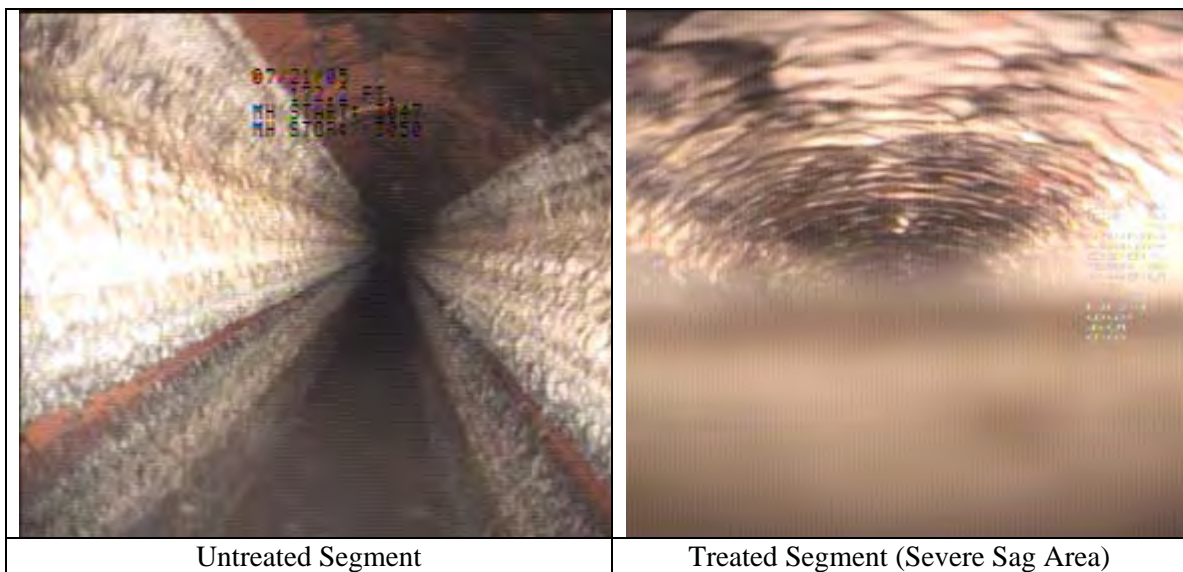
**Figure 2.38** FOG Accumulation 6 Months after Cleaning

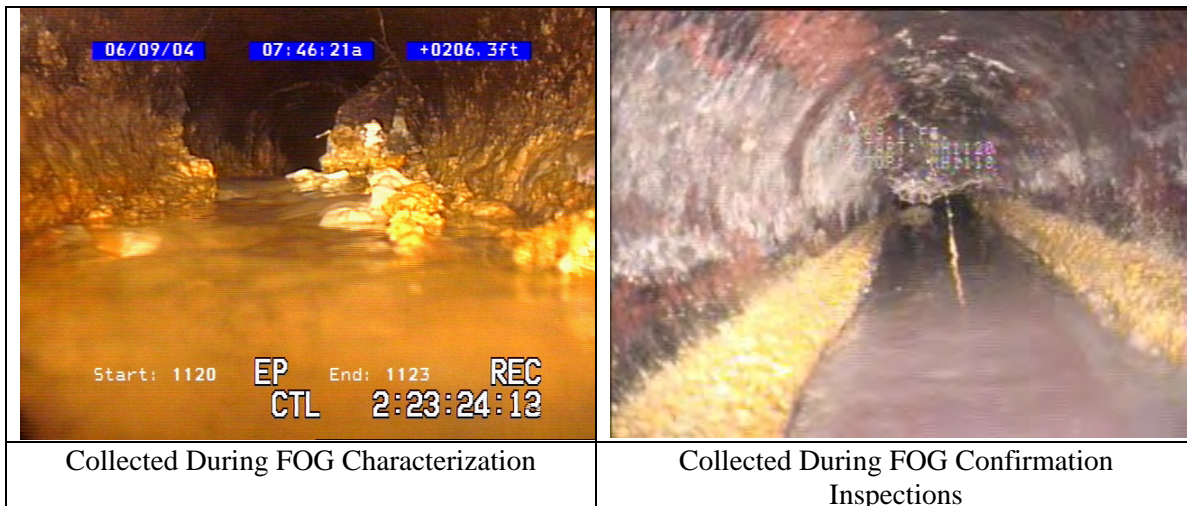
**Figure 2.39** FOG Accumulation at COLH HS14 before Field Testing

Prior to suspension of the sewer cleaning for this evaluation, cleaning in this mixed residential/commercial location was conducted on a quarterly basis due to grease accumulation from an FSE discharging directly to the hot spot pipe segment. A low flow condition due to the proximity of this pipe segment to the starter may contribute to grease accumulation in this location. Selection of this location as a candidate for the study was based on CCTV inspections conducted during FOG characterization and confirmed with CCTV inspections prior to the start of this study (see photos below).

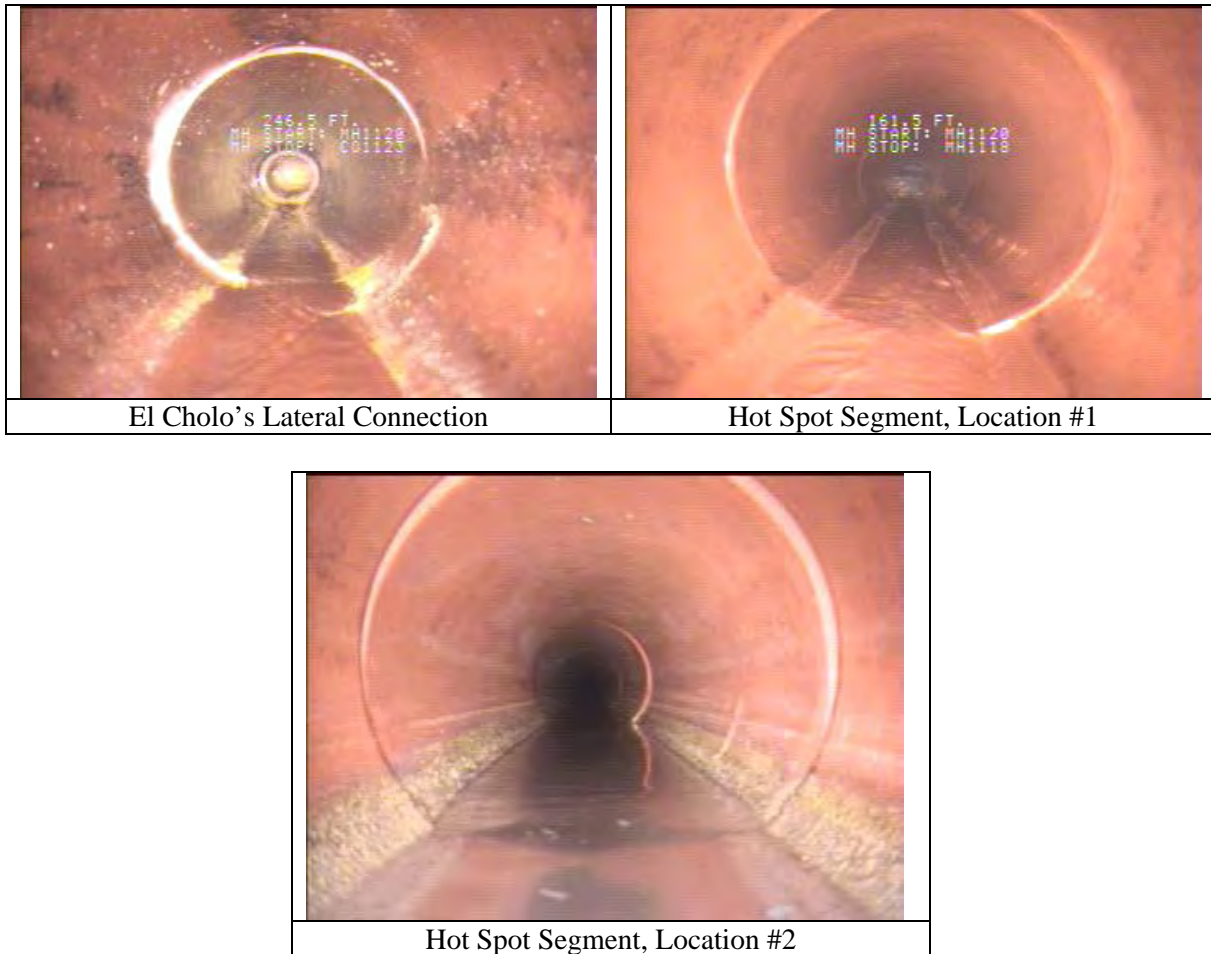
**Figure 2.40** COLH HS14 Immediately after Line Cleaning

Lateral cleaning was conducted by an FSE contractor on 2/1/05. Line cleaning of this hot spot was conducted with a standard jetting nozzle on 2/2/05, followed by CCTV inspection where the following baseline (clean pipe) images were collected. The images are for the sewer line (depicting the FSE's lateral connection) upstream of the manhole MH1120 and the sewer line downstream of MH1120.

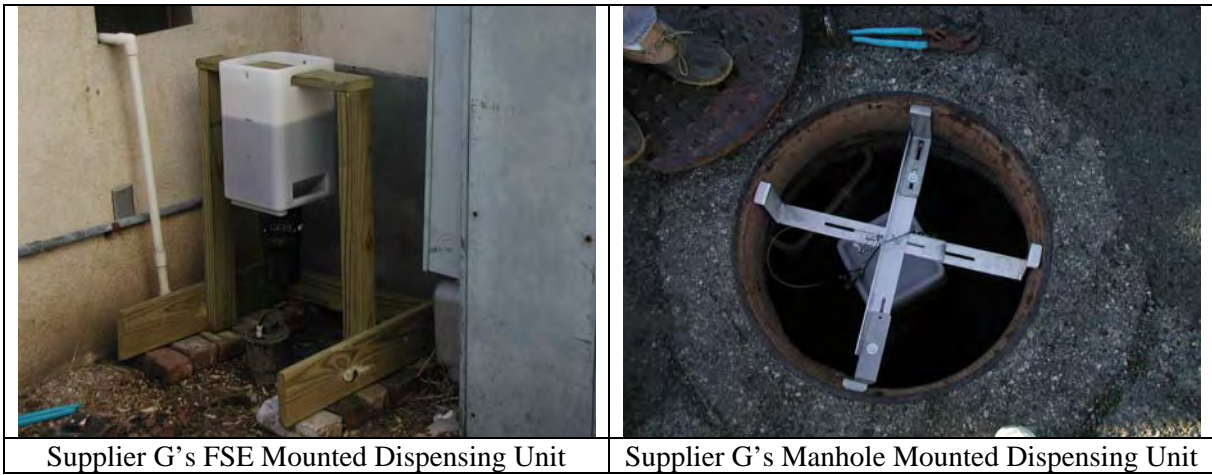
**Figure 2.41** Additive Dispenser Setup at COLH HS14

The additive setup for this location was conducted on 2/3/05 by a Supplier G representative. The Supplier G product was dispensed in a liquid form from a holding tank. One dispensing unit was located at a clean-out at the Café El Cholo Facility (photo below). Another dispensing unit was located inside the manhole at MH1120 (photo below). The holding tanks were replenished on a 2-week basis. Problems with the support bracket for the dispensing unit located in the manhole resulted in some dosing inconsistencies.

For this application, due to the additive dispensing/application locations in one of the FSE's cleanouts and also in a manhole, there is not an untreated pipe segment to compare with the treated pipe segment results. This is why this application is being called a hybrid between Sewer Line-applied and FSE-applied. CCTV inspections were conducted on a monthly basis for this location for the treated pipe segments upstream and downstream of manhole MH1120. The following images were collected from the CCTV inspection of the treated pipe segments conducted after 3 months of additive application.

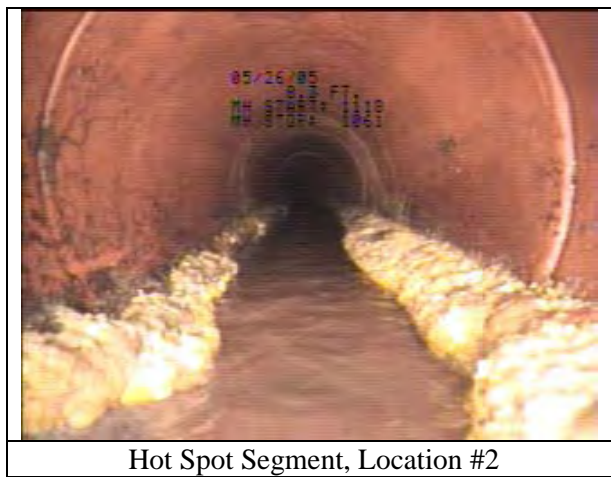
**Figure 2.43** FOG Accumulation 4 Months after Cleaning

From the CCTV inspection conducted on 5/26/05, it was determined by La Habra Sewer Maintenance Staff that line cleaning was required and the additive evaluation was terminated in this location. This was based on evaluation of the grease accumulation in the treated segments of this hot spot (photos below).

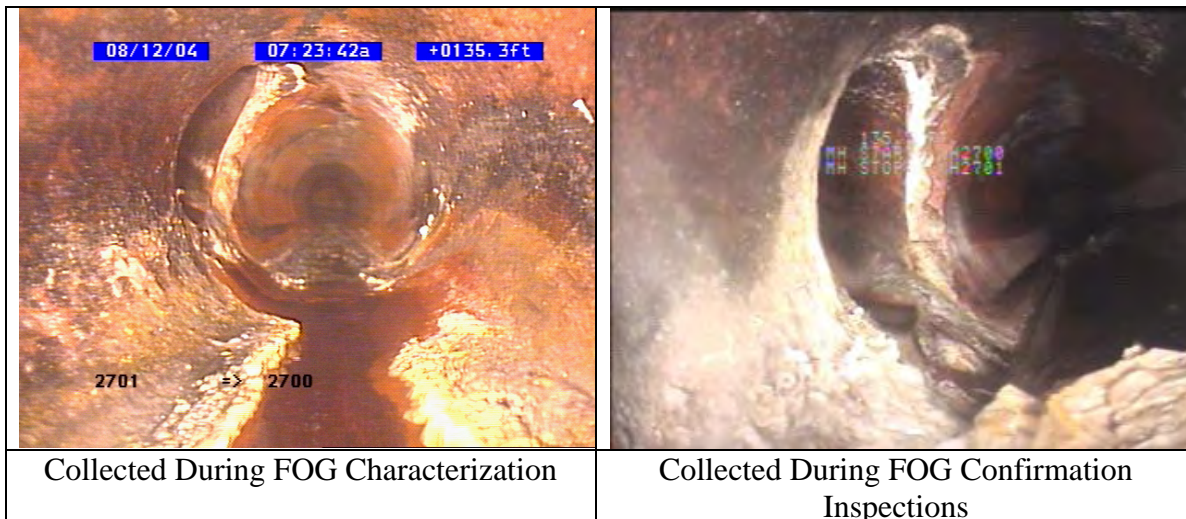
**Figure 2.44** FOG Accumulation at COLH HS6 before Field Testing

Prior to suspension of the sewer cleaning for this evaluation, cleaning in this location was conducted on a quarterly basis due to grease accumulation from an FSE discharging directly to the hot spot pipe segment. A low flow condition due to the proximity of this pipe segment to the starter may contribute to grease accumulation in this location. Selection of this location as a candidate for the study was based on CCTV inspections conducted during FOG characterization and confirmed with CCTV inspections prior to the start of this study (see photos below).

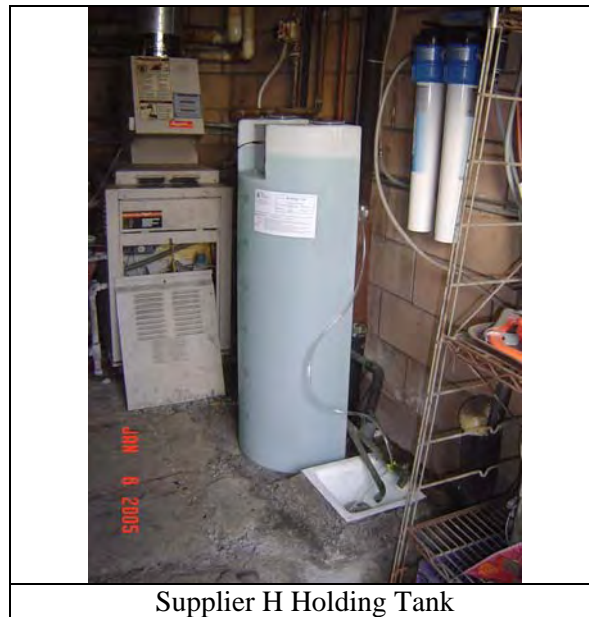
**Figure 2.46** Additive Dispenser Setup at COLH HS6

The additive setup for this location was conducted on 1/6/05 by a Supplier H representative. The Supplier H product is dispensed in a liquid form from a holding tank located inside the Carrow's facility (photo below). The holding tank is replenished on a 2-week basis. No problems or complications were encountered during additive setup and service.

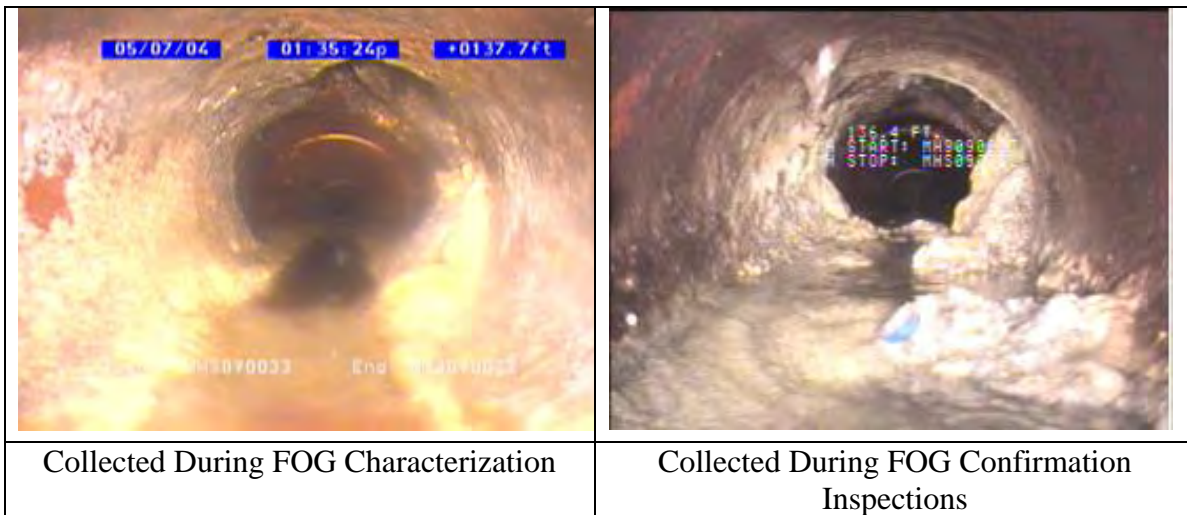
**Figure 2.49** FOG Accumulation at GGSD HS106 before Field Testing

Prior to suspension of the sewer cleaning for this evaluation, cleaning in this location was conducted on a monthly basis due to grease accumulation from an FSE discharging directly to the hot spot pipe segment. A low flow condition due to the proximity of this pipe segment to the starter may contribute to grease accumulation in this location. Selection of this location as a candidate for the study was based on CCTV inspections conducted during FOG characterization and confirmed with CCTV inspections prior to the start of this study (see photos below).

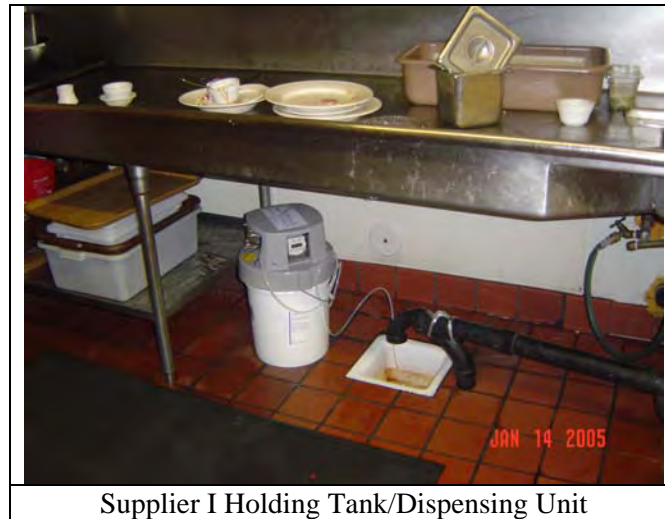
**Figure 2.51** Additive Dispenser Setup at GGSD HS106

The additive setup for this location was conducted on 1/14/05 by a Supplier I representative. The Supplier I product was dispensed in a liquid form from a holding tank located inside the Coco's facility (photo below). The holding tank was replenished on a monthly basis. Each of the 14 drains in the facility were also sprayed with the Supplier I product by a Supplier I representative on a weekly basis. No problems or complications were encountered during additive setup and service.

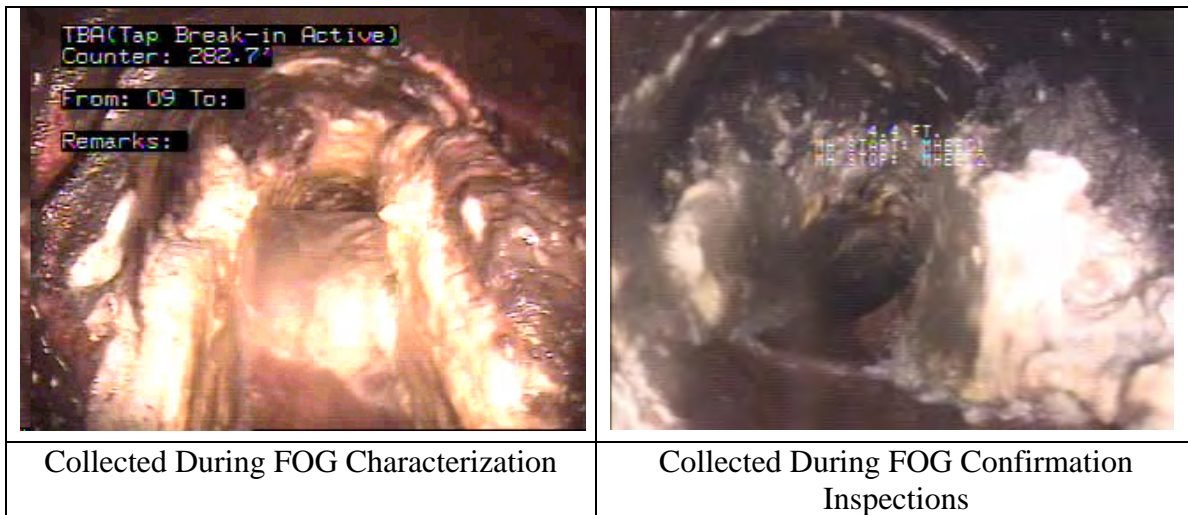
**Figure 2.55** FOG Accumulation at OCSD HS30 before Field Testing

Prior to suspension of the sewer cleaning for this evaluation, cleaning in this location was conducted on an 8-week basis due to grease accumulation from an FSE discharging directly to the hot spot pipe segment. A low flow condition due to the proximity of this pipe segment to the starter may contribute to grease accumulation in this location. Selection of this location as a candidate for the study was based on CCTV inspections conducted during FOG characterization and confirmed with CCTV inspections prior to the start of this study (see photos below).

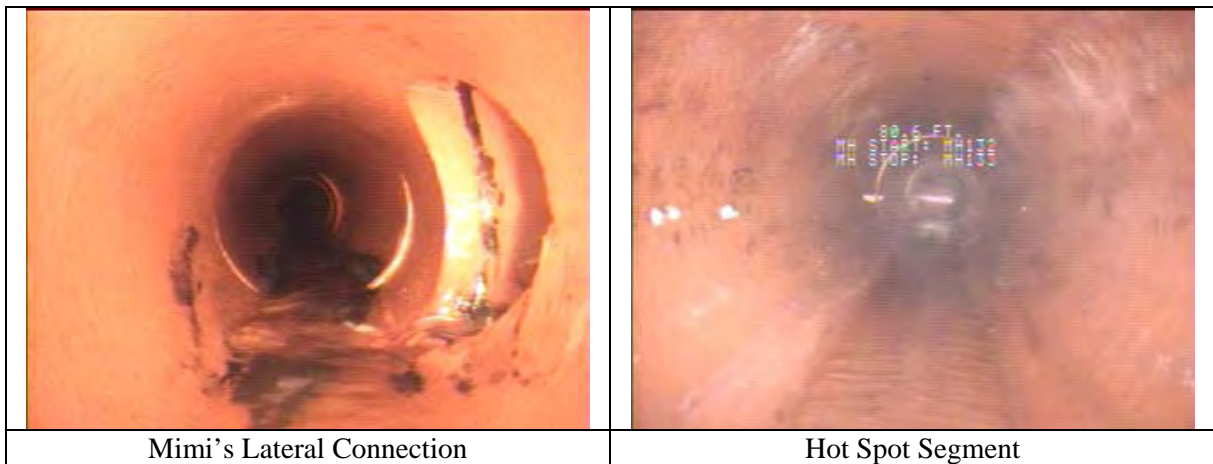
**Figure 2.61** CMSD HS14 Immediately after Line Cleaning

Lateral cleaning was conducted by an FSE contractor on 1/18/05. Line cleaning of this hot spot was conducted with a standard jetting nozzle on 1/19/05, followed by CCTV inspection where the following baseline (clean pipe) images were collected:

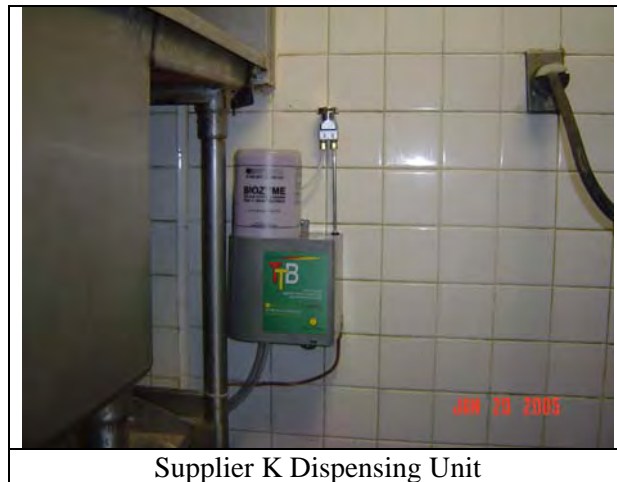
**Figure 2.62** Additive Dispenser Setup at CMSD HS14

The additive setup for this location was conducted on 1/20/05 by a Supplier K representative. The Supplier K product is dispensed in a liquid form to a single drain inside the facility (photo below). A dispensing unit electrical problem caused a 2 week delay at start-up. No other problems or complications were encountered during the evaluation.
