# ORANGE COUNTY SANITATION DISTRICT

SUBJECT: Final Phase II FOG Control Study Report

*ORANGE COUNTY*  
**Fats, Oils, and Grease (FOG) Control Study**  
**Phase II – Final Report**

**FOG Control Technology**  
**Field Testing Evaluations**

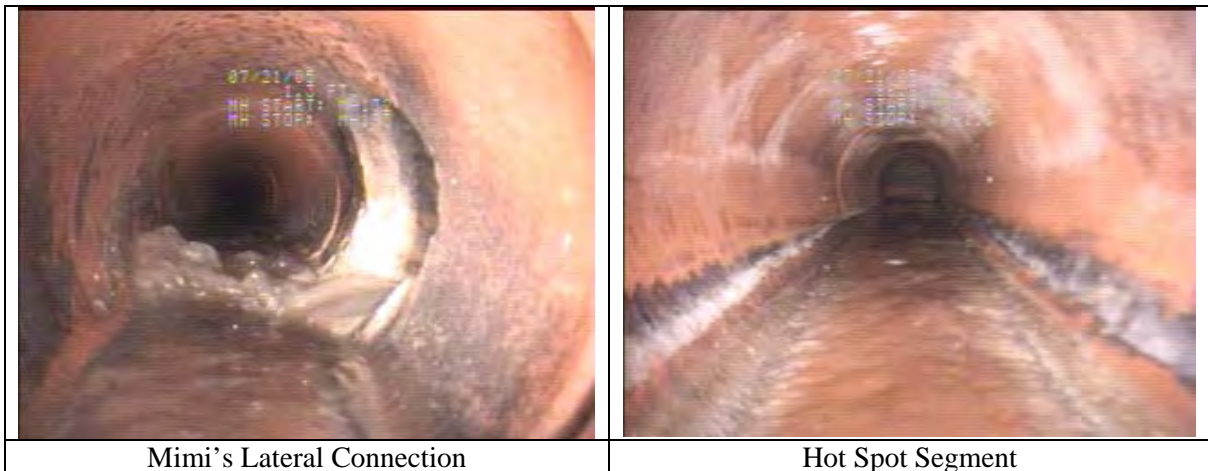
**Figure 2.67** FOG Accumulation 6.5 Months after Cleaning

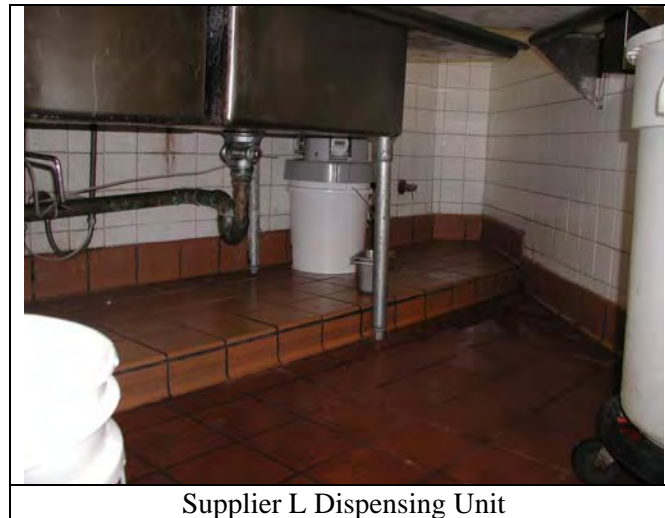
**Figure 2.70** Additive Dispenser Setup at CMSD HS57

The additive setup for this location was conducted on 1/20/05 by a Supplier L representative. The Supplier L product was dispensed in a liquid form from a holding tank located inside the facility (photo below). The holding tank was replenished on a monthly basis. An additional liquid product was applied once monthly to each facility drain by a Supplier L representative. No problems or complications were encountered during the evaluation.

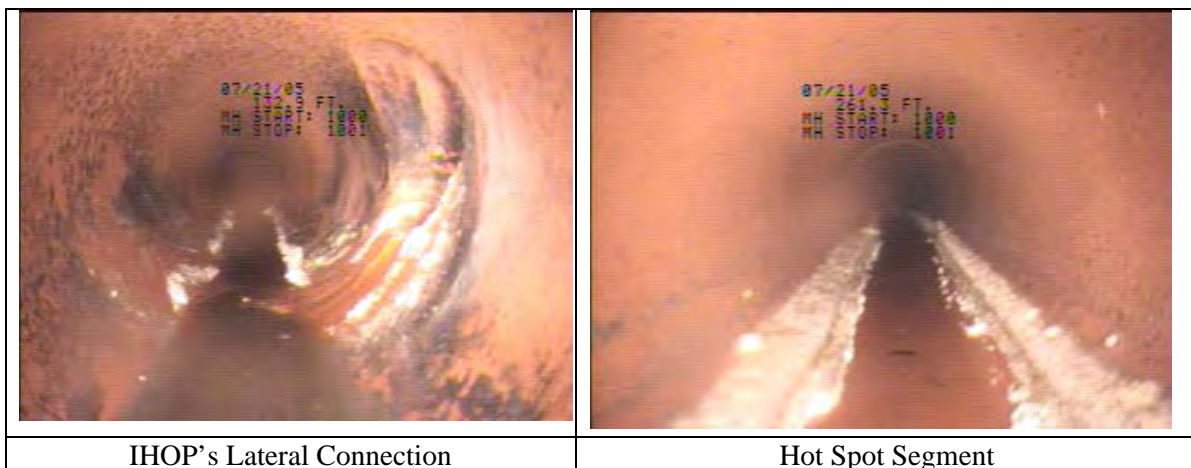
**Figure 2.74** FOG Accumulation 6.5 Months after Cleaning

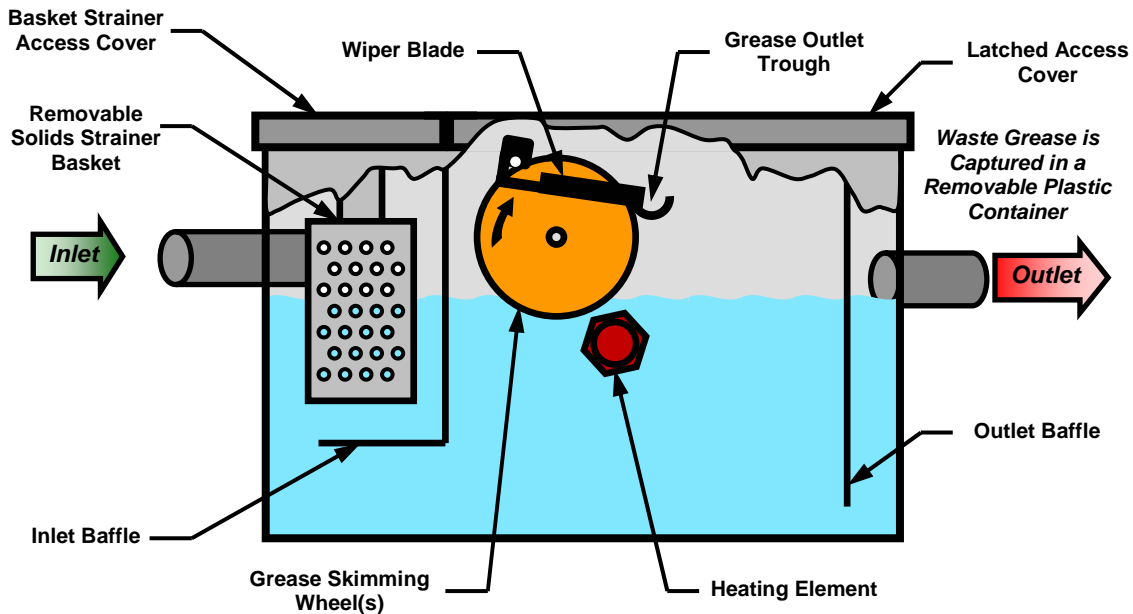
**Figure 3.1** GRD with Grease Skimming Wheel(s) (Sketch Based on *ASPE Data Book*, Volume 4, Chapter 8, and Information Provided By Suppliers)

The only products that were offered by suppliers for evaluation in this portion of the Study were GRDs. The 3 suppliers that committed to the Study provided 2 types of GRDs for evaluation. A conceptual diagram of a GRD with a grease skimming wheel to remove the grease from the main chamber is depicted in Figure 3.1. A conceptual diagram of a GRD that utilizes a grease level monitor and pump rather than a skimming wheel to remove the grease is depicted in Figure 3.2.

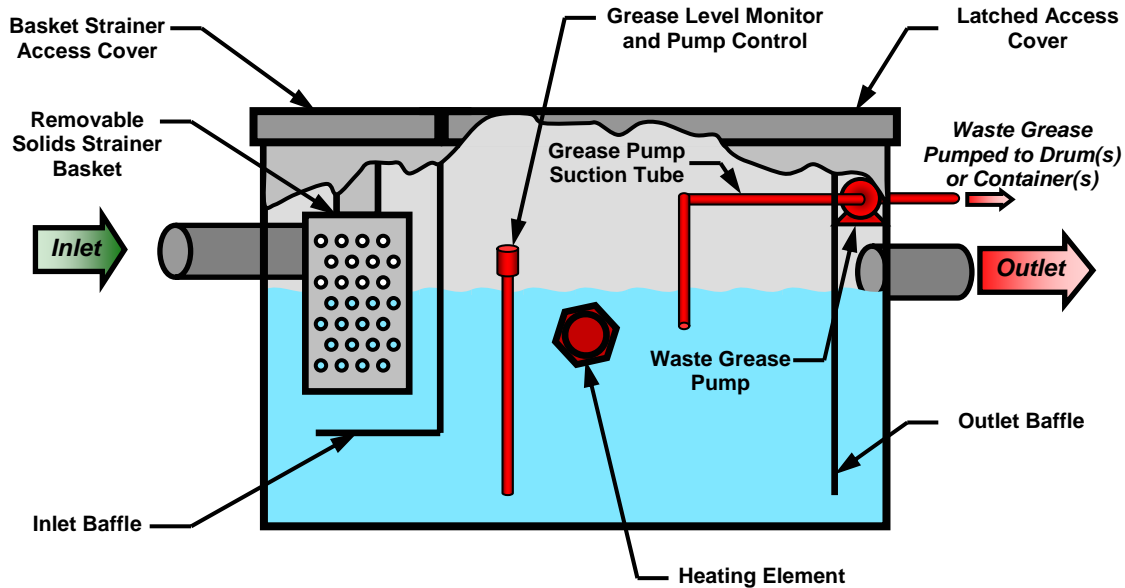
**Figure 3.2** GRD with Grease Level Monitor and Pump (Sketch Based on *ASPE Data Book*, Volume 4, Chapter 8, and Information Provided by Supplier)

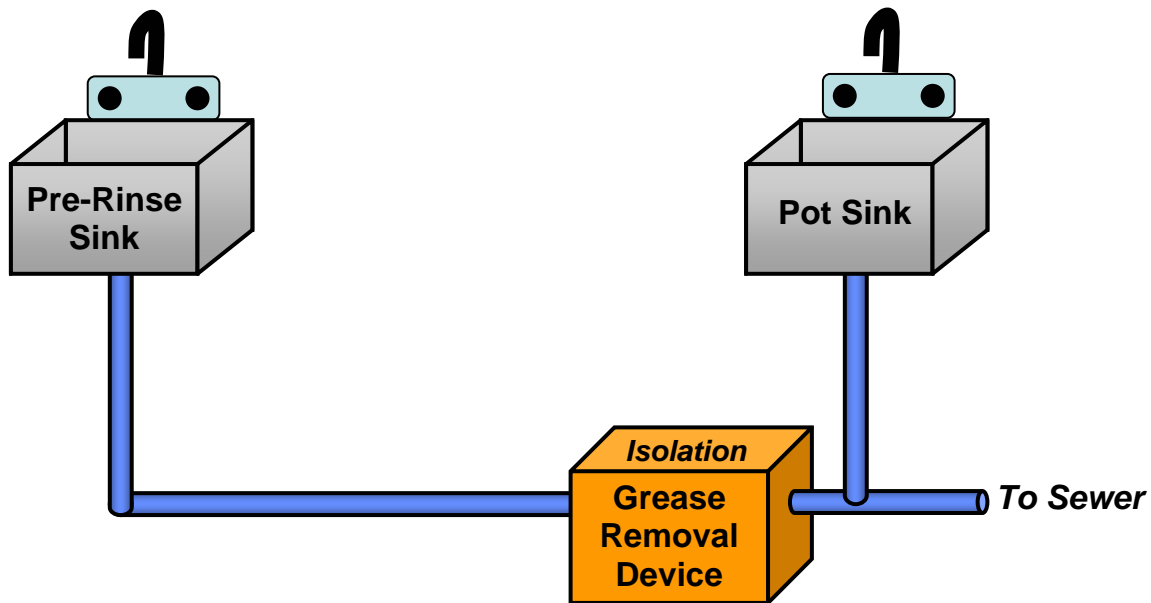
**Figure 3.3** Isolation-type GRD Application (1 GRD Example) – One (1) grease waste drain is typically connected to 1 GRD. In many cases, other grease waste drains are not connected to any grease control devices.

In this application, the GRD is connected to 1 grease waste drain (e.g., the pre-rinse sink), thereby isolating the grease from that drain and protecting the facility's internal drain lines (Figure 3.3). In some cases, more than 1 grease waste drain is connected to the same GRD if they are in close proximity. In rare cases, more than 1 GRD is installed in a single kitchen to treat multiple grease waste drains (Figure 3.4). Depending upon the manufacturer, the purchase price for 20- to 35-gallon per minute (gpm), isolation-type GRDs ranges from \$2,500 to \$8,000. Installation costs range from \$500 to \$1,000 in most cases.

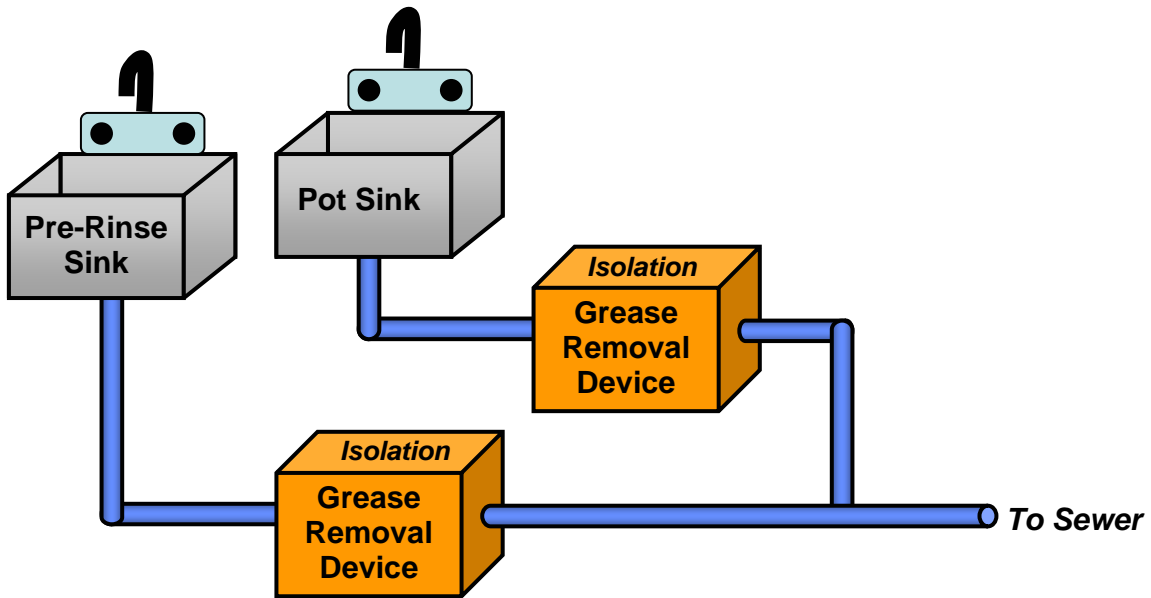
**Figure 3.4** Isolation-type GRD Application (Multiple GRDs Example) - Each grease waste drain is connected to a separate GRD.

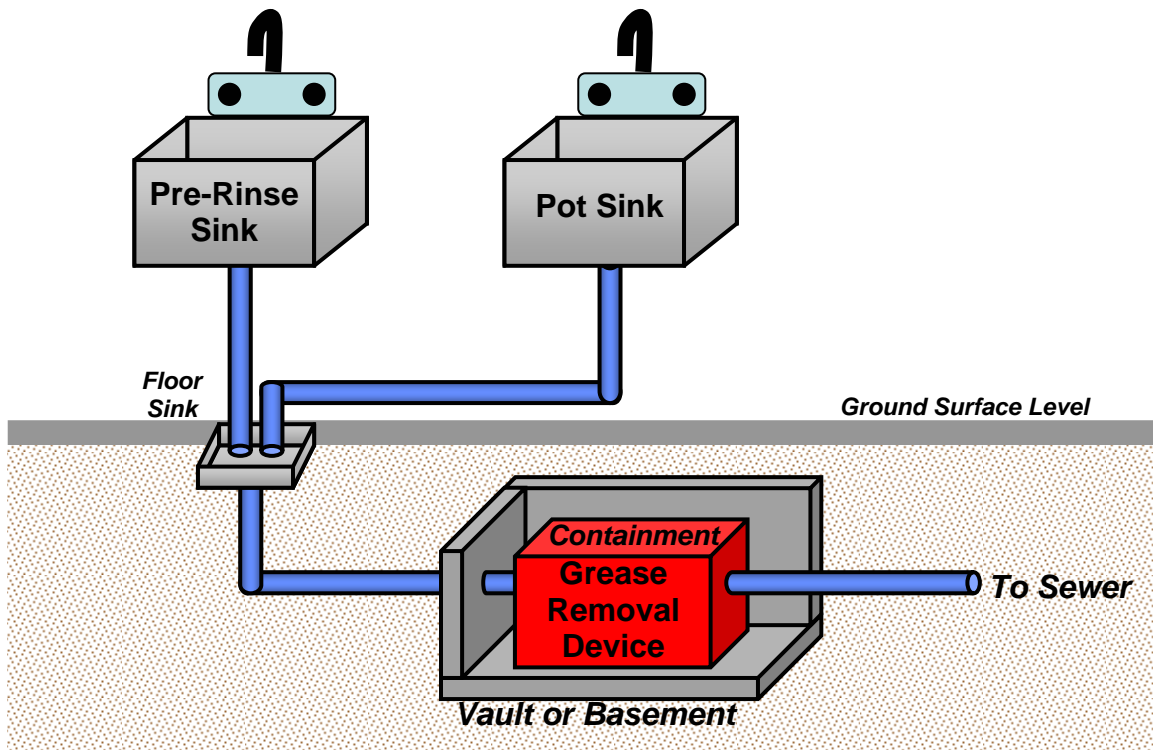
**Figure 3.5** Containment-type GRD Application.- One (1) GRD is connected to all the potential grease waste drains. The GRD is typically located in a vault or basement.

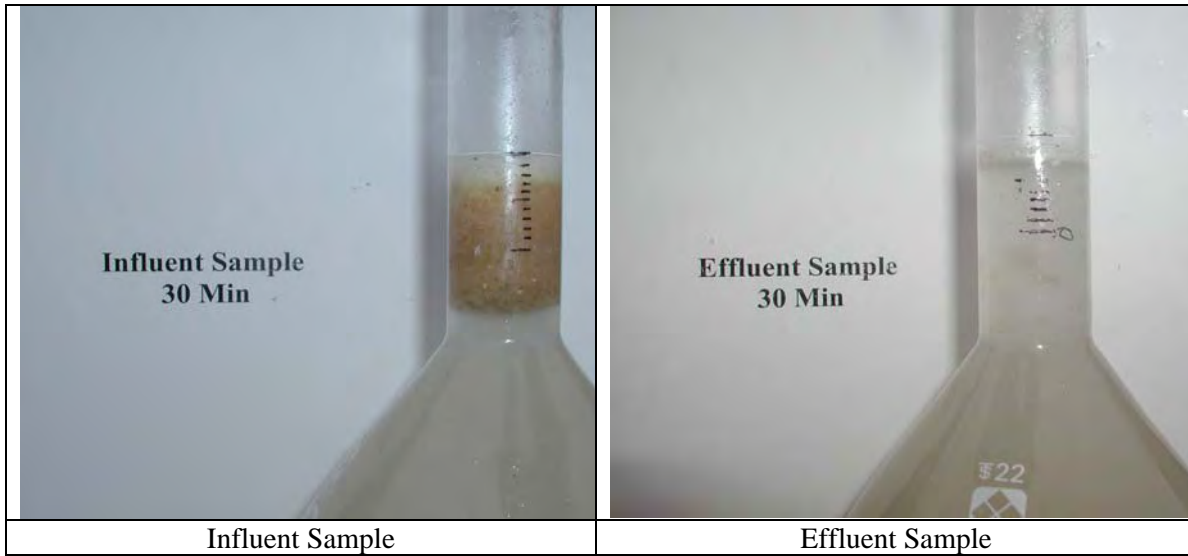
**Figure 3.7** Example of Floating FOG Samples after 30 Minutes of Separation Time in the Flask

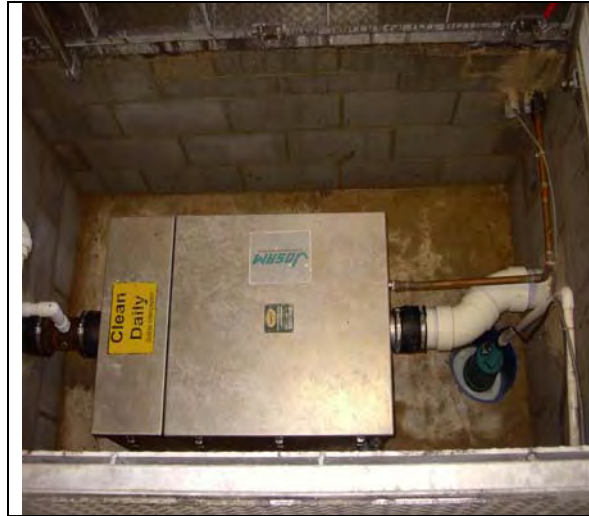
**Figure 3.8** 35-gpm Supplier M GRD in an Underground Vault in the Bravo Pizza Kitchen

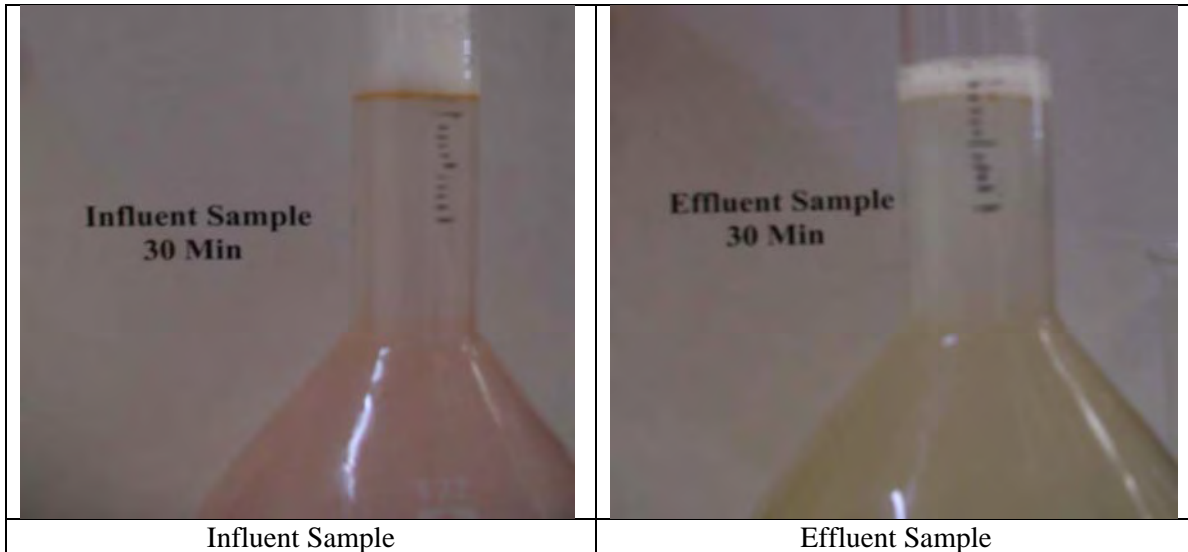
**Figure 3.9** Example of Floating FOG Samples after 30 Minutes of Separation Time in the Flask Collected from Bravo Pizza

providing a simple and logical field method of determining the GRD's effectiveness in removing floating FOG from the wastewater. Utilizing this test, measurements of the influent and effluent floating FOG were collected on multiple occasions over a period of 4-6 months under a variety of conditions. Examples of the floating FOG samples are shown below:

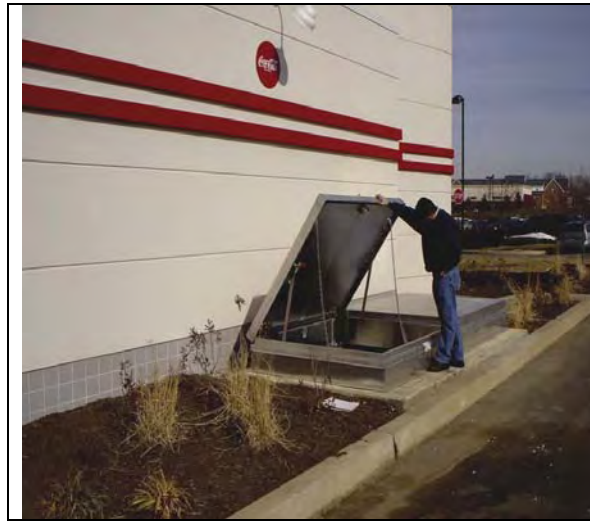
**Figure 3.10** 150-gpm Supplier M GRD in an Underground Vault Outside at Ruby's Diner

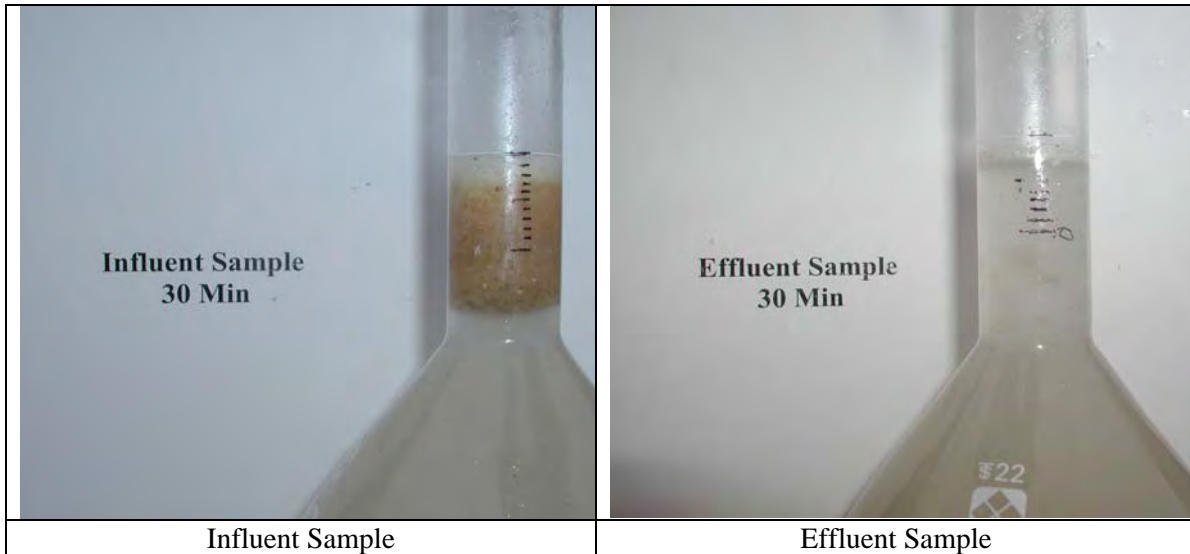
**Figure 3.11** Example of Floating FOG Samples after 30 Minutes of Separation Time in the Flask Collected from Ruby's Diner

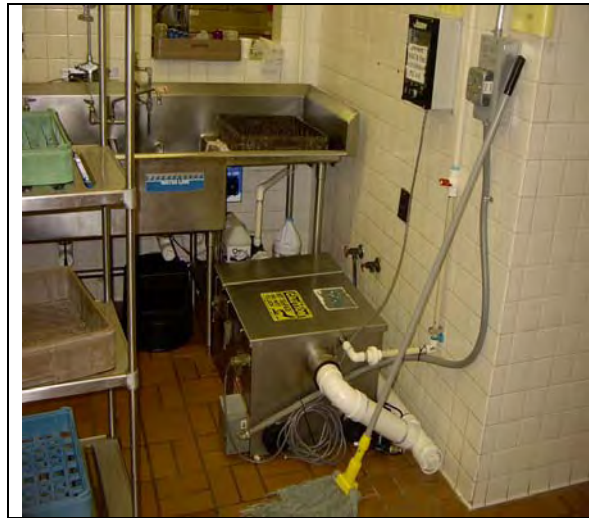
**Figure 3.12** 25-gpm Supplier M GRD Under the Sink in the Assisi House Kitchen

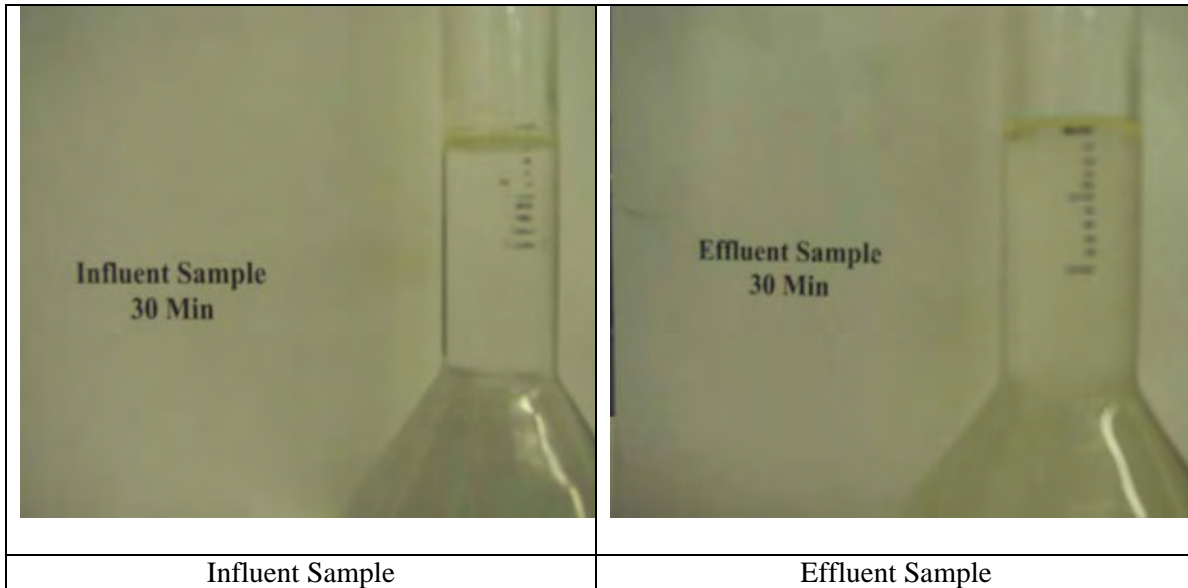
**Figure 3.13** Example of Floating FOG Samples after 30 Minutes of Separation Time in the Flask Collected from Assisi House

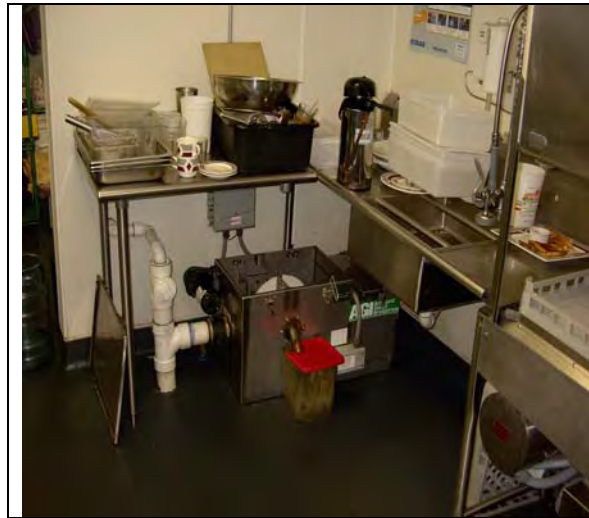
**Figure 3.14** 25-gpm Supplier N GRD Under a Sink in the Hi-Hat Kitchen

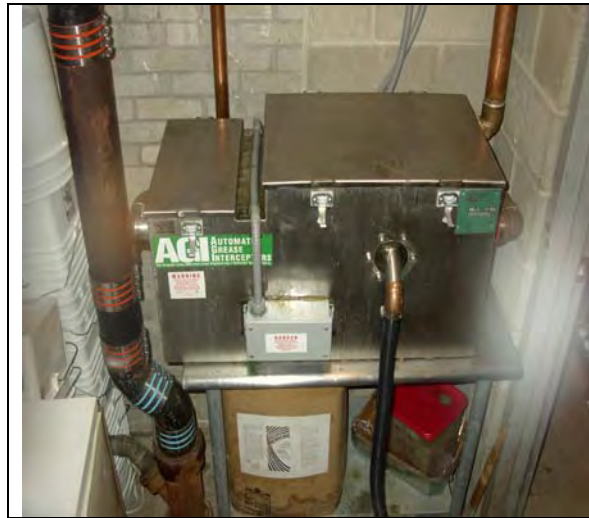
**Figure 3.16** 35-gpm Supplier N GRD in the L'Alouette Basement

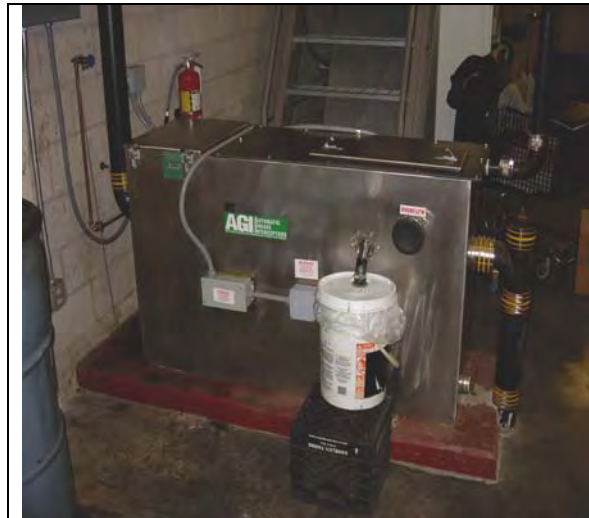
**Figure 3.18** 150-gpm Supplier N GRD in the RI Convention Center Basement

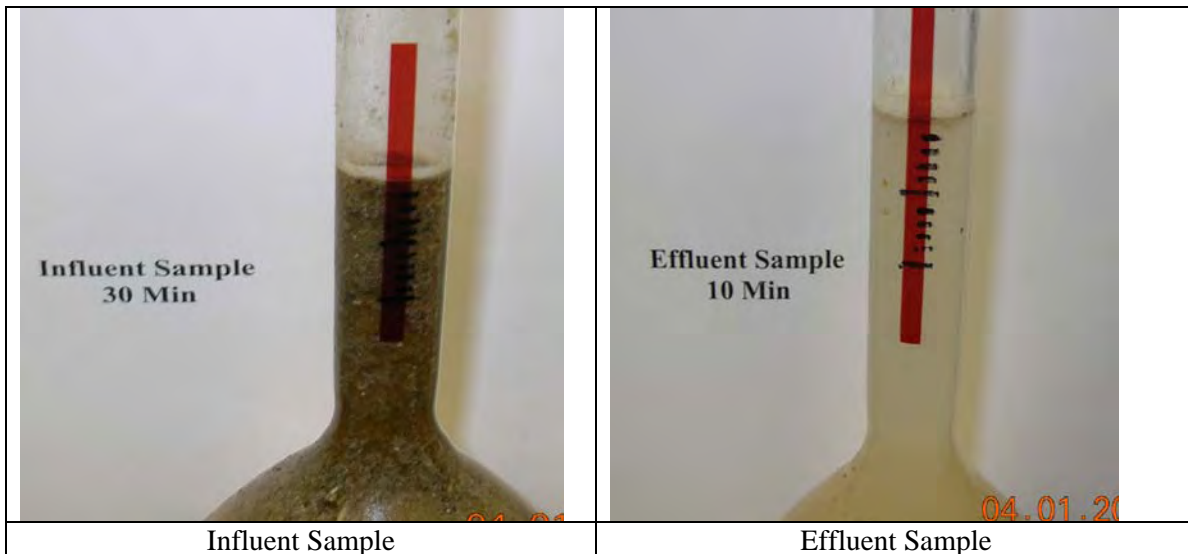
**Figure 3.19** Example of Floating FOG Samples after 30 Minutes of Separation Time in the Flask Collected from the RI Convention Center

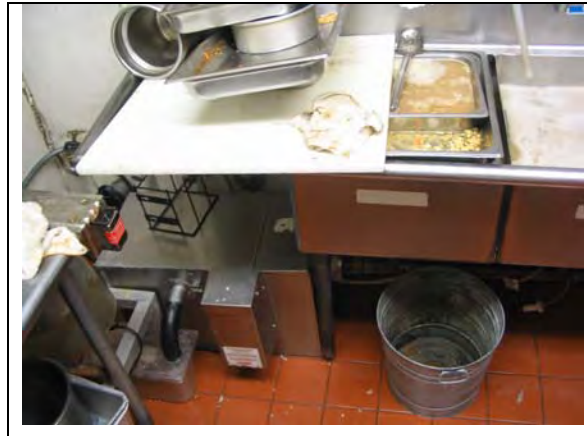
**Figure 3.20** 25-gpm Supplier O GRD Under a Sink in the El Tapatio Kitchen

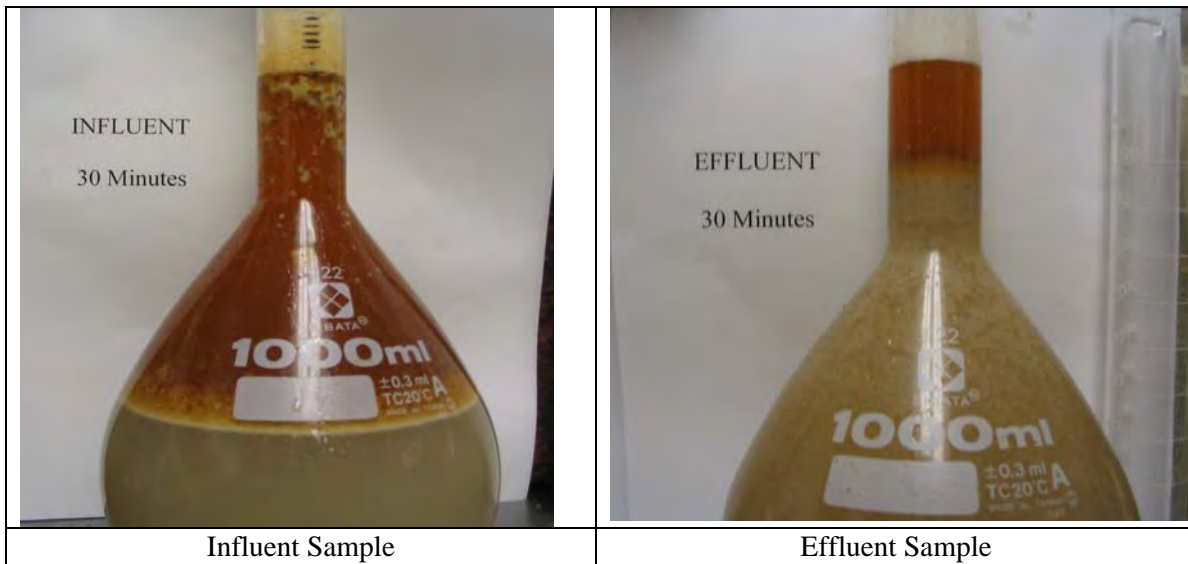
**Figure 3.21** Example of Floating FOG Samples after 30 Minutes of Separation Time in the Flask Collected from El Tapatio

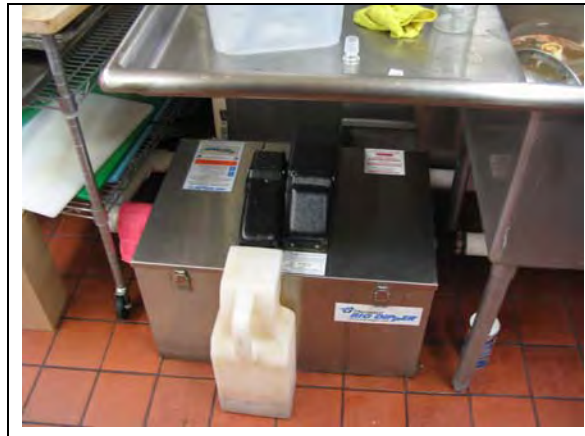
**Figure 3.22** 25-gpm Supplier O GRD Under a Sink in the Oh's Catering Kitchen

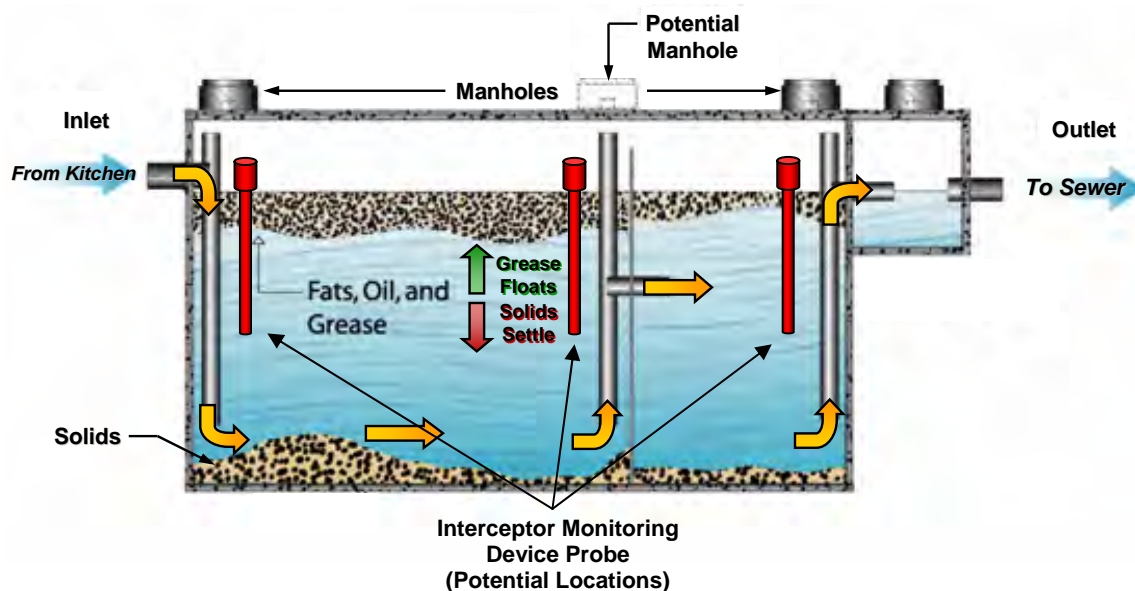
**Figure 4.1** Interceptor Monitoring Device (IMD) Installation (Probe Installation Location May Vary)

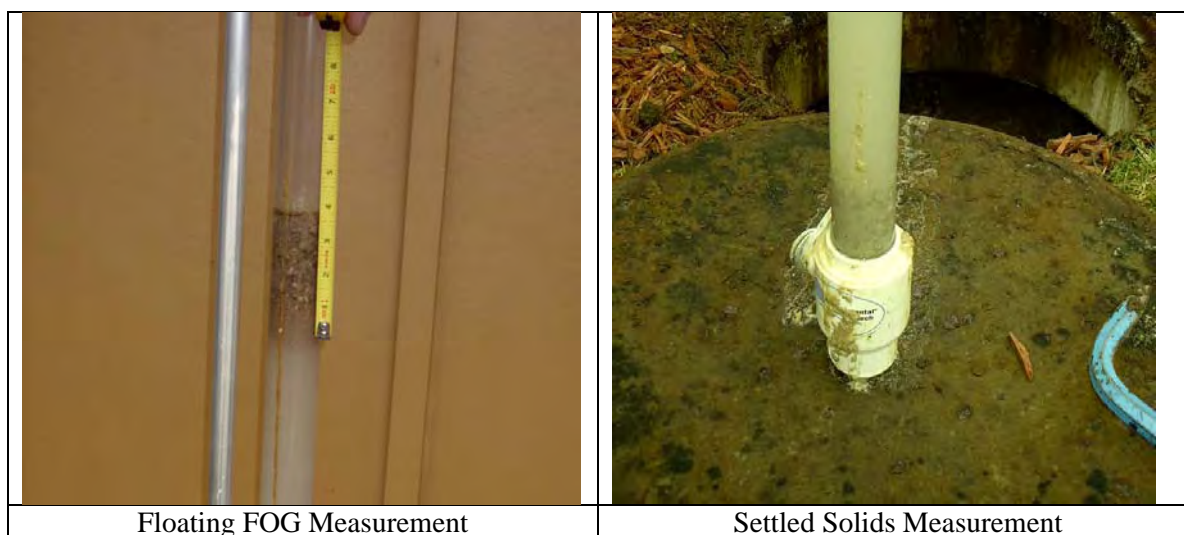
**Figure 4.2** Core Sampler Measurements
