Discovery of unknown “chalk-like” substance found in collection system

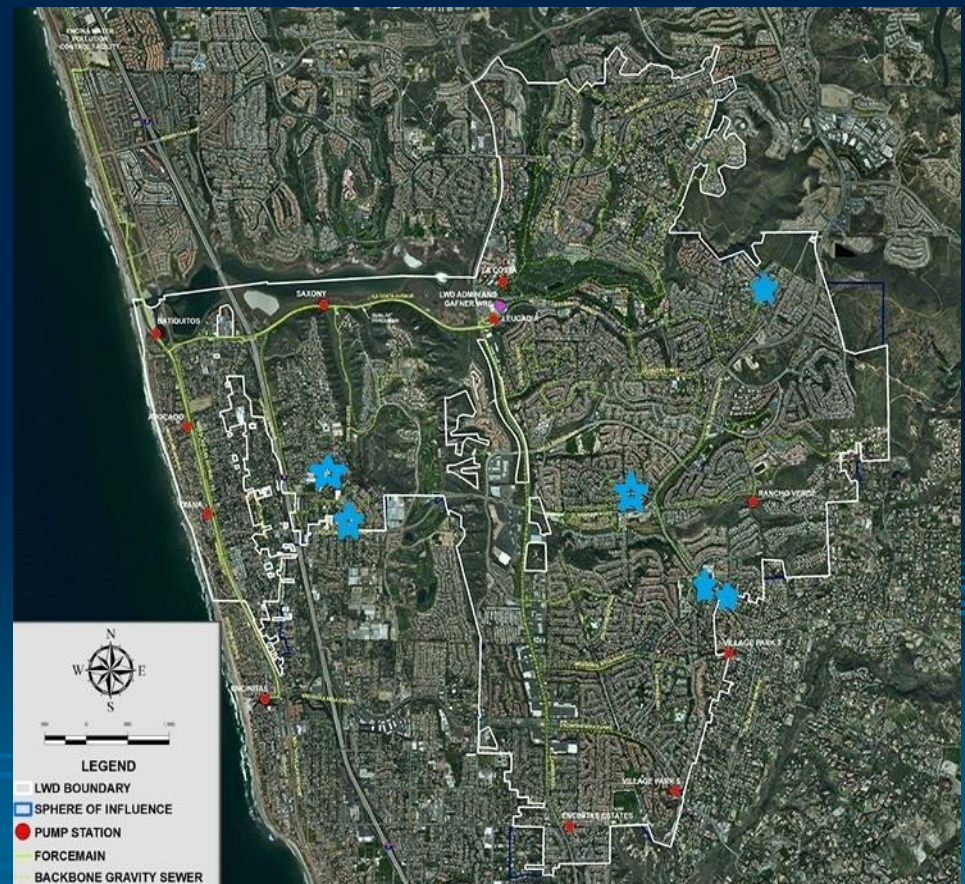
Other instances since initial discovery

➤ Total of five other instances since the initial discovery.

- Rancho Santa Fe (2)
- Saxony Road
- Sombrosa St
- Dolphin Circle
