# Condition Assessment of Metallic Force Mains

Gull Lake  
1.94 mile 12" DIP forcemain  
inspection

November 16 – 20, 2014

Richland, MI

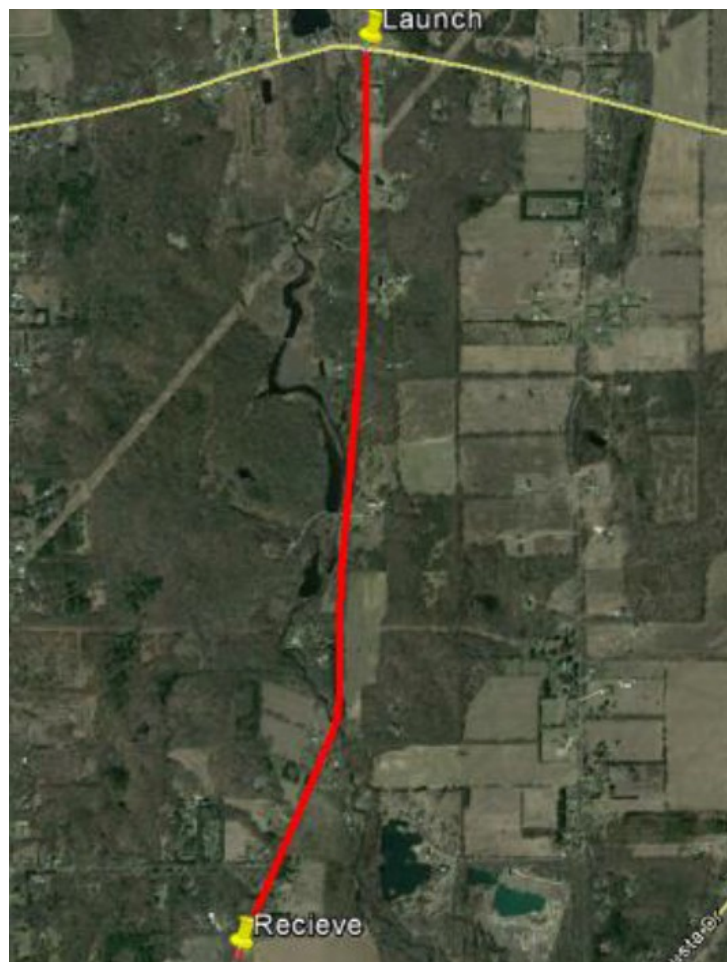
- 12 inch DIP forcemain
- 10,237 ft in length
- Multiple peaks and valleys
- Installed 1983
- Never cleaned or inspected
- Manhole discharge used as a retrieval point

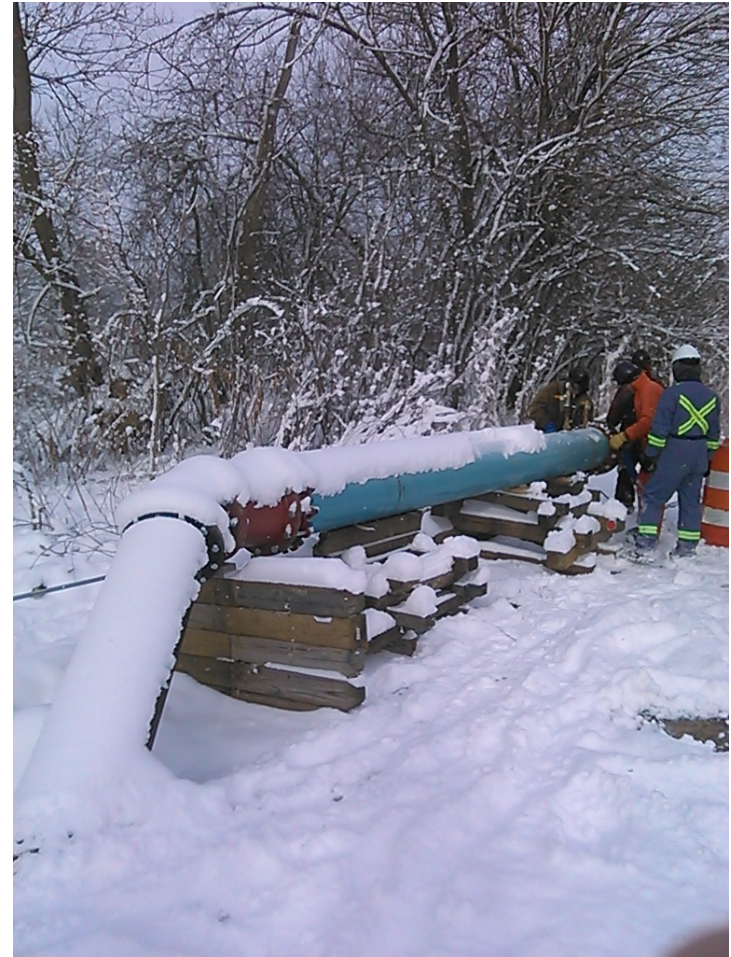
- 14" launch barrel installed prior to arrival
- Used water from a pumper truck to propel tools through the line
- Barrel inserted in a wye and then the forcemain
- Low flow rates > 1.2ft per second

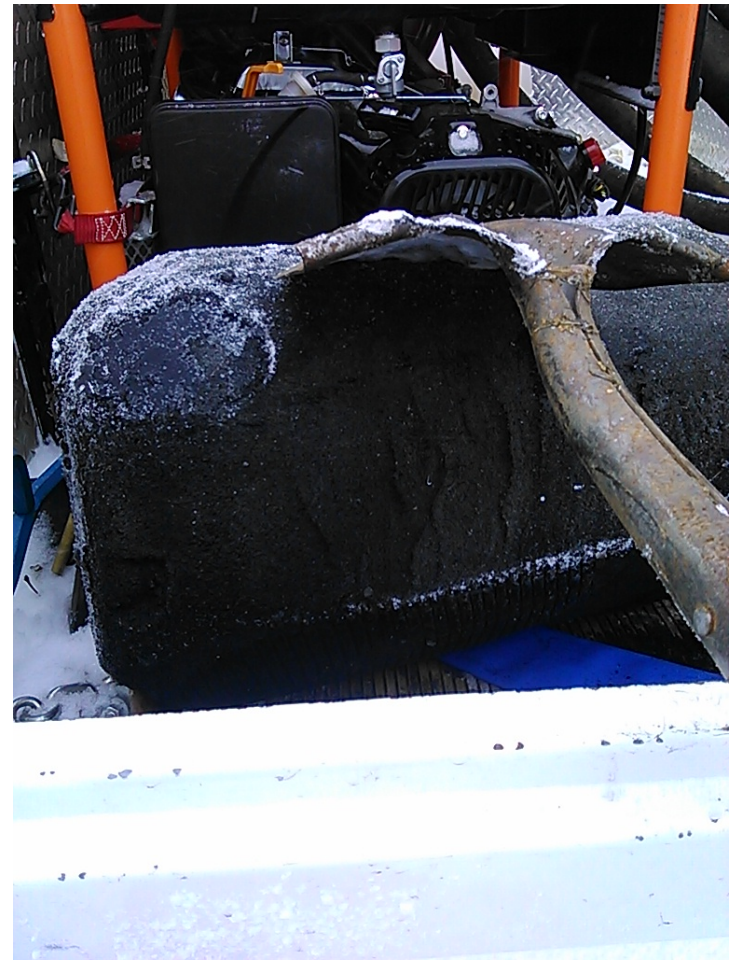
- Pig took about 2 hours to complete its run
- Looked really good
- Crew was very positive the gauge pig run would go as smoothly
- NOT!

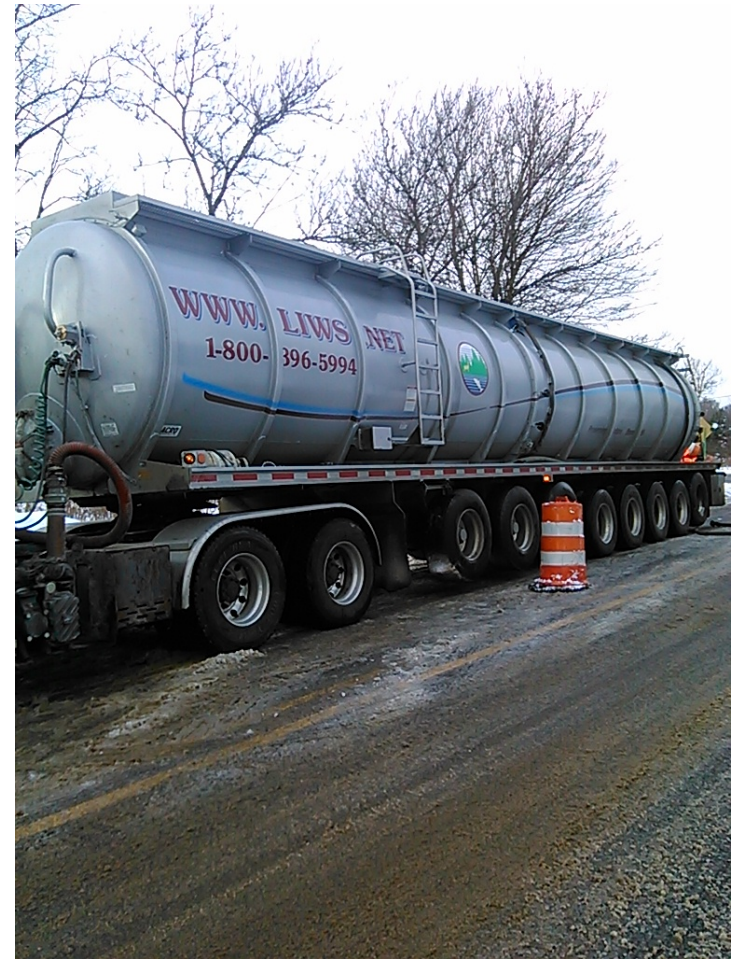
- Launched the following night at 5 pm – taking advantage of lower demands
- Winter still here!
- Used E-Vac truck to help launch tool
  - Brought in the big boys!

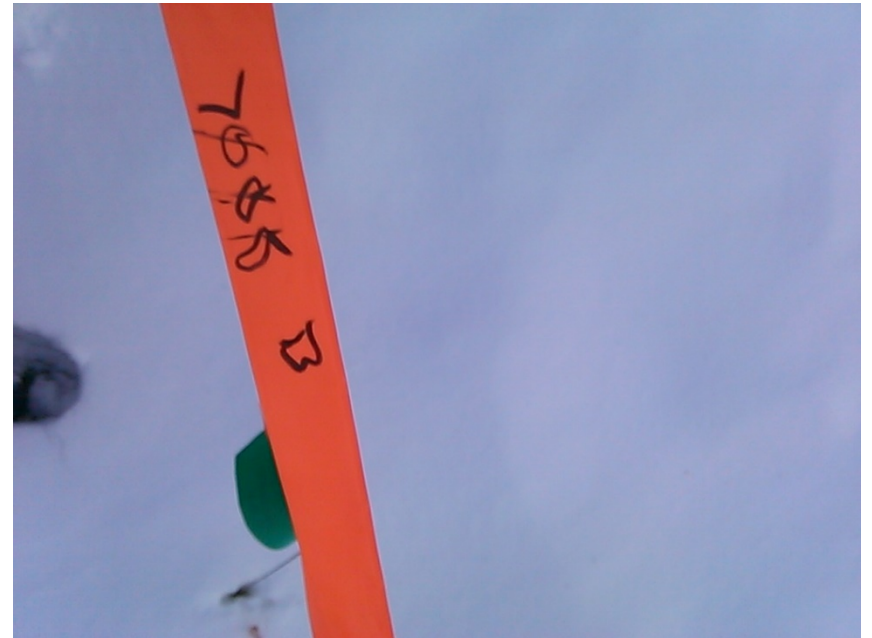
- Stakes were placed every 1000 feet
- Tool was tracked using AGMs – frequency changed to 41MHz
- Since it was a rural road at night 2 trucks used to protect 3 trackers from any traffic

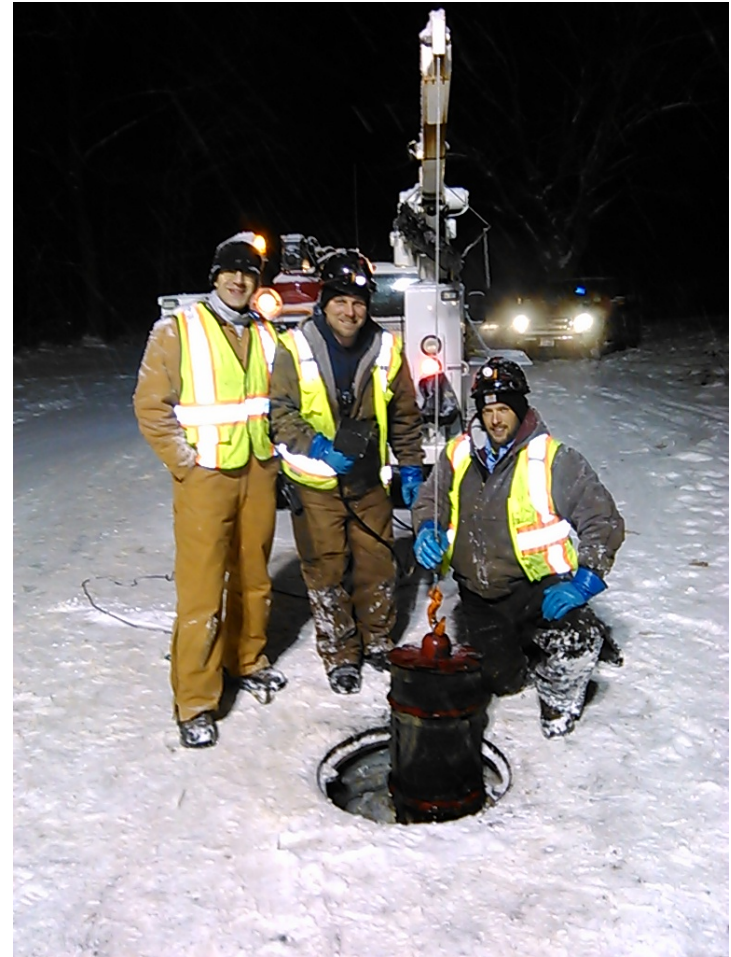
- Approximately 8 hours later the tool arrived in good shape at the manhole
- Tool extracted and taken back to shop to download data
- Very happy and cold crew!
